Air, Maritime and Railway Traffic Accidents Investigation Agency
Department for Railway Traffic Accident Investigation

Zagreb, 16 March 2015

FINAL REPORT
Derailment of railway vehicles on the Knin-Zadar
line
22 April 2014

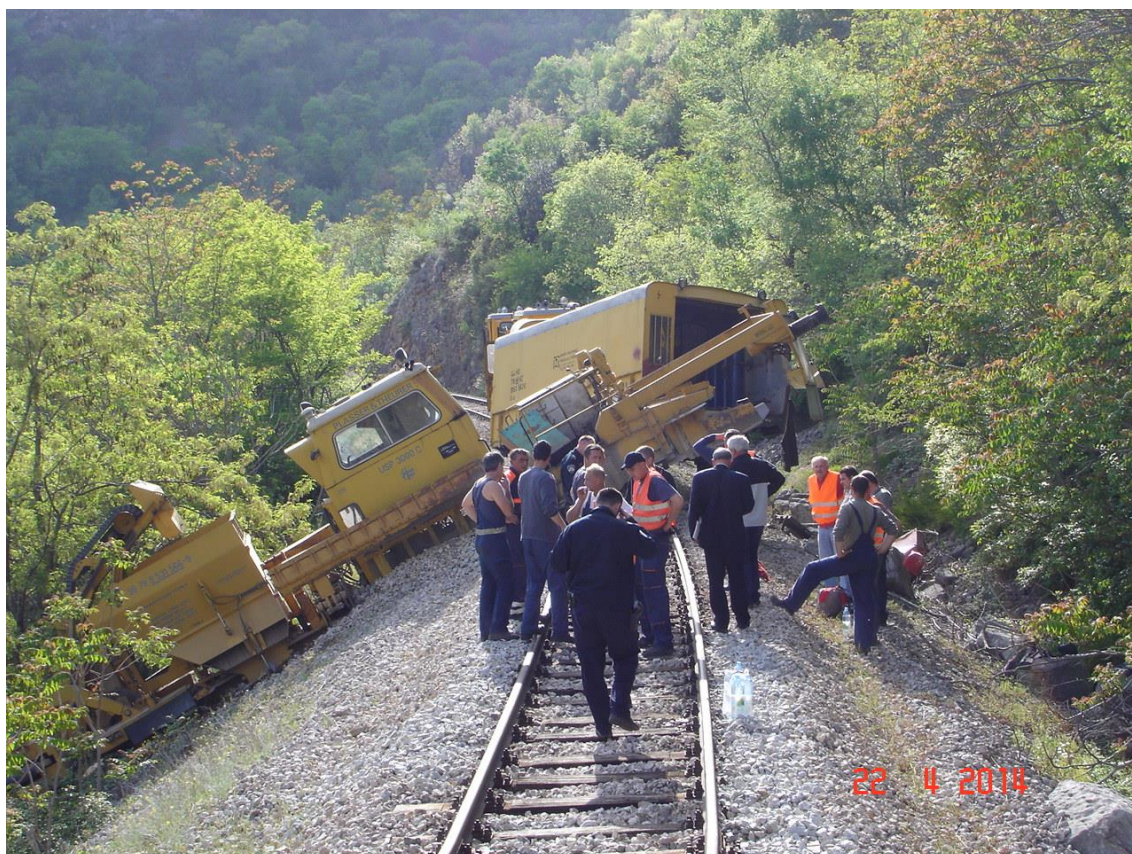
After the vehicles stopped, the first vehicle remained in the position under ca. 90° in relation to the track, and its front part skidded off onto the embankment and was left hanging on the slope, and the second vehicle (the trailer of the first railway vehicle) derailed with both axles to the left side in the direction of movement, while the third and the fourth vehicle stayed completely on the tracks.

Image 2 – Scene of the accident with derailed vehicles (image source: HŽ Infrastruktura d.o.o.)

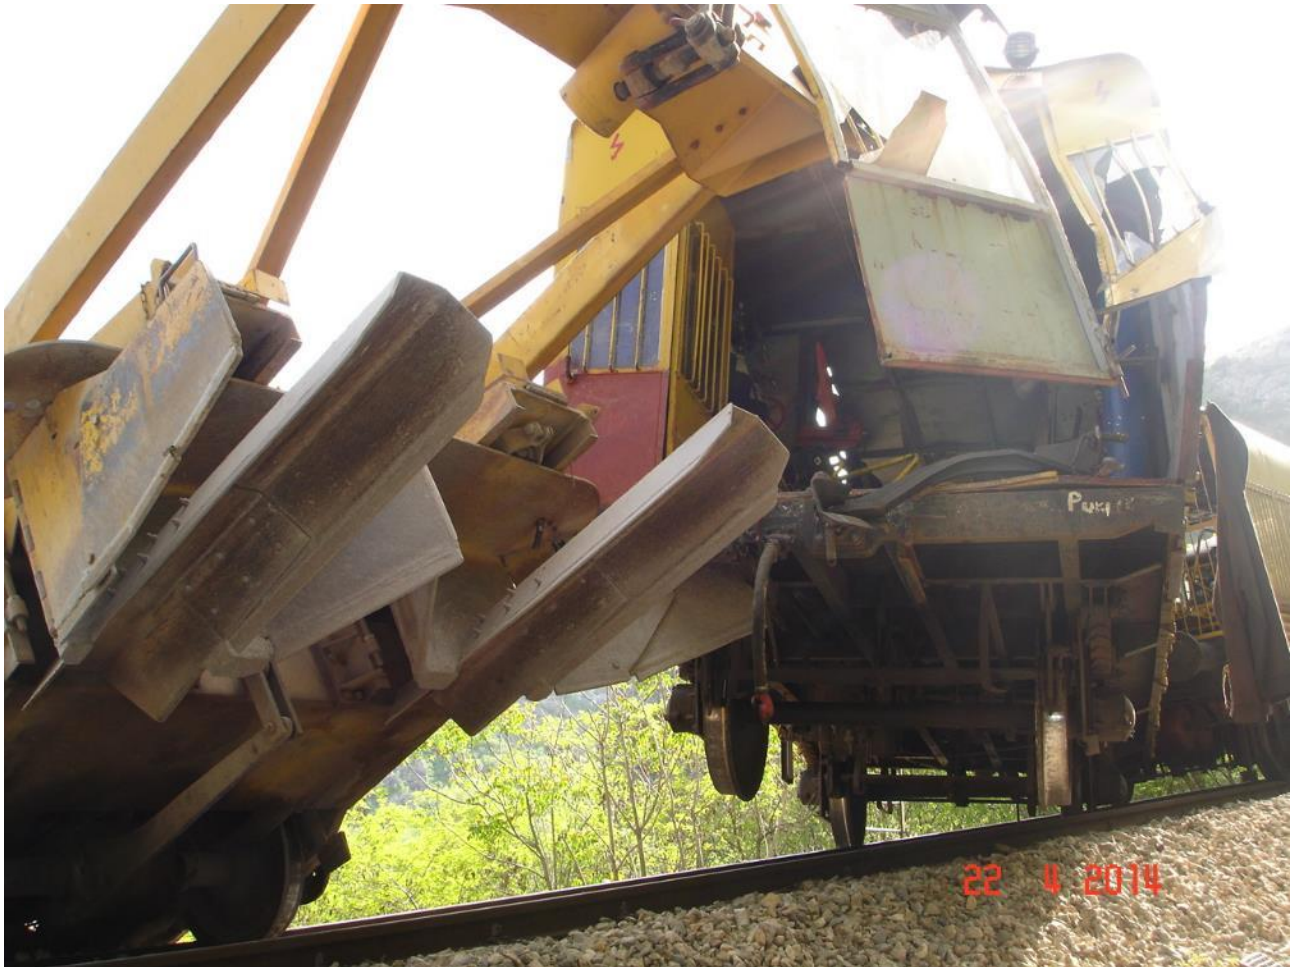
Image 3—the position of derailed vehicles after they stopped (image source: HŽ Infrastruktura d.o.o.)

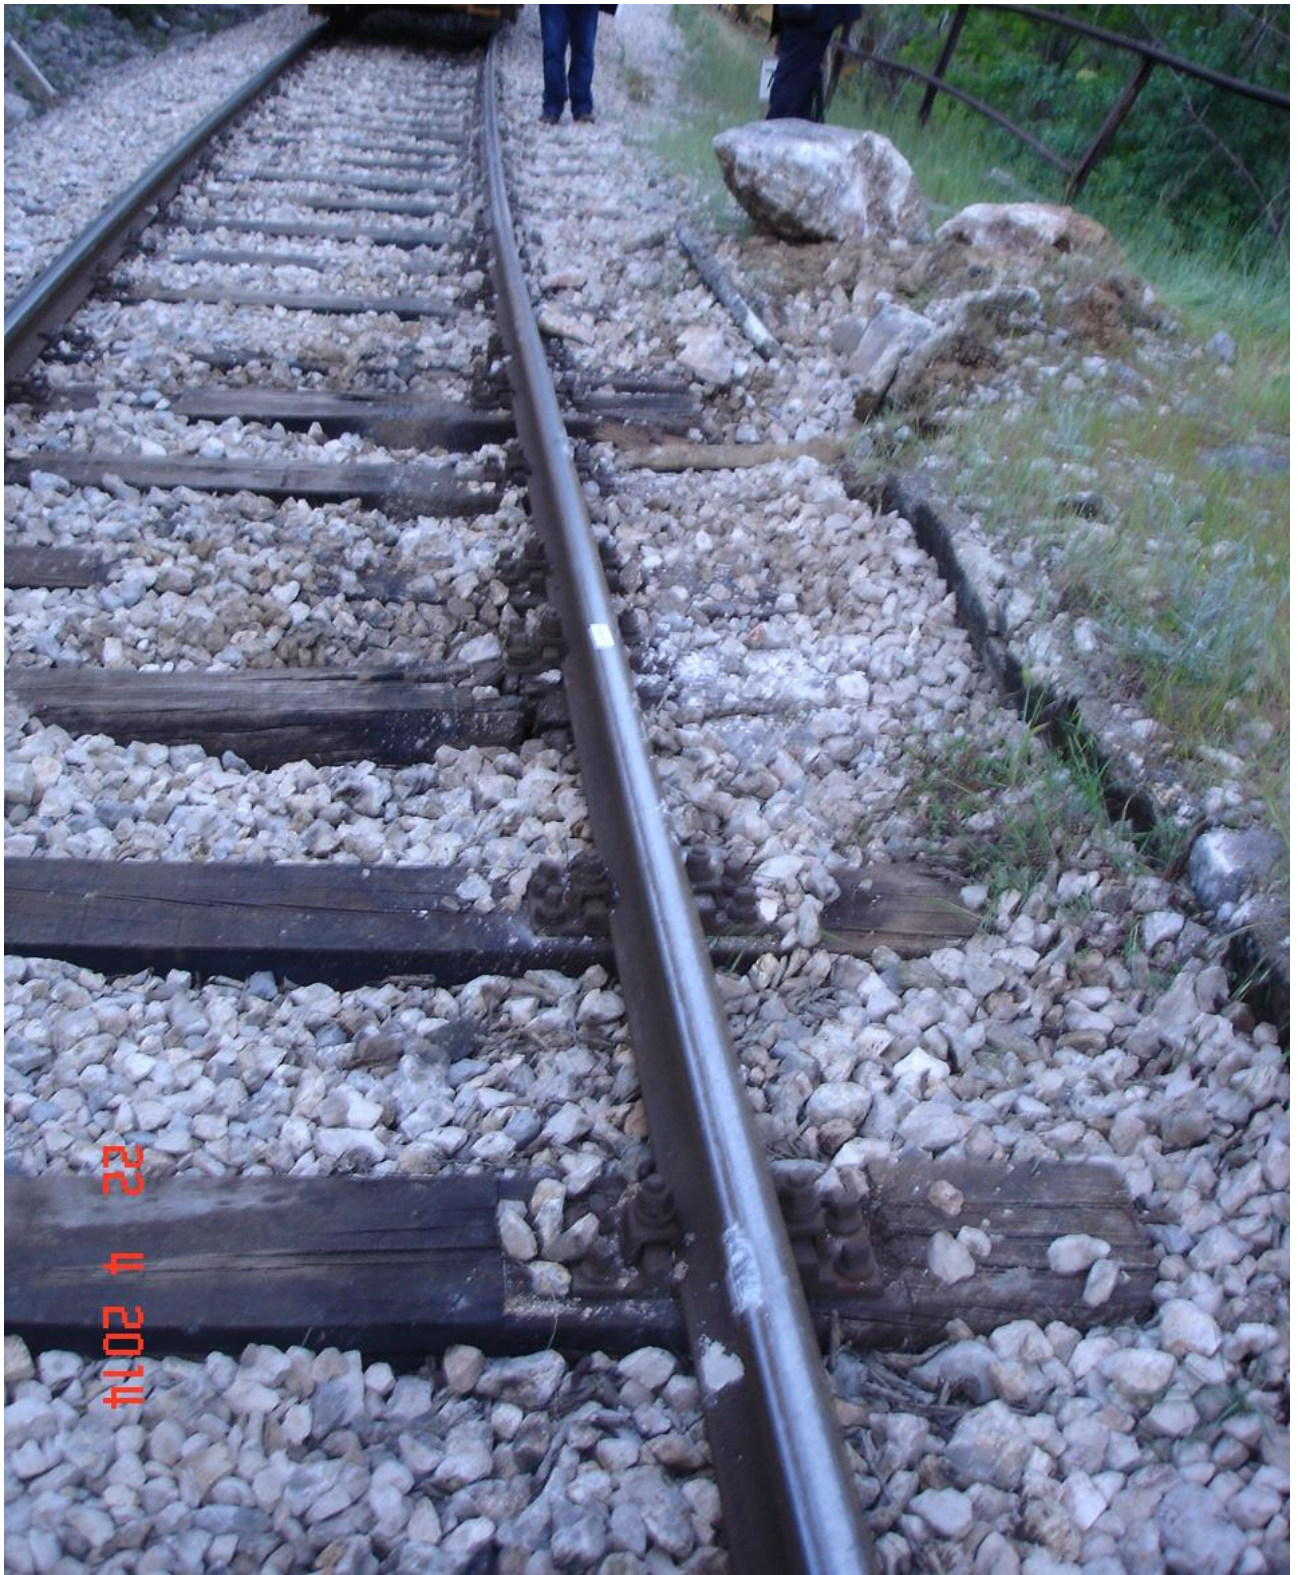
Considerable material damage was done to the first and second vehicle but no-one was injured. Damage was also done to the line, where a great number of wooden sleepers was destroyed and damaged, as well as the rails, to a lesser extent.

Image 4—Line damage at the point of the rockfall (image source: HŽ Infrastruktura d.o.o.)

35 wooden sleepers were damaged and destroyed on the line and the tracks were damage as well.

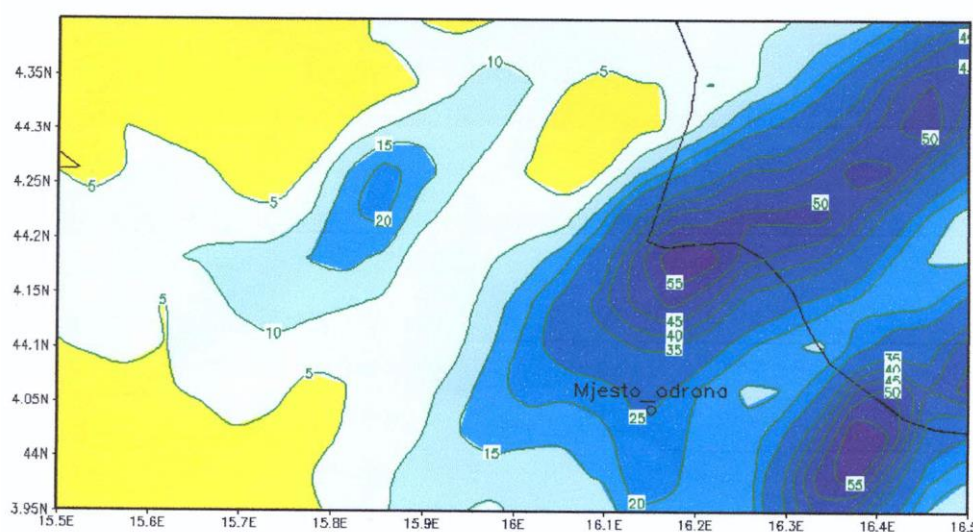
For the purpose of this investigation, company “Geo-Meteo” was asked to prepare an analysis of the weather conditions at the scene in the period of several days before the very accident. The weather analysis shows that on the wider area around the scene between 20 and 40 l of rain per square metre fell in the past 39 hours, representing a relatively large amount of precipitation in such a short time span. Rockfall is most frequently caused by the impact of profuse precipitation.

Image 6 – Accumulated amount of precipitation at the rockfall site (Source: Meteorological report for the railway accident, prepared by Geo-Meteo).

- Copious precipitation at the site of rockfall the day before the accident
- Poor long-distance visibility at the Očestovo stop
