# **FINAL REPORT**

## **ON VERY SERIOUS MARINE CASUALTY**

**Collision of boat with registration number “MT 1839” and  
boat with registration number “CZ 111 018”**

**Pelješki kanal, 12 July 2017**

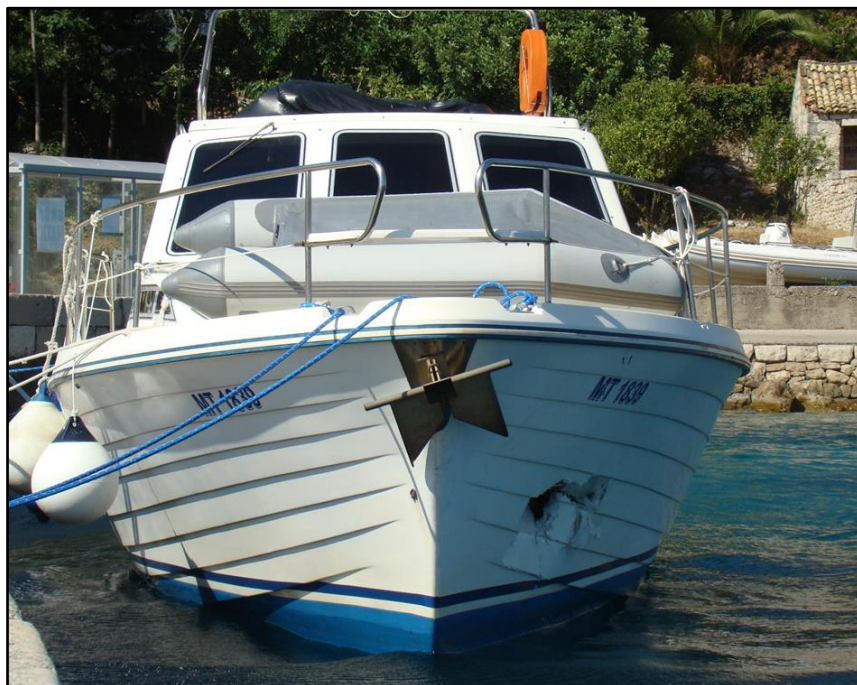
- pleasure craft with registration number "MT 1839" - as a result of the collision there was visible damage to the forward port side of the shell plating above the water level at about 1.2 meters in length, about 65 centimetres in height and 20 centimetres in depth. There were no fatalities or injured persons on the boat nor third parties. There was no cargo on the boat. There was no damage to third parties. No pollution of the sea or of the environment by fuel or oil from the boat was detected.

**Picture 5 Visible damage to the forward port side of the shell plating above the water level of the boat with registration number "MT 1839"**  
*(source: Harbour Master's Office Dubrovnik)*

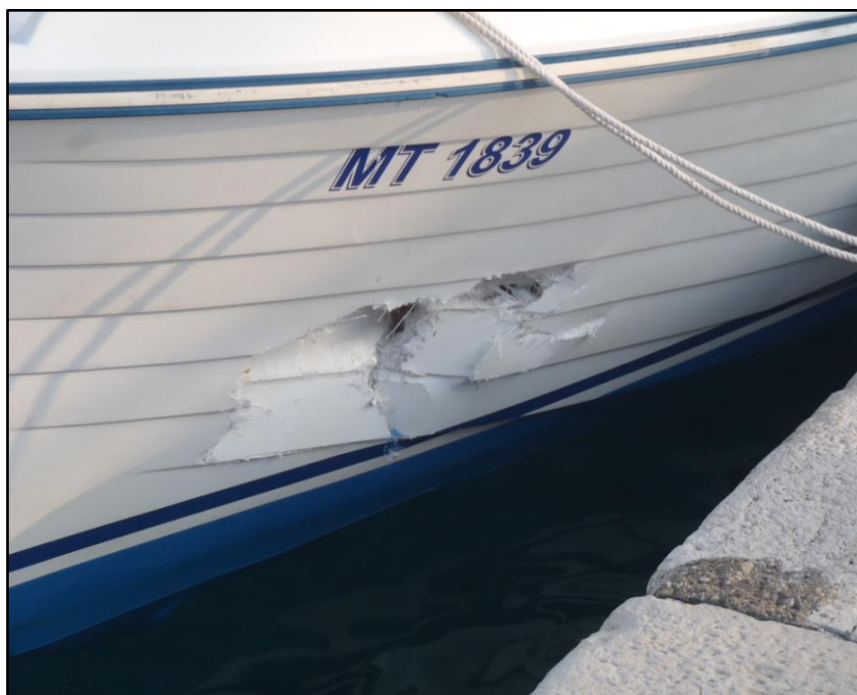
**Picture 6 Visible damage to the forward port side of the shell plating above the water level of the boat with registration number "MT 1839"- close up**  
*(source: Harbour Master's Office Dubrovnik)*

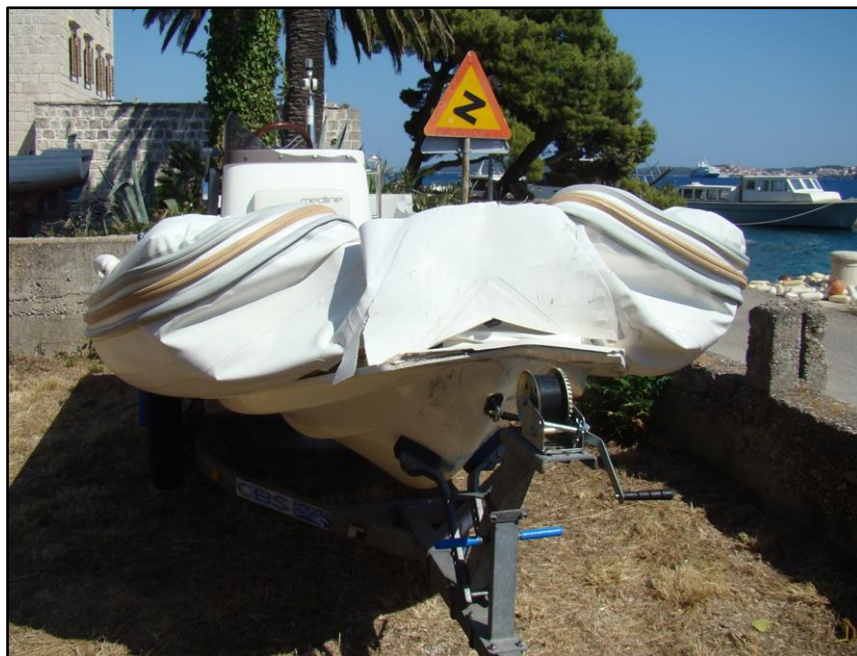
- pleasure craft with registration number "CZ 111 018" - as a result of the collision there was visible damage to the bow above and below the water level and to the windscreen. One person died (skipper of the boat). There were no passengers. There were no fatalities or injured third parties. There was no cargo on the boat. There was no damage to third parties. No pollution of the sea or of the environment by fuel or oil from the boat was detected.

**Picture 7 Visible bow damage of the boat with registration number "CZ 111 018" – front view**  
(source: Harbour Master's Office Dubrovnik)

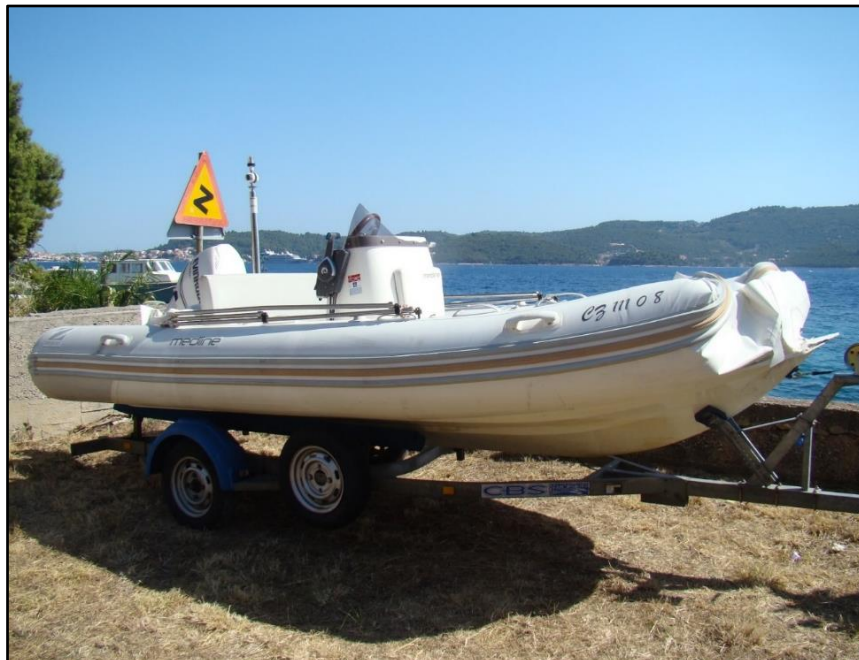
**Picture 8 Boat with registration number "CZ 111 018" after the marine casualty – starboard side view**

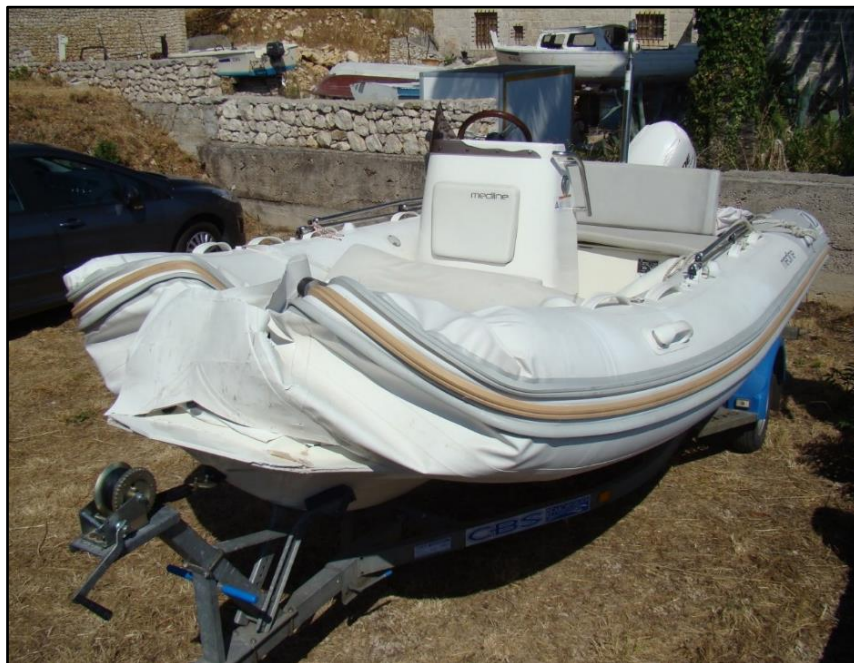
**Picture 9 Boat with registration number "CZ 111 018" after the marine casualty – port side view**

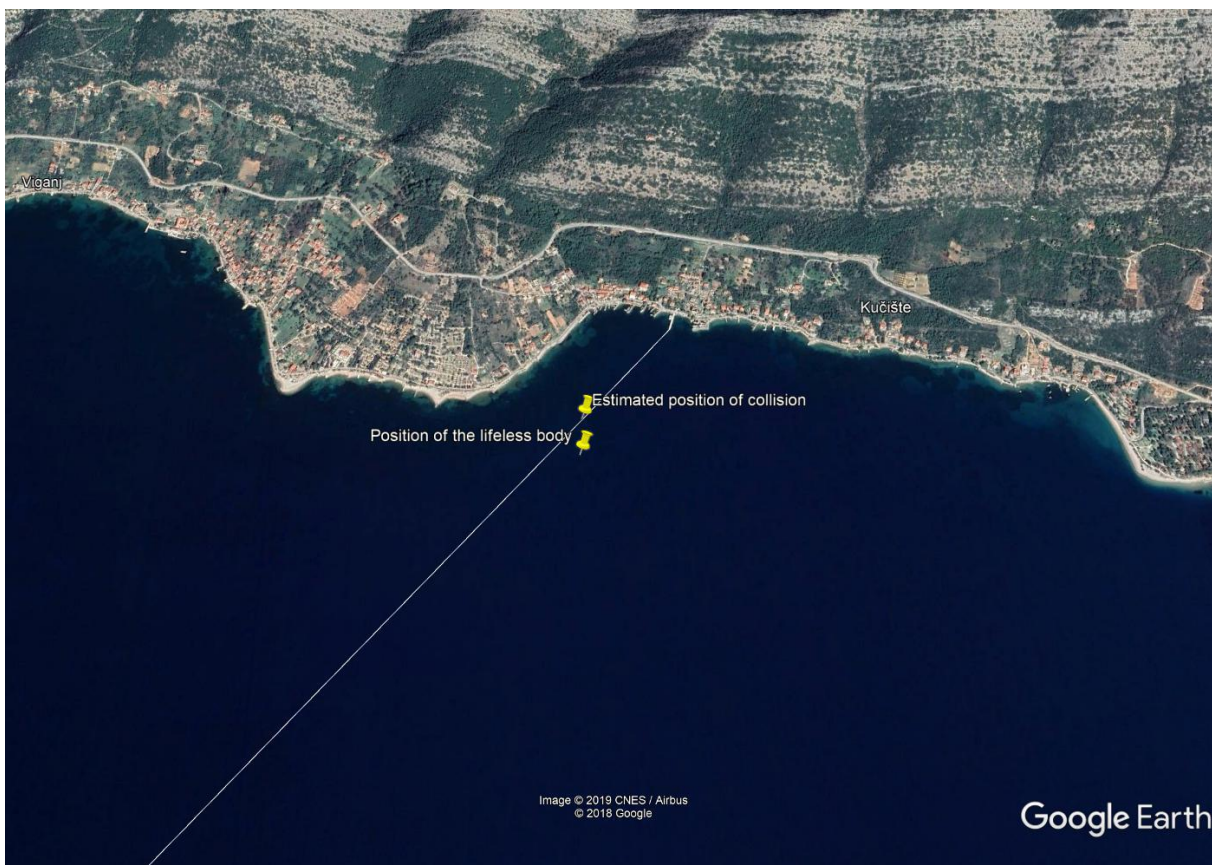
Based on the obtained information it can be estimated that the position of the collision of the boats is located in the line between the main pier in Kučište and Tri žala on the island of Korčula, about 350 meters from the main pier and about 200 meters from the coast of the nearest mainland, i.e. in 42° 58' 39" N, 017° 06' 45" E. The estimated position is about 95 meters away from the position where the lifeless body was found (Picture 10).

**Picture 10 Estimated position of the collision in relation to the position where the lifeless body was found**

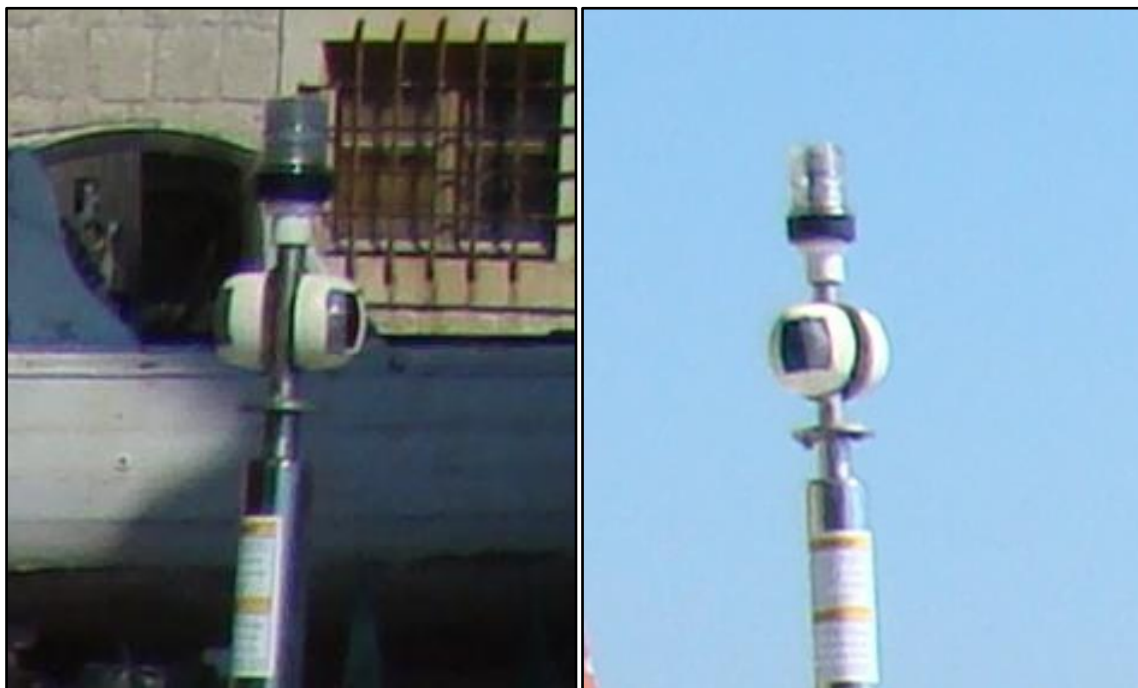
The boat had installed all-round white light and sidelights. During the inspection of the vessel "CZ 111 018" the permanent court expert for vessels and maritime affairs noticed the following irregularities:

- on the mast there was an all-round white light with visible modifications by duct tape
- on the mast there was a red sidelight with visible modifications by duct tape
- on the mast there was a green sidelight with visible modifications by duct tape.

**Picture 11 Showing of modifications by duct tape on the navigation lights**
