Air, Maritime and Railway Traffic Accidents Investigation Agency
Maritime Accident Investigation Department

FINAL REPORT

ON VERY SERIOUS MARINE CASUALTY
of the m/v “Fidelity”

Bay of Raša, 22 June 2018

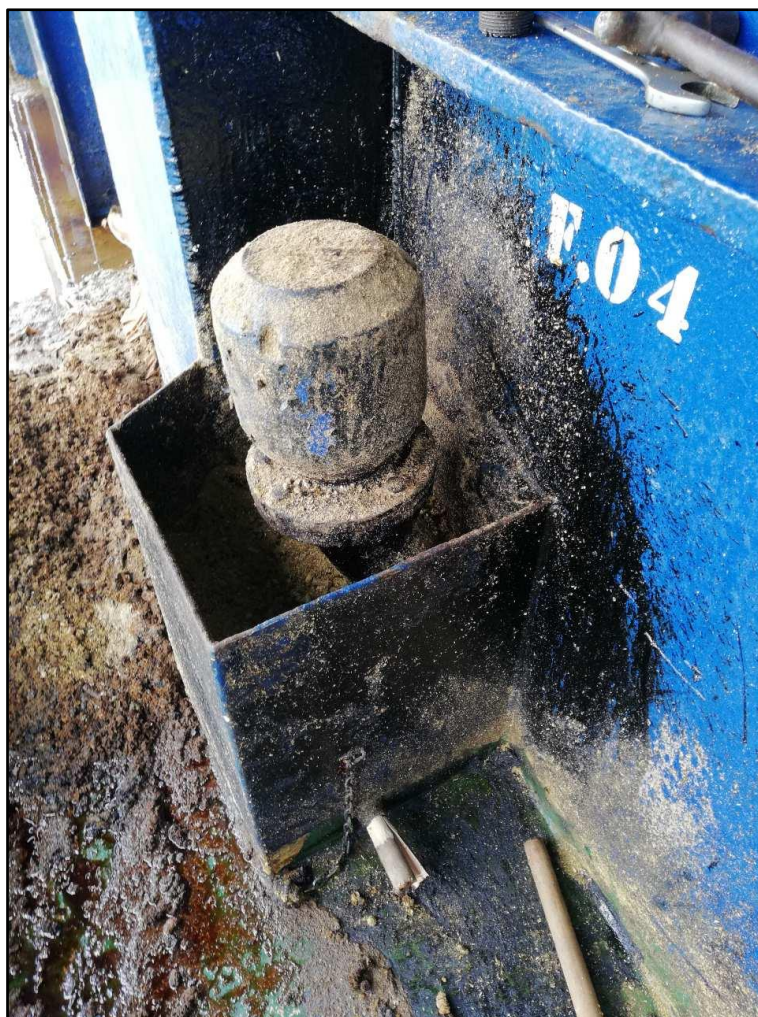
Place on board: overflow from the Fuel tank no 4 (port side of the vessel) through the vent (Picture 4) and sounding pipe on the deck, and then over the deck and through the scuppers into the sea.

Picture 4 Marine Residual Fuel on the deck and on the vent of the Fuel tank no 4

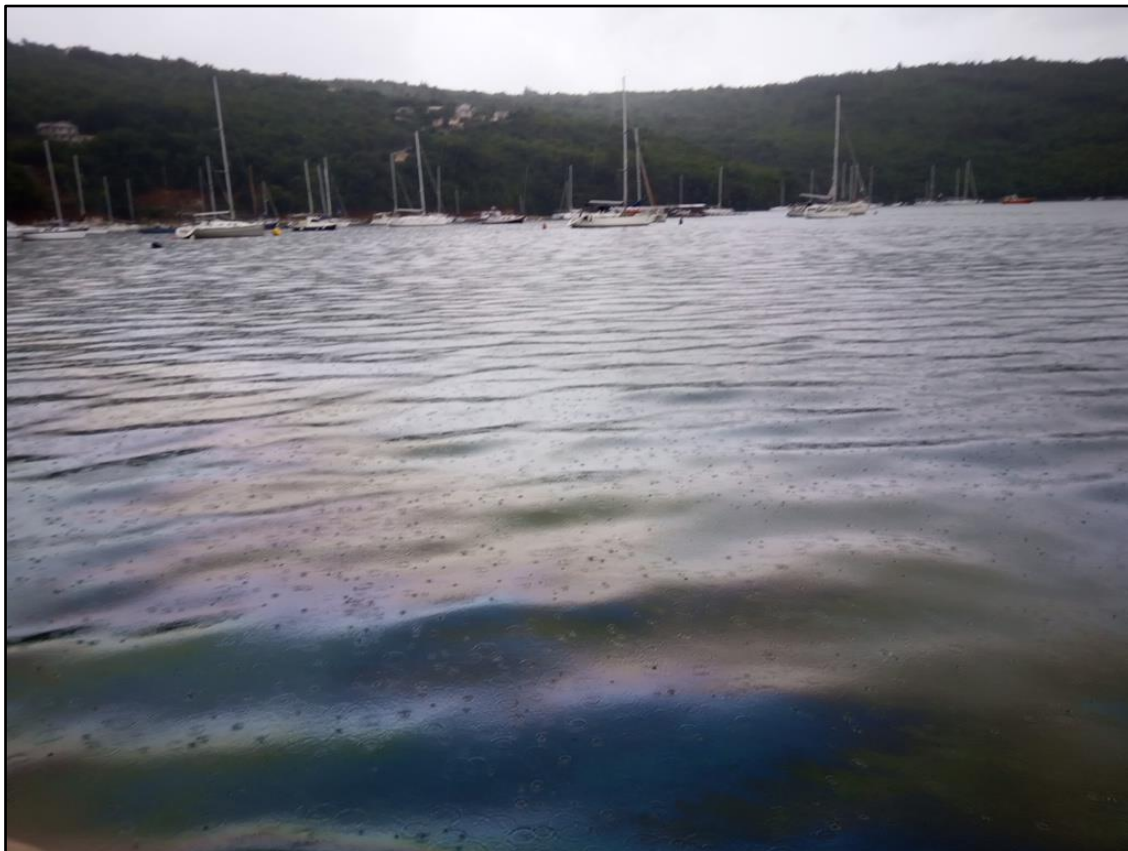
Picture 5 Pollution of the sea in Bay of Raša after the marine casualty

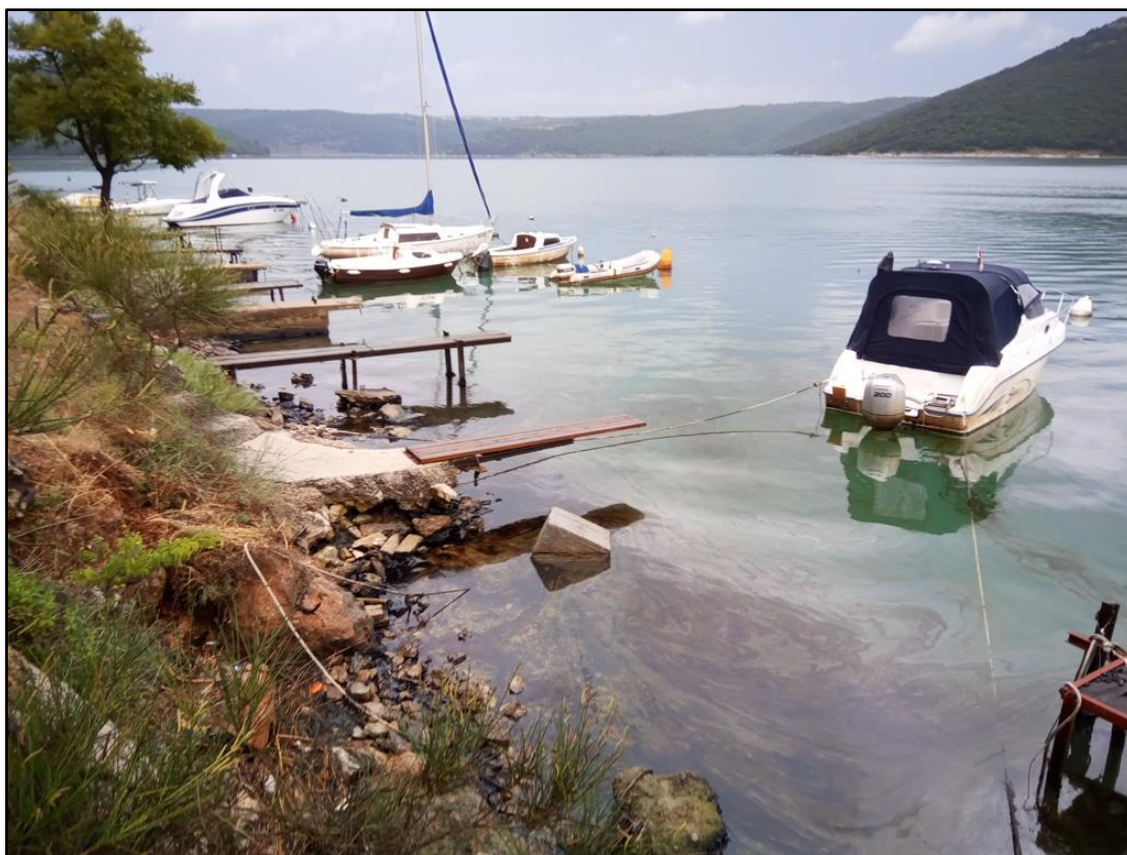
Picture 6 Pollution of the sea, coast and boats in the Bay of Raša

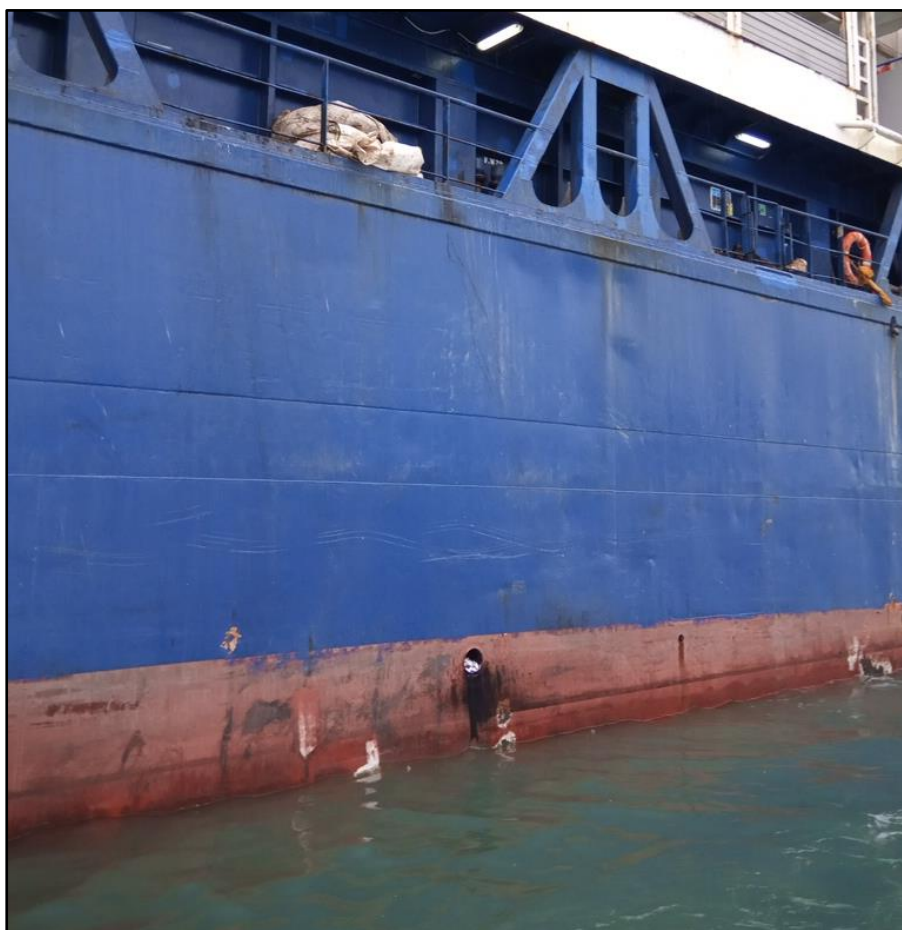
The employees of the Harbour Master's Office Pula and Branch Office in Raša on the field confirmed the pollution of the sea and marine environment by the hydrocarbons which extends from the Port of Trget and the Bršica terminal, and the traces of fuel on the surrounding boats. Also, they noticed traces of fuel oil on the port side of the hull plating and below the scuppers (bottom ends) on the m/v "Fidelity" (Picture 7).

Picture 7 Traces of fuel below the scupper on hull plating of the m/v "Fidelity"
(Source: Harbour Master's Office Pula)

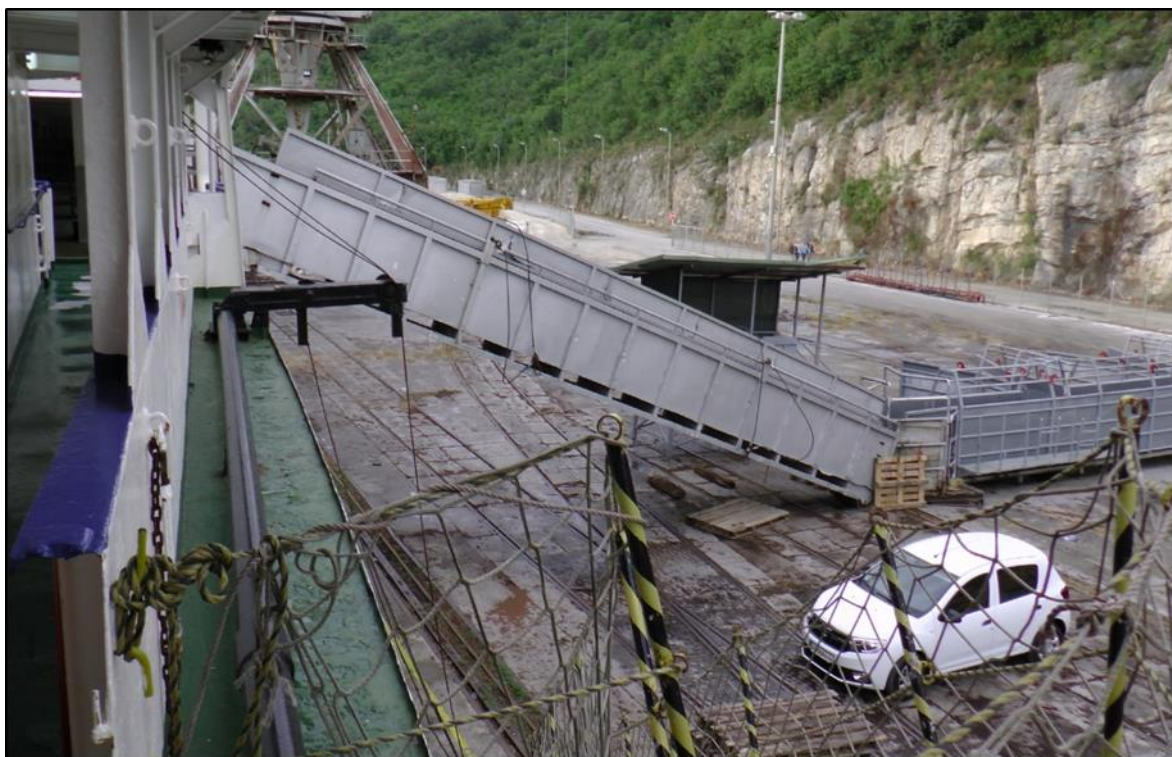
According to the Able Seaman's statement, he was the only crew member on duty on the deck. His view from the gangway to the place where the tank trucks were located was obstructed by the cattle ramp (Picture 8), hay and fodder stowed at the terminal, and he was not allowed to leave his place of duty. Also, it can be assumed that the rain and then heavy rain with thunder had a negative impact on his ability to observe by sight and hearing the actions happening around the vessel.

Picture 8 Obstructed view from the gangway towards the place where the tank trucks were located (below and beside the port crane)
