**Air, Maritime and Railway Traffic Accident Investigation Agency**

# **FINAL REPORT**

**ON ACCIDENT OF THE HELICOPTER  
type Alouette II, SE-313B,  
registration 9A-HAT**

**Zlarin, 3 July 2018**

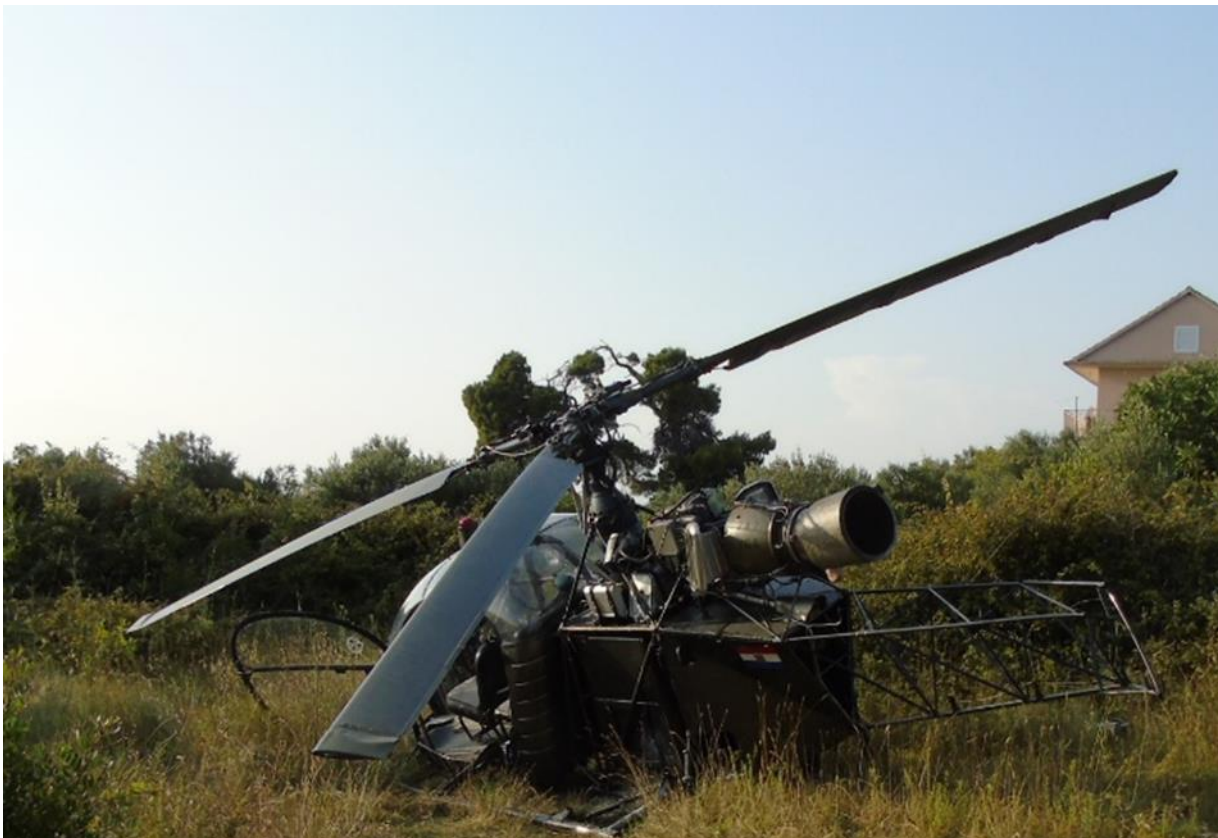
Figure 3 – Helicopter 9A-HAT at the accident site

In this accident the helicopter was substantially damaged (Figure 3). Damages were present on parts of the construction, landing gear, power transmission system, controls, and certain aggregates around the power plant and the main gearbox. During the landing there was a minor fire on the helicopter, which was extinguished thanks to the rapid reaction of the pilot. No signs of birds or other flying objects such as drone were found on the helicopter.

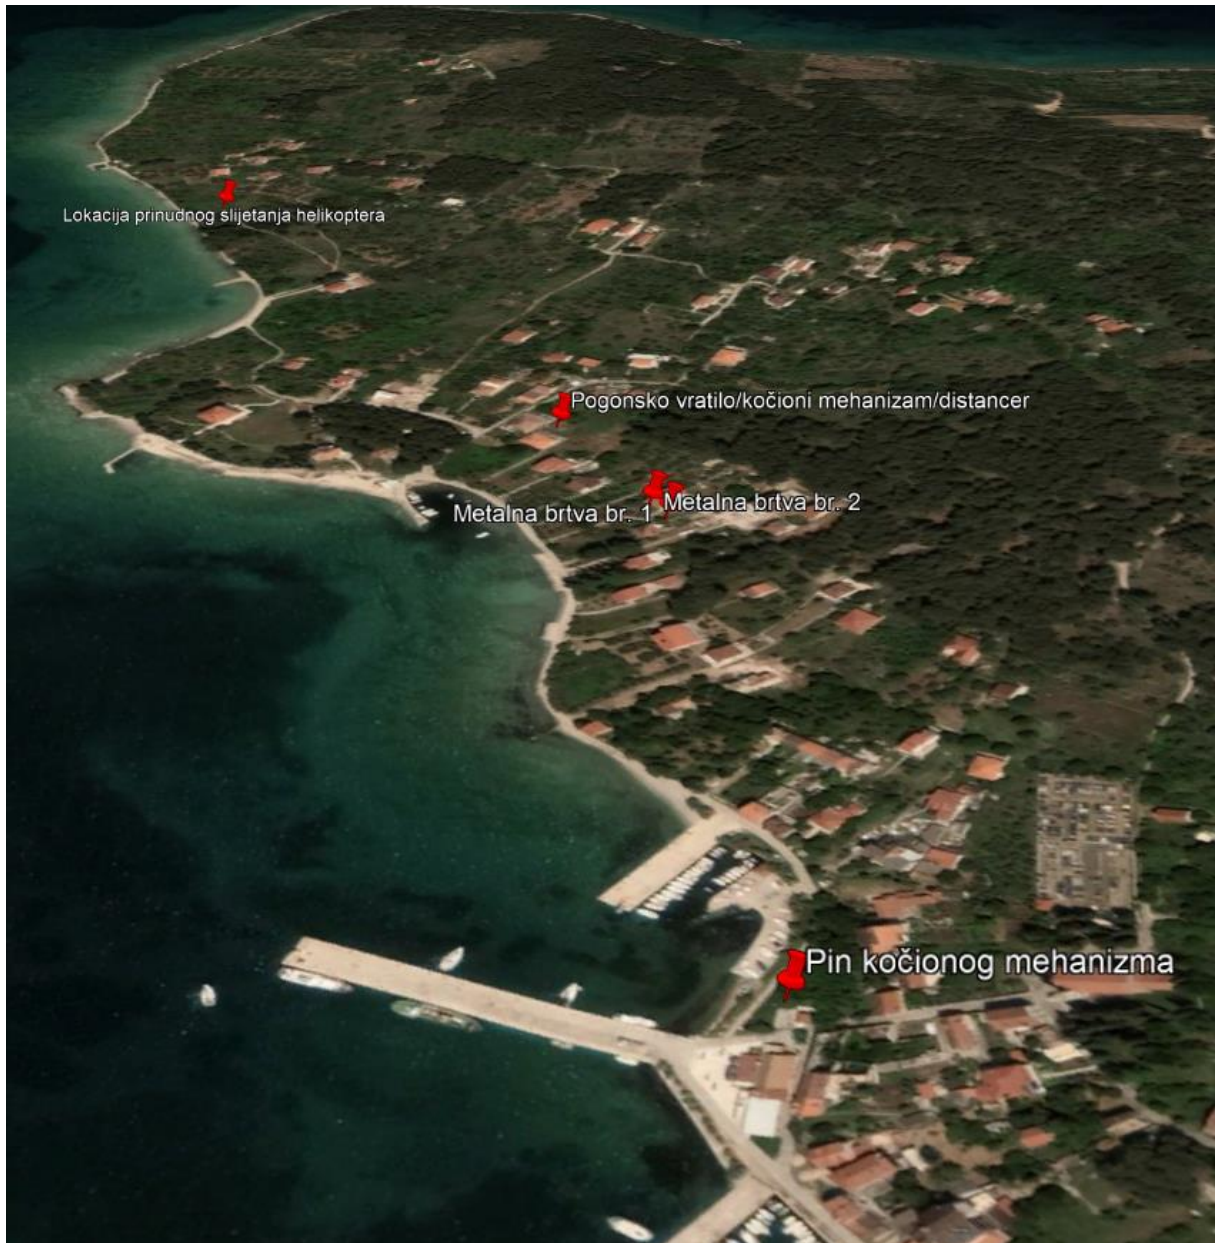
Figure 5 – Locations where helicopter parts had been found

The helicopter force-landed about 800 meters air distance north of the centre of the town of Zlarin, on the dirt trail connecting the centre of Zlarin to the north side of the island. During the last few moments of the flight, the mechanical parts which had completely been separated from their corresponding system, were falling from the helicopter. The Figure 5 shows the locations where the separated parts had been found in order to better understand the course of events that preceded the forced landing.

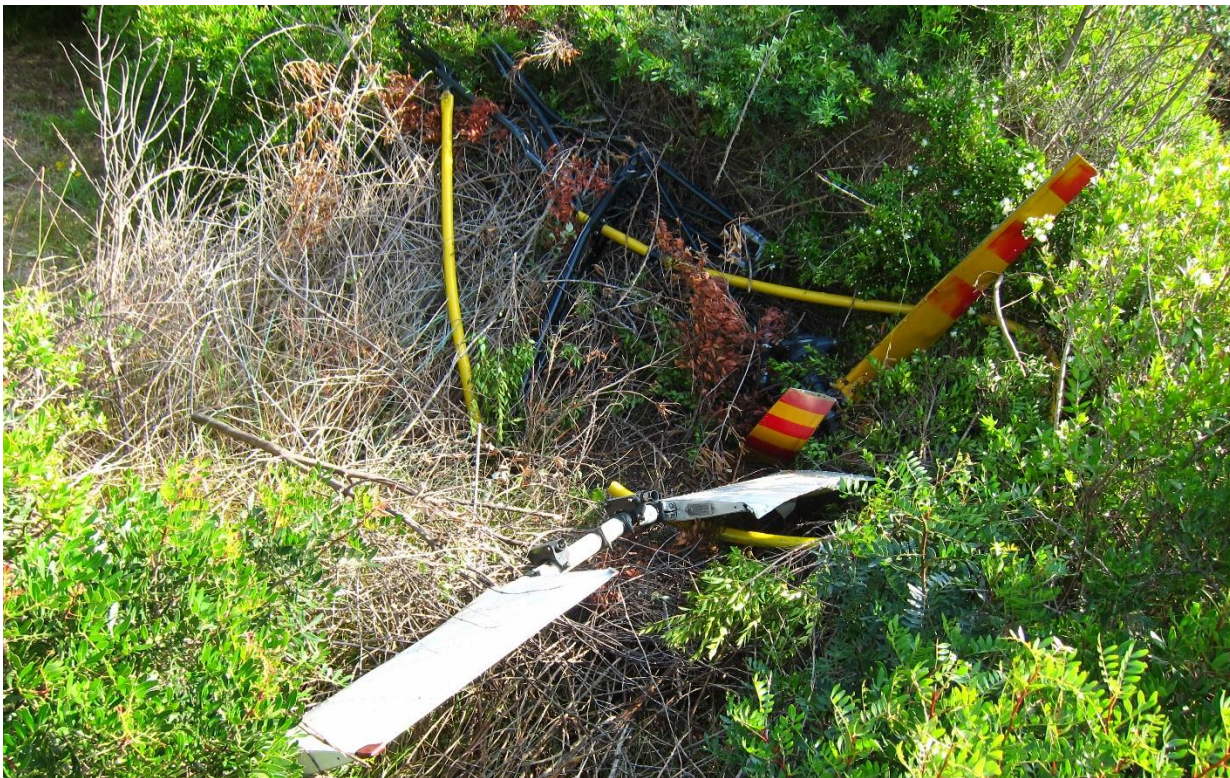
Figure 6 – Part of the separated tail structure with pertaining parts

At the accident site, the helicopter was turned in the direction  $300^{\circ}$ , with the separated tail structure to which the tail rotor, tail gearbox and tail stabilizer were attached. The part of the separated tail structure was located about 7 meters away from the helicopter in the south-west direction, i.e. in the

direction of rotation of the main rotor (clockwise), (Figure 6). The tail structure which remained attached to the main structure of the helicopter was bent at the point of breakage in the direction of rotation of the main rotor (Figure 7).

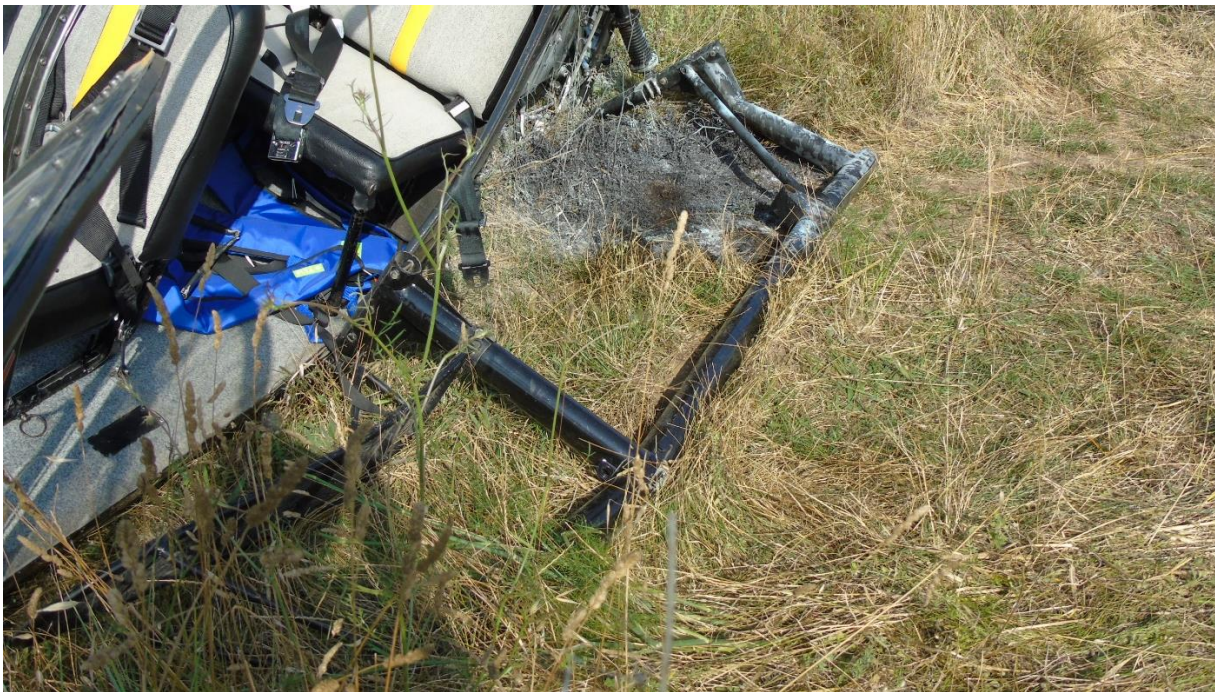
Certain parts of the main helicopter structure were bent in several places. The left skid was completely bent as a result of the impact to the ground and was found in a horizontal position (Figure 8). At the attaching points between the skid and the helicopter structure, cracks occurred.

Figure 8 – Bent left skid with the ruptures at the junction points to the helicopter structure

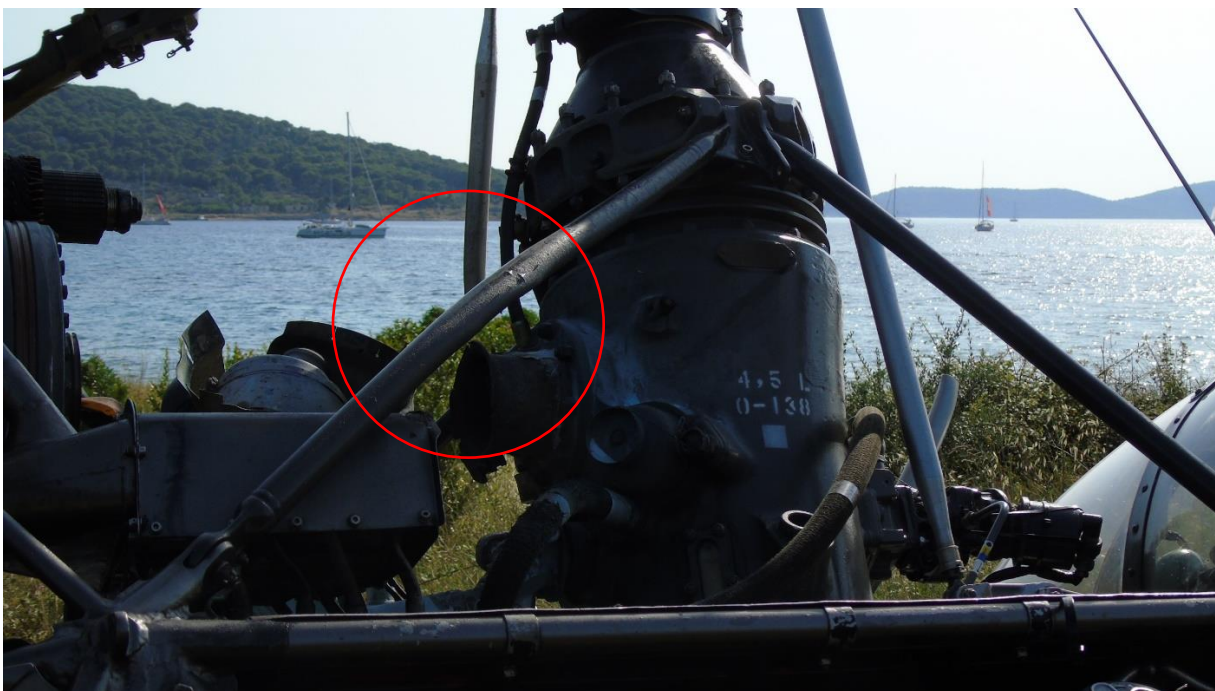
Figure 9 – Bent main gearbox mount

Figure 9 shows one bent main gearbox mount rod.

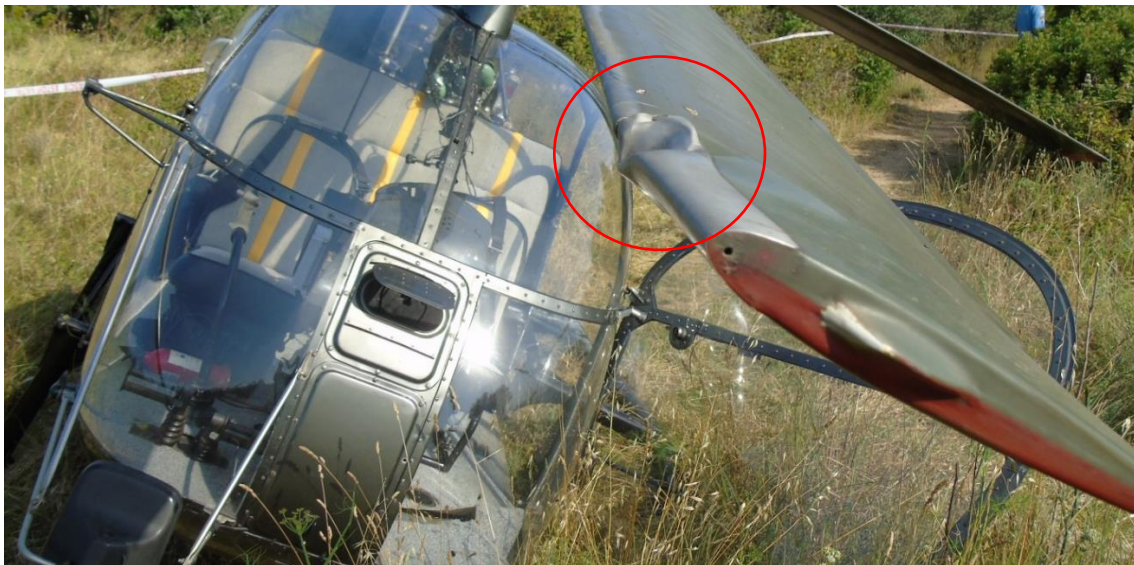
During the preliminary inspection of the helicopter, on two blades of the main rotor damages were detected caused by the impact to the tail structure of the helicopter, causing tearing of the tail structure (Figures 10 and 11).

Figure 10 – Damage to the blade no. 1 of the main rotor marked in red

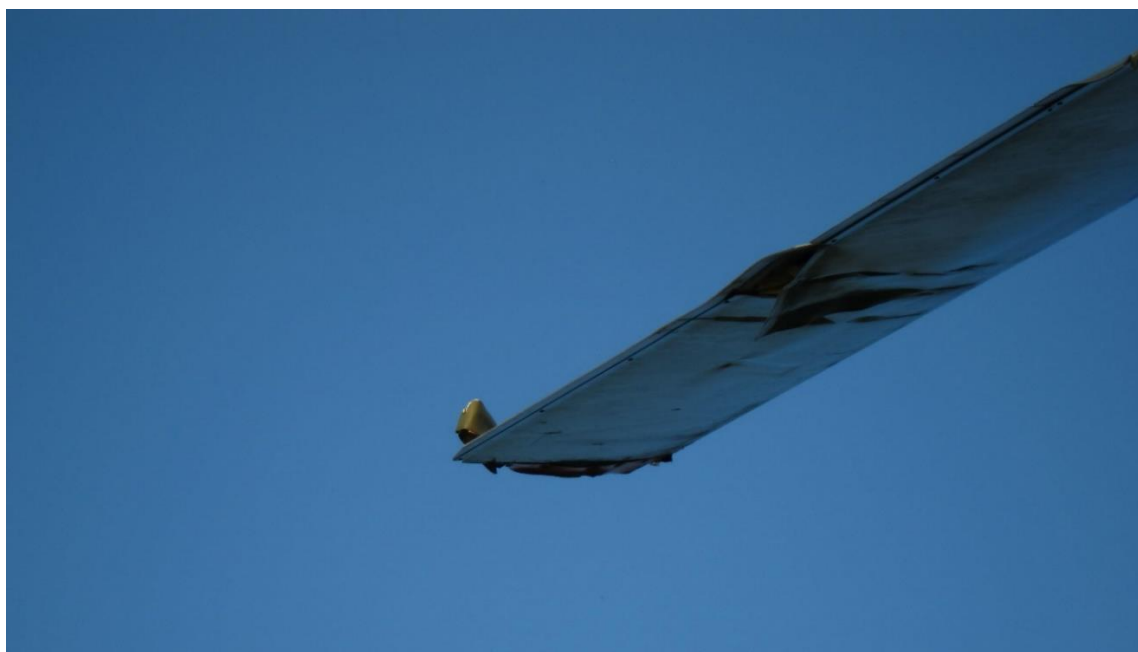
Figure 11 – Damage to the blade no. 2

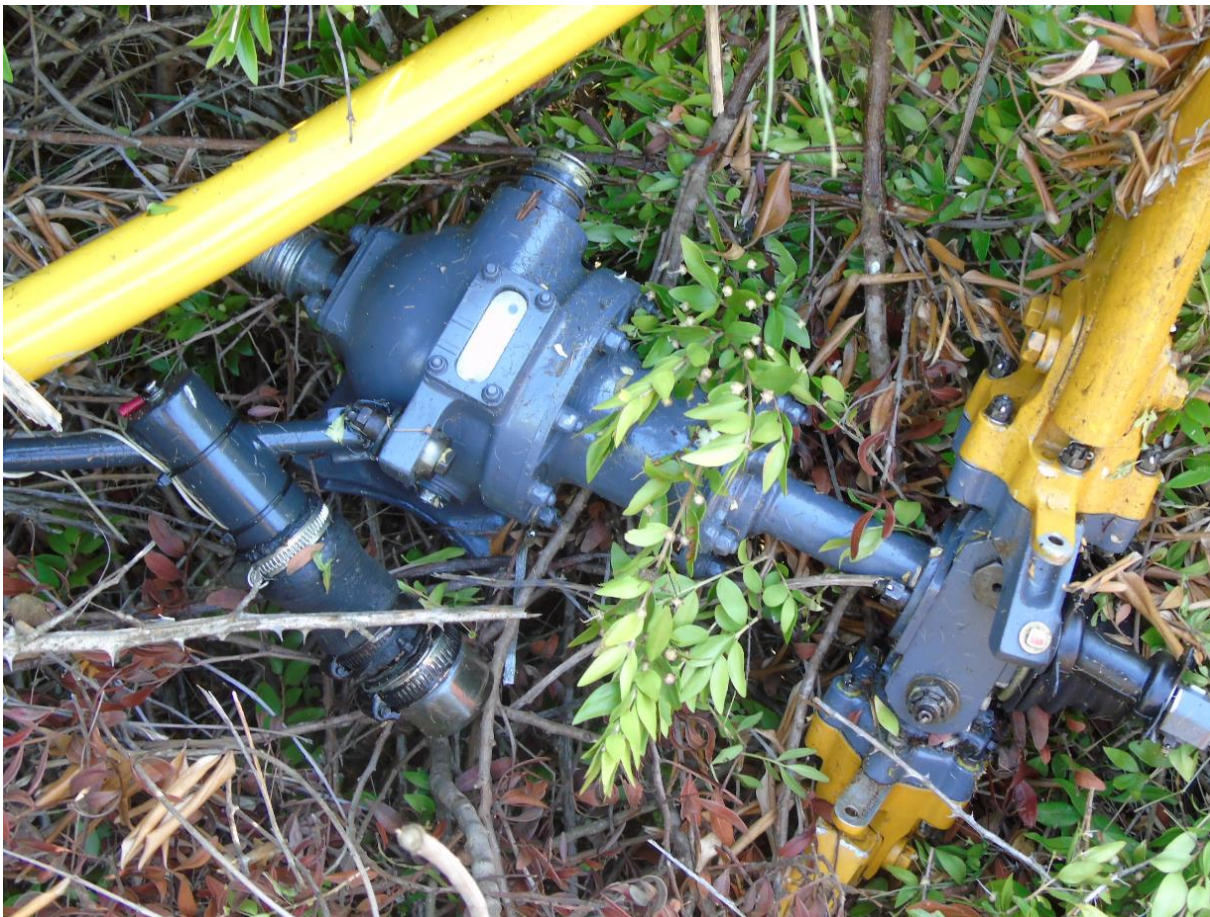
Figure 14 – Tail gearbox

No pre impact damage has been found on the tail gearbox (Figure 14). Traces of lubricating oil were found on the tail gearbox. Tail rotor gearbox oil level was found below minimum. No damage was found on the tail gearbox that could have caused the oil leakage, except for the opening which was a result of separation of the tail rotor shaft from the tail gearbox.

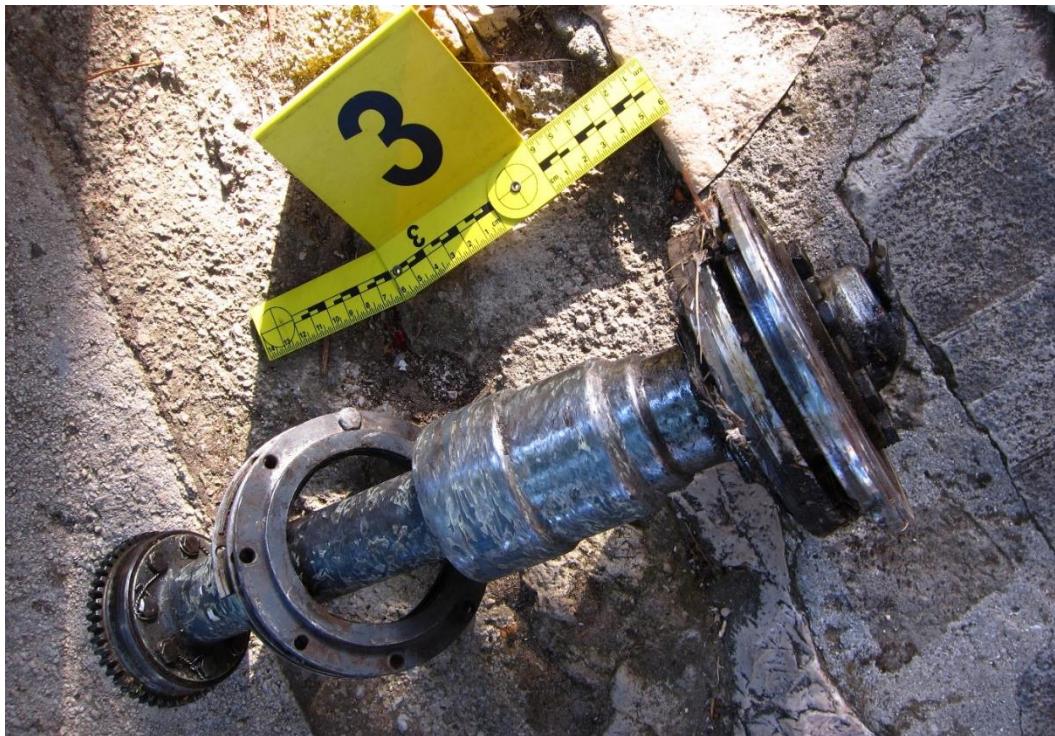
Figure 15 – Drive shaft

Drive shaft assy. which transmits the engine power to the input bevel drive shaft of the main gearbox, was completely separated and has fallen to the ground as the aircraft was in flight during the damaging sequence. It was found 350 m south of the accident site in the yard of the family house (Figure 15). Traces of overheating of the material in the form of deformation of material and discoloration were visible at the point of cracking (Figure 16), and traces of surface damage which occurred when the shaft touched the surrounding components during rotation were visible.

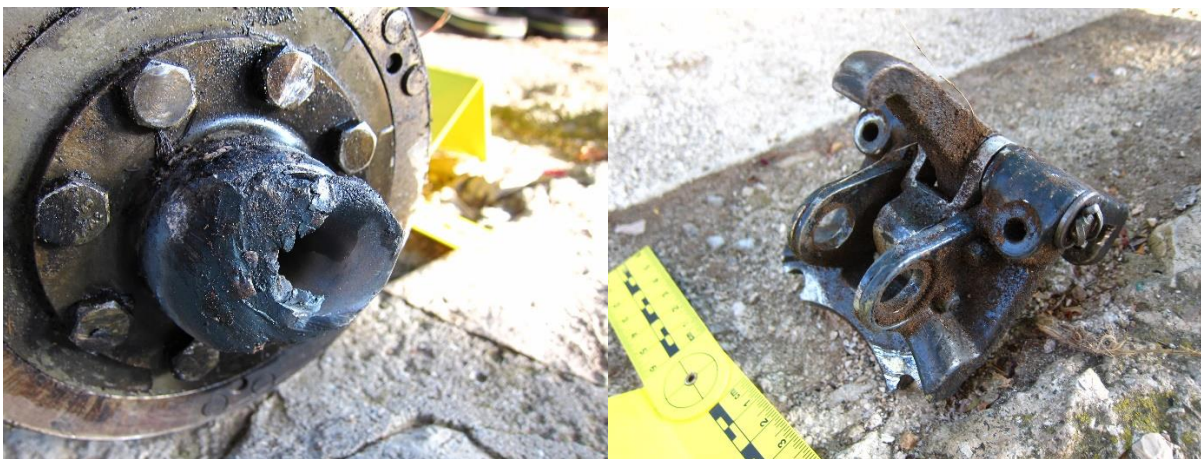
Beside the draft shaft assy. a mechanism of brake calliper with major damages in the form of cracks was found (Figure 17). A pin which forms an integral part of the brake calliper mechanism was found 430 m south of the location where the mechanism was found.

Figure 16 – Point of rupture of input bevel drive shaft Figure 17 – Calliper mechanism

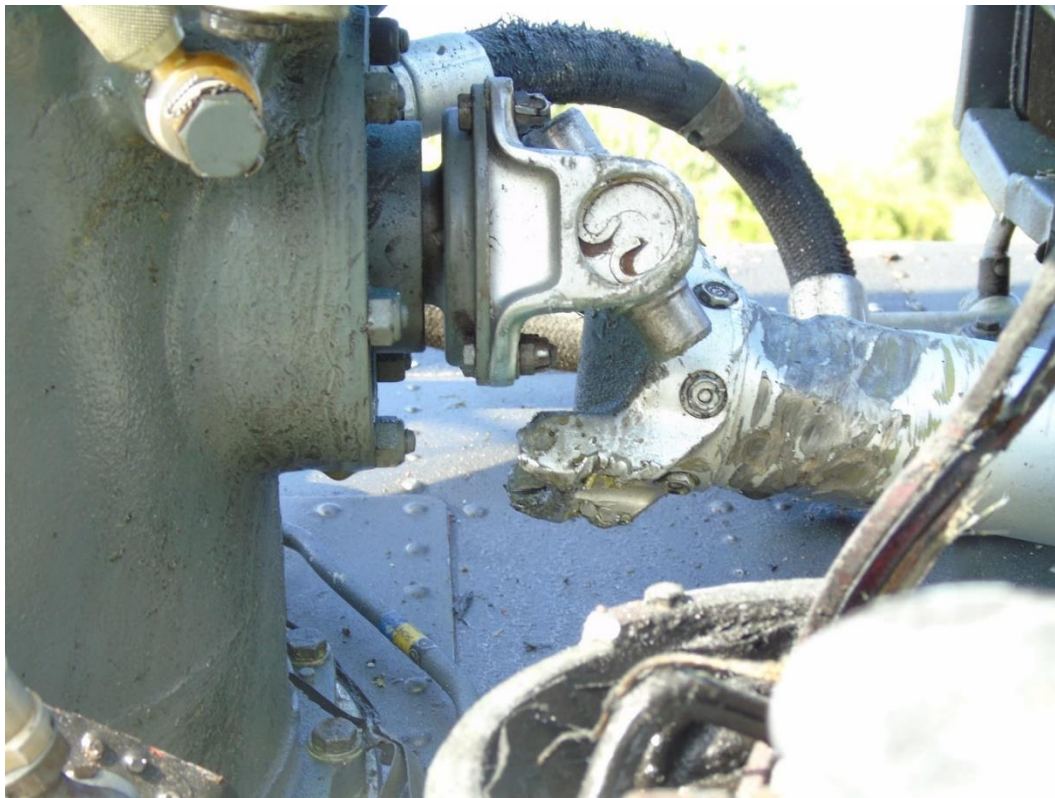
Universal joint of the cardan shaft assy. broke at the connection of the shaft yoke with the joint axle and the visible damages occurred as a result of impact during rotation with the drive shaft assembly (Figure 18).

Figure 18 –Cardan shaft drive assy. at the cracking point

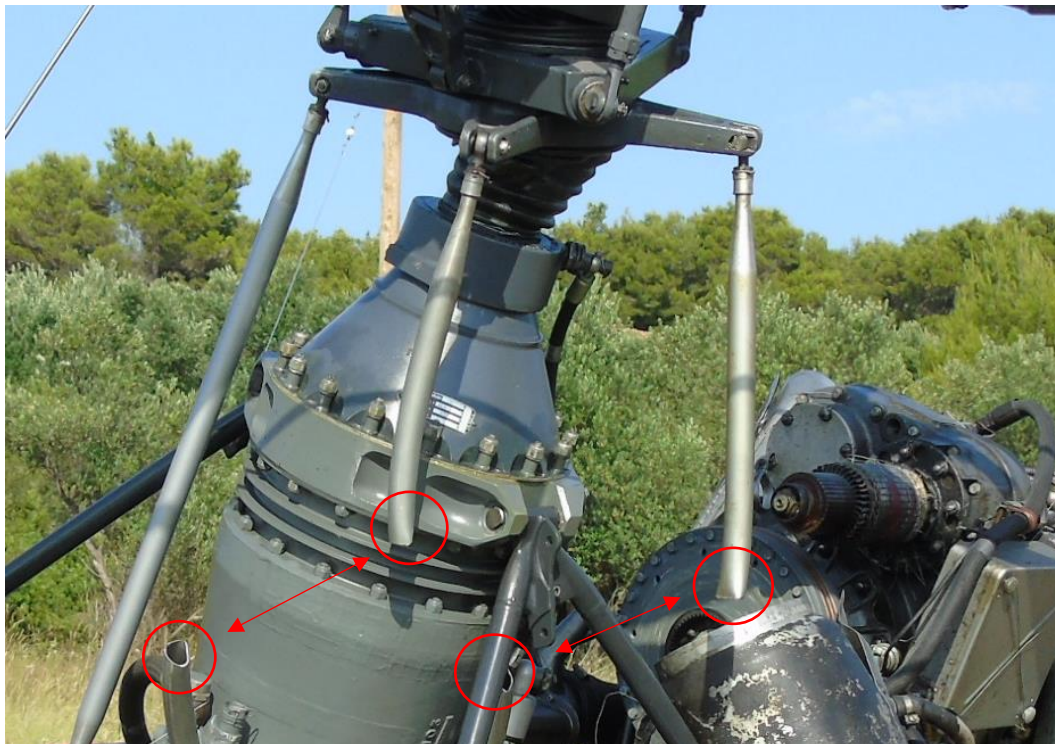
Two rods for controlling the main rotor blades angle of attack has failed by overload during the accident sequence in the area of the main gearbox. The two broken rods were part of the mechanism for controlling the cyclic and collective steps of the main rotor blades (Figure 19).

Figure 19 –Cracking points of the two levers for controlling the main rotor blades

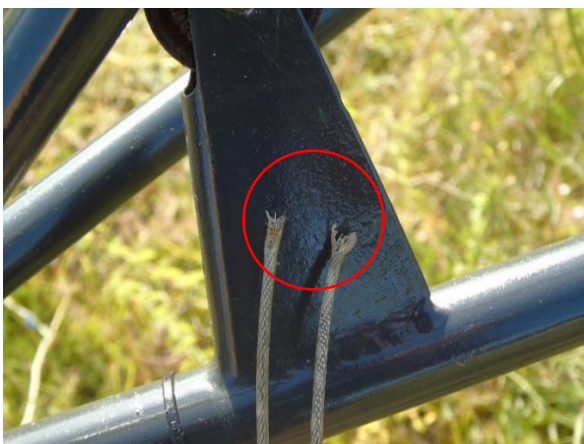
Tail rotor pitch cable controls were found broken by overload at the point where the tail structure was cut off upon the impact of the main rotor (Figure 20).

Figure 20 – Damaged tail rotor cable controls

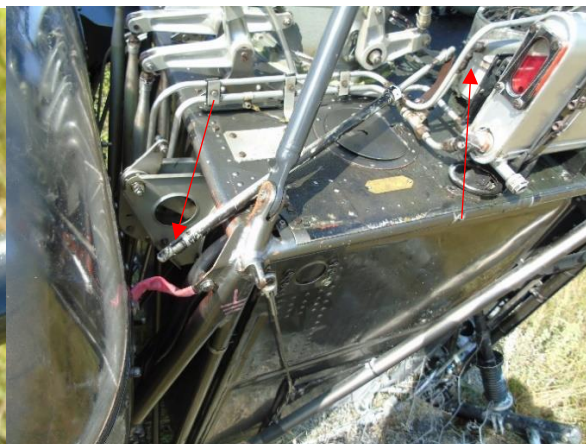
The main rotor brake command rod around the main gearbox area was found detached at the connection with the mechanical transmission (Figure 21), and the brake callipers were not found at the accident site.

Figure 21 – Main rotor brake control lever

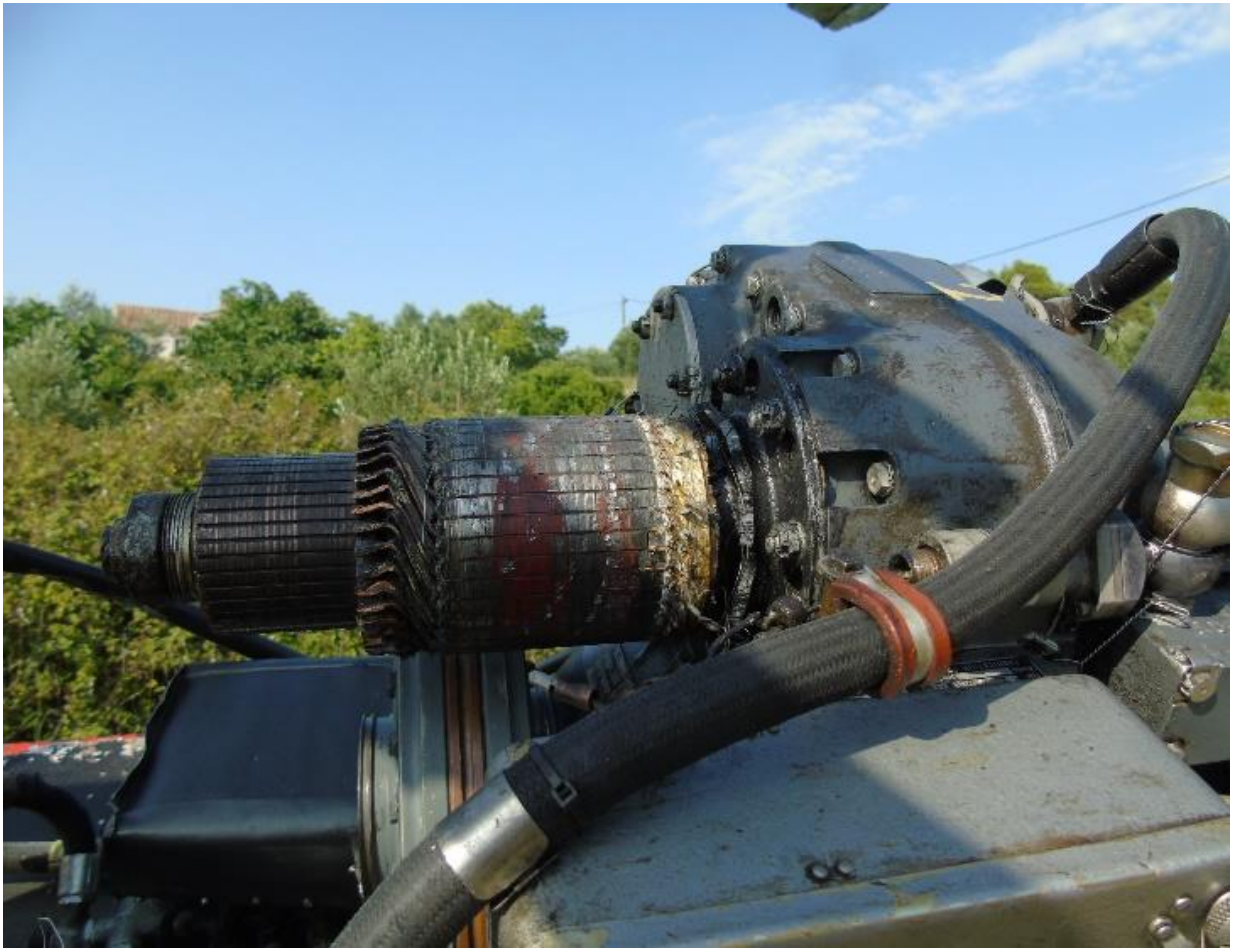
Figure 22 – Starter generator rotor

In the power plant section significant damage to the starter-generator was detected. Damage caused by contact of the starter generator rotor and stator was visible on the rotor (Figure 22). The stator flange was broken at its root and was completely mechanically separated from the engine (Figure 23).

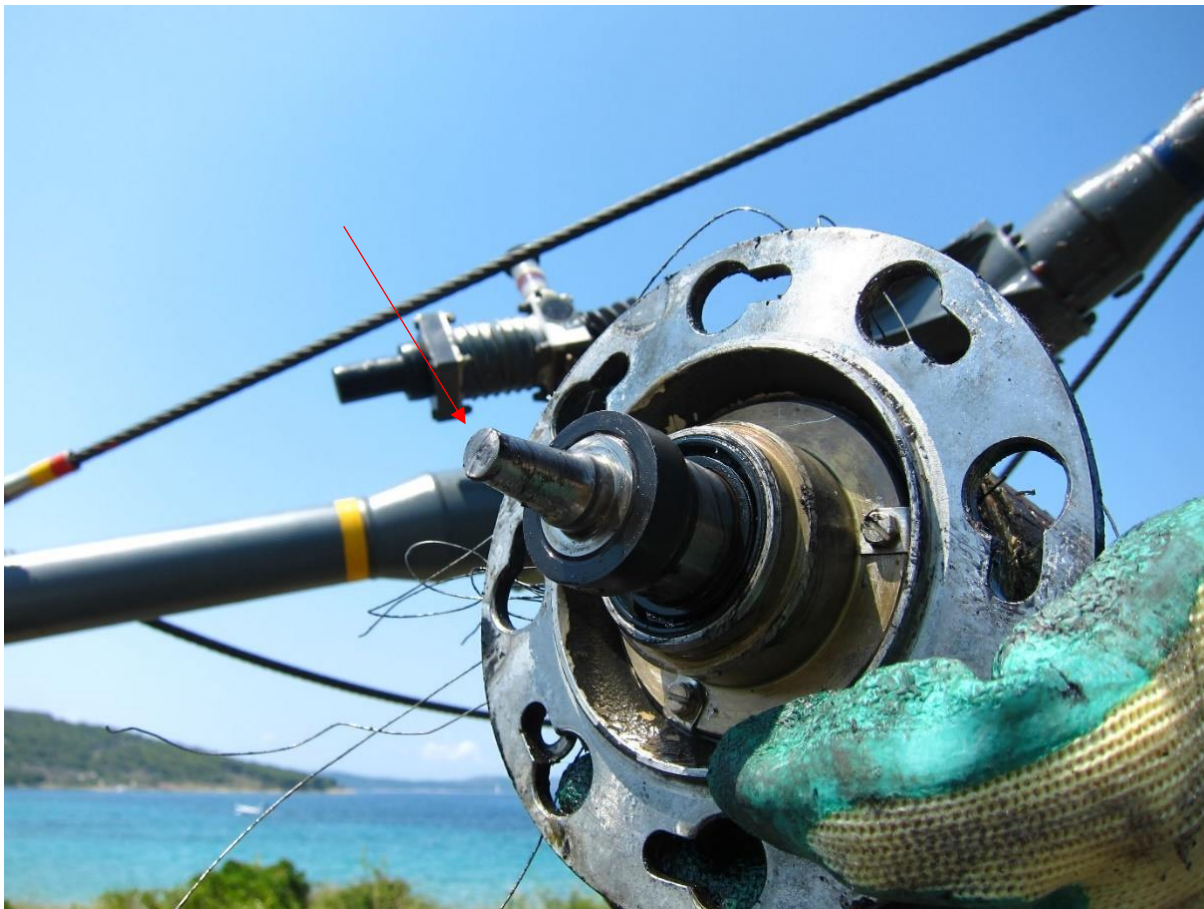
Figure 24 – Broken starter-generator shaft

The starter generator shaft was found broken at the point intended for it, due to the increased resistance which was a result of contact of the stator and rotor when the stator flange broke off (Figure 24).

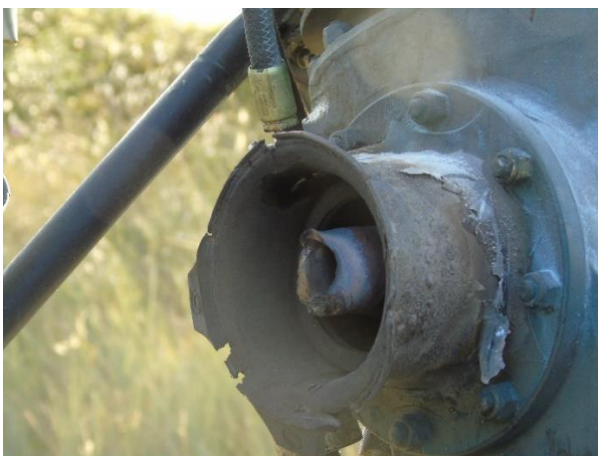
Figure 25 – Opening on the main gearbox

During the last moments of the flight, the eyewitnesses noticed the smoke coming out of the helicopter. In their statements, they did not specify precisely from which part of the helicopter the smoke had been coming from. After the forced landing and exiting the helicopter, the pilot noticed the fire in the opening of the main gearbox caused by cracking of the drive shaft (Figure 25). Also he noticed

We can assume that the fire around the main gearbox opening occurred due to the leaking of oil vapours and the lubricating oil of the main gearbox over the cracked input bevel drive shaft of the main gearbox, which occurred due to the high temperature of the material and sparks generated by the damaged starter generator. The grass in the left skid area caught fire due to the fall of the metal seal from the drive shaft system, which at that moment was significantly heated, very likely incandescent, on the dry grass.

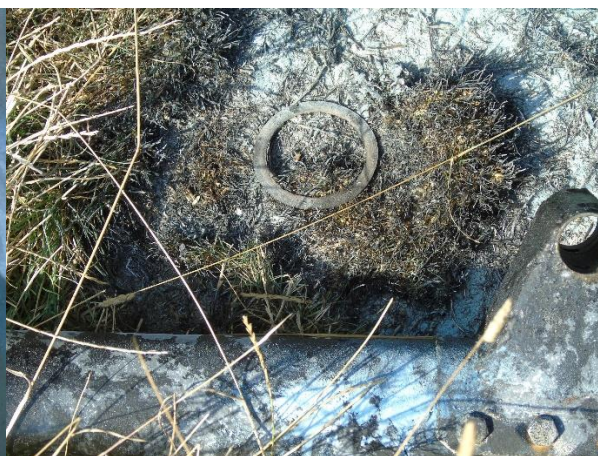
Figure 26 – Seal in the fire site near the skid

that the fire had caught the dry grass in area of the left skid (Figure 26). The pilot successfully extinguished the fire using a fire extinguisher located in the helicopter.

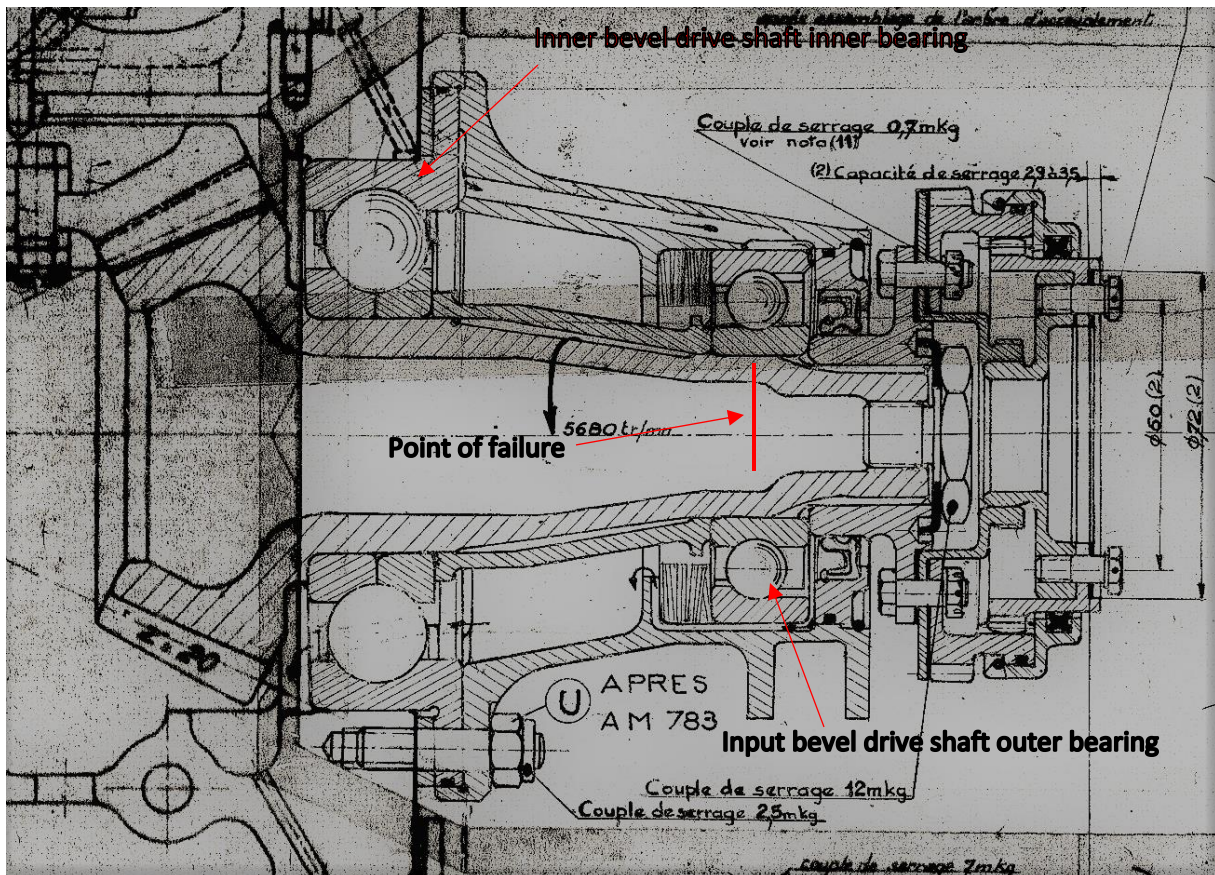
Figure 27 – Input bevel drive shaft flange with attaching components

- Drive shaft assy. with freewheel assy.
- Input Bevel Drive shaft
- Drive shaft bevel gear
- Input bevel drive shaft Inner bearing
- Input bevel drive shaft flange (Figure 27)

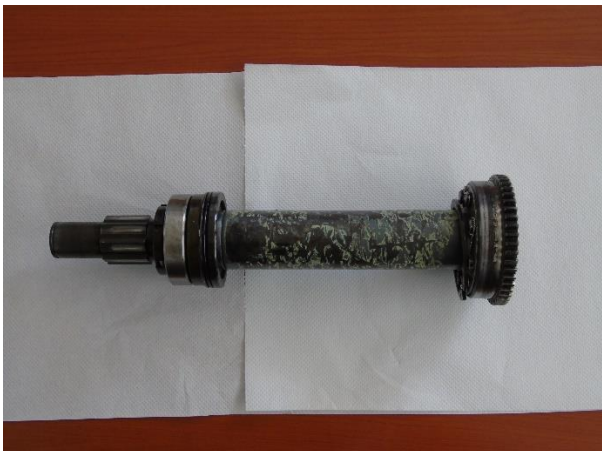
Figure 28 – Drive shaft

For the purposes of investigation, the drive shaft was disassembled into individual parts. By the inspection of the drive shaft, it was established that the “freewheel” function of the shaft was serviceable and that particular components in the “freewheel” mechanism were not damaged (Figures 28 and 29). Lubricating oil was found in the “freewheel” mechanism. The serrated cracked part of the input bevel drive shaft remained stuck and welded into the drive shaft.

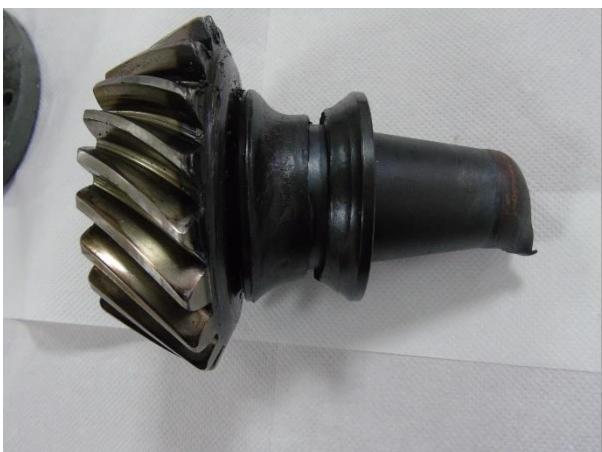
Figure 30 – Input bevel drive shaft with gear

The inspection of the input bevel drive shaft established its failure at the position of the outer bearing. At the point of cracking, the material was completely distorted with traces of discoloration (Figures 30 and 31). Damages in the form of overheating and mechanical damages were found on the input bevel drive shaft gear.

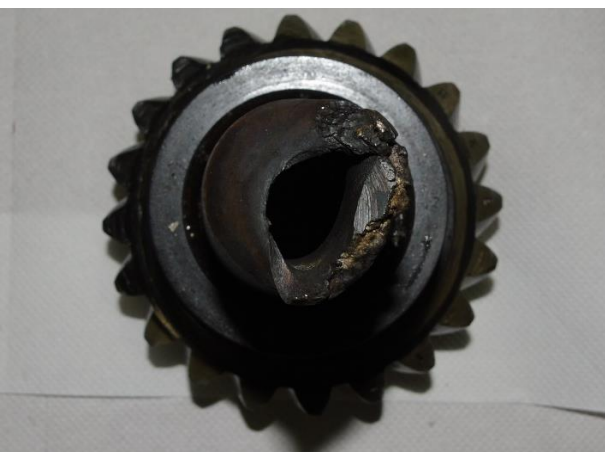
Figure 31 – Point of rupture of the input bevel drive shaft

Following the above analysis, a conclusion was reached. The input bevel drive shaft cracked due to torque overload with a characteristic inclination of the cracking surface at an angle of 45° to the transverse level. The cracking of the input bevel drive shaft consequently caused destruction of the outer bearing.

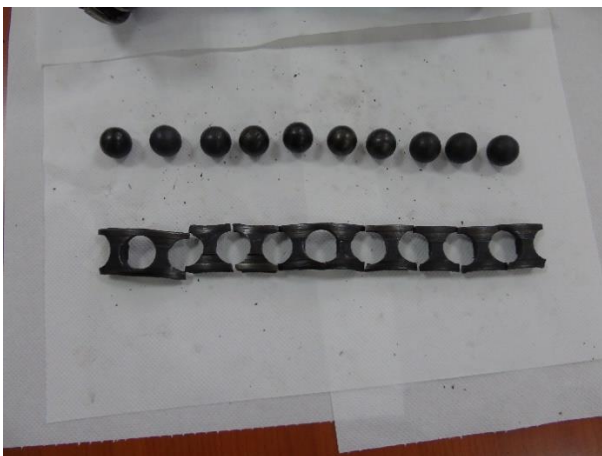
Damages to the inner bearing were considerable. Due to the high temperature, the inner track of the inner bearing changed its shape, cracked and remained welded to the input bevel drive shaft. The bearing cage was cracked in several places and completely changed its colour. The ball bearings have changed their colour, had surface damages, and had been deformed in several places ( Figure 32). The outer race of the internal bearing was damaged as the result of spalling (Figure 33). The external bearing located in the same plan than the input bevel gear drive shaft was not found.

Figure 32 – Elements of inner bearing

By analysing the cracking surfaces of the elements of the inner ball bearing, it can be concluded that the cracking occurred suddenly, and that a foreign body with a large share of copper passed through the bearing. This particles could be separated from the installed shims, or the inner or outer bearing cage.

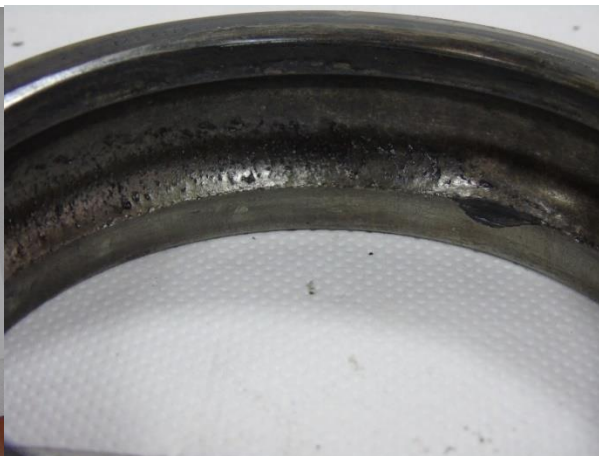
Figure 33 – Outer track of the inner bearing

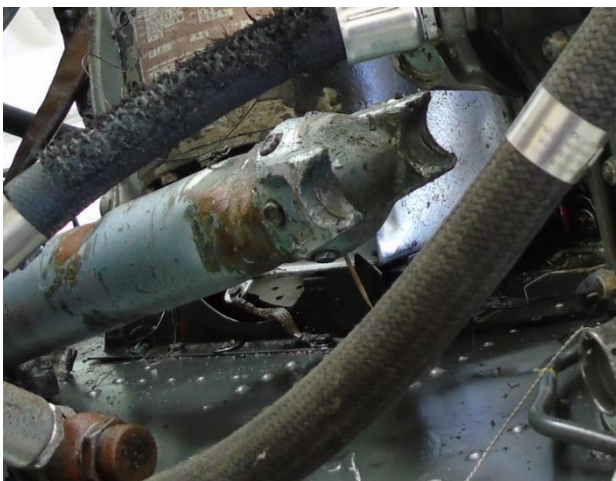
The cardan shaft was broken by overload at the universal joint, and was significantly damaged in the form of dents (Figure 34). The clutch unit inspection identified no technical defects (Figure 35).

Figure 34 – Cracked cardan shaft universal joint

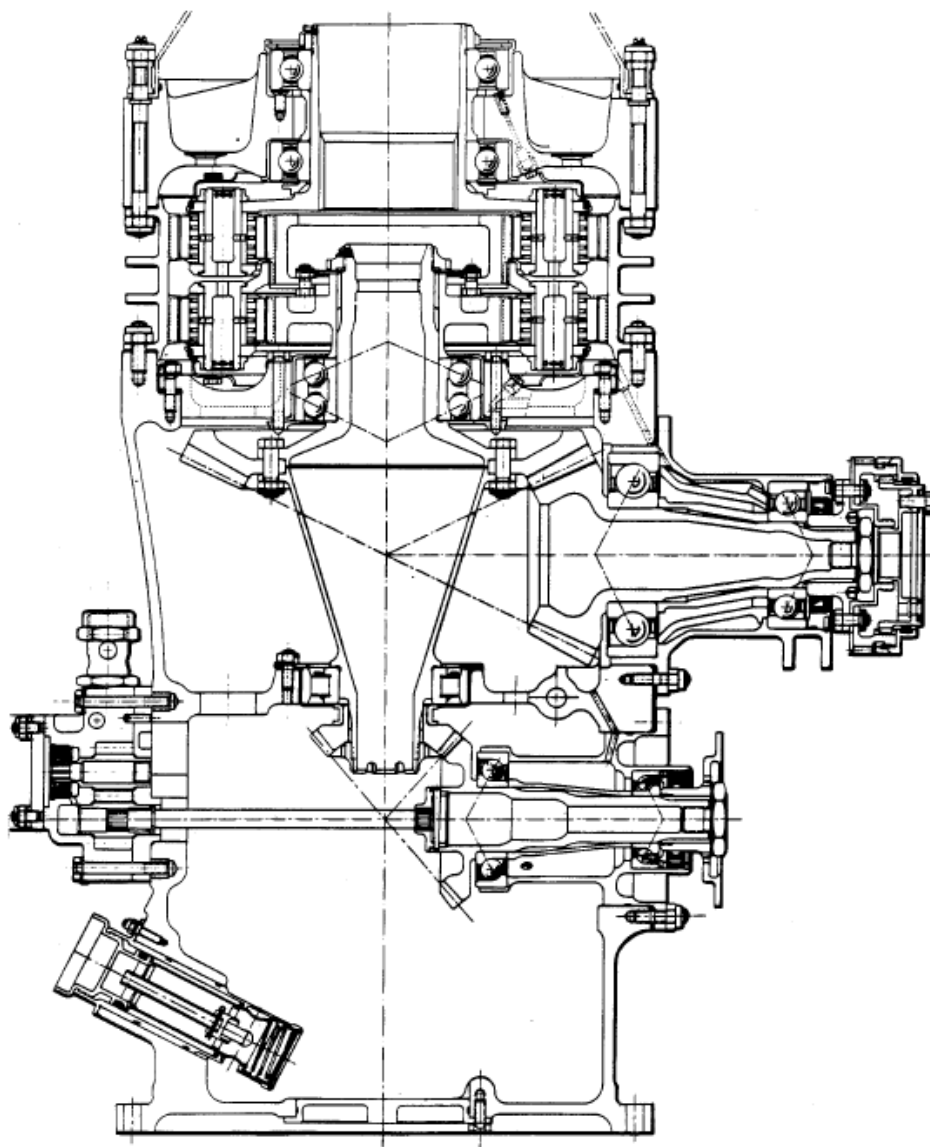
Figure 36 – Main gearbox

The main gearbox (PN: 3130.62.40.000, SN: 1153) was installed on the helicopter in 2014 by the Hungarian Annex II Maintenance Organization. The gearbox was delivered to the Maintenance Organization by the helicopter operator and installed with a total of 199 operating hours since overhaul and 5722 operating hours since new.

The inspection of the available technical documentation of the main gearbox showed that the same was removed from another helicopter (serial number: 1351) with a total of 10767.35 operating hours. It is also apparent that in 2014 and 2017 the Annex II Maintenance Organization carried out a three-year calendar inspection prior to installation to the subject helicopter.
