**Air, Maritime and Railway Traffic Accident Investigation Agency**  
**Air Traffic Accident Investigation Department**

## **FINAL REPORT**

**ON ACCIDENT OF THE AIRCRAFT  
CESSNA 182, registration OE-DDU**

**Dubrovnik Airport, 25 July 2018**

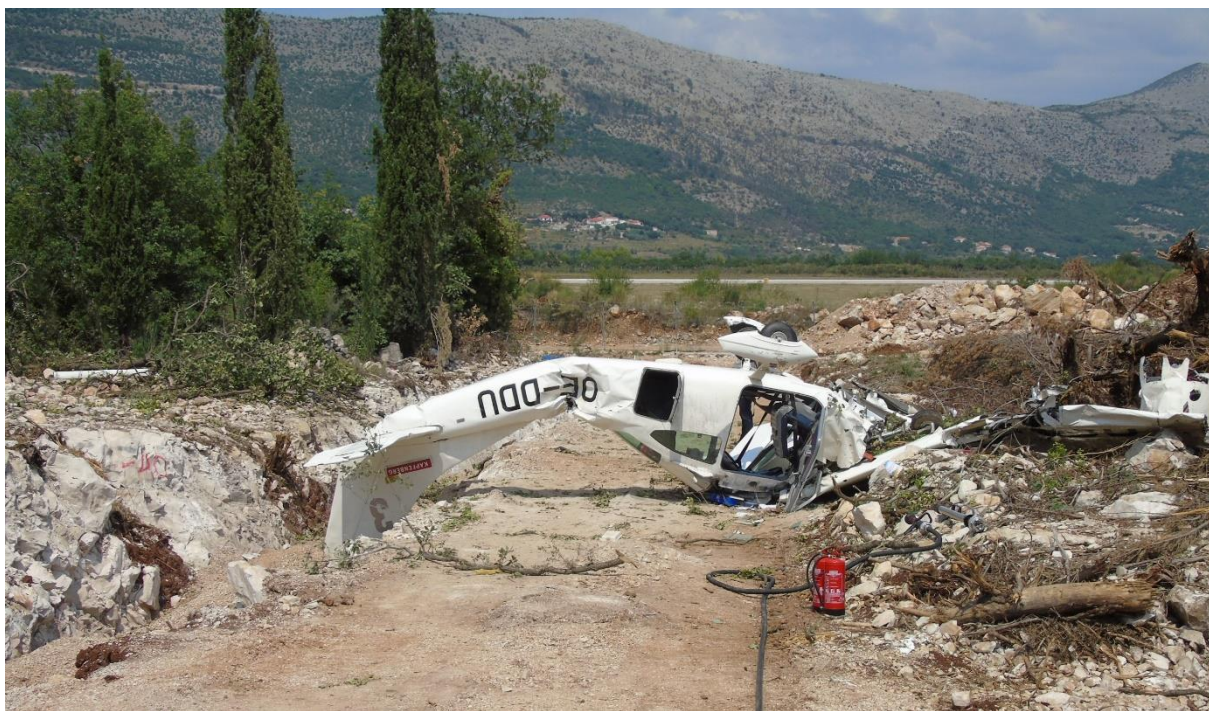
In this accident the aircraft was destroyed.

Picture 1 – Aircraft OE-DDU at the accident site

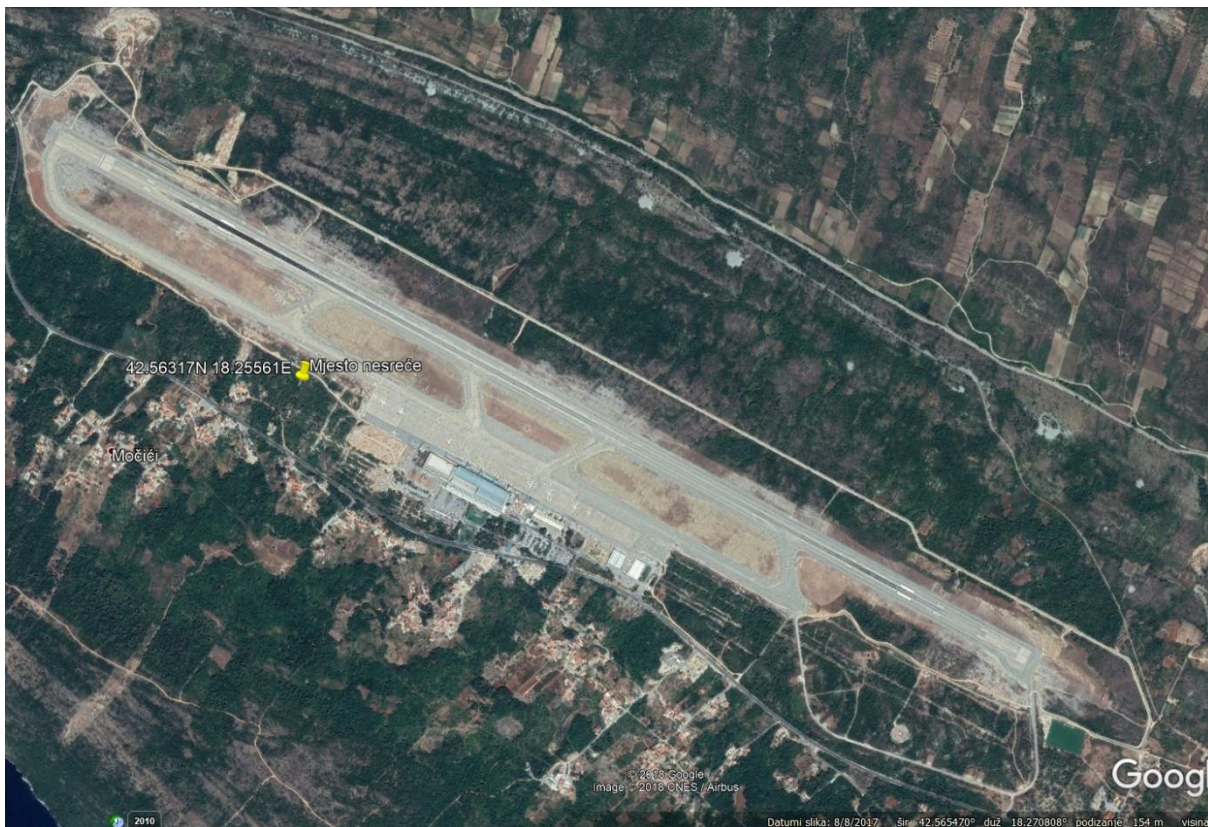
Before the impact, the aircraft rased the treetops of the lower trees and immediately thereafter crashed to the ground and turned to the back. The position of the crash was located to the right of the runway 12, about 350 m from its axis and 900 m from the threshold in the direction of 139°.

Picture 6 – Dubrovnik Airport, the crash site of the aircraft OE-DDU is marked yellow
