**Air, Maritime and Railway Traffic Accident Investigation Agency**  
**Air Traffic Accident Investigation Department**

## **FINAL REPORT**

**ON ACCIDENT OF THE DRONE  
UAVISION - WINGO OGASSA  
tail number 18106**

**Brač Airport, 20 November 2018**

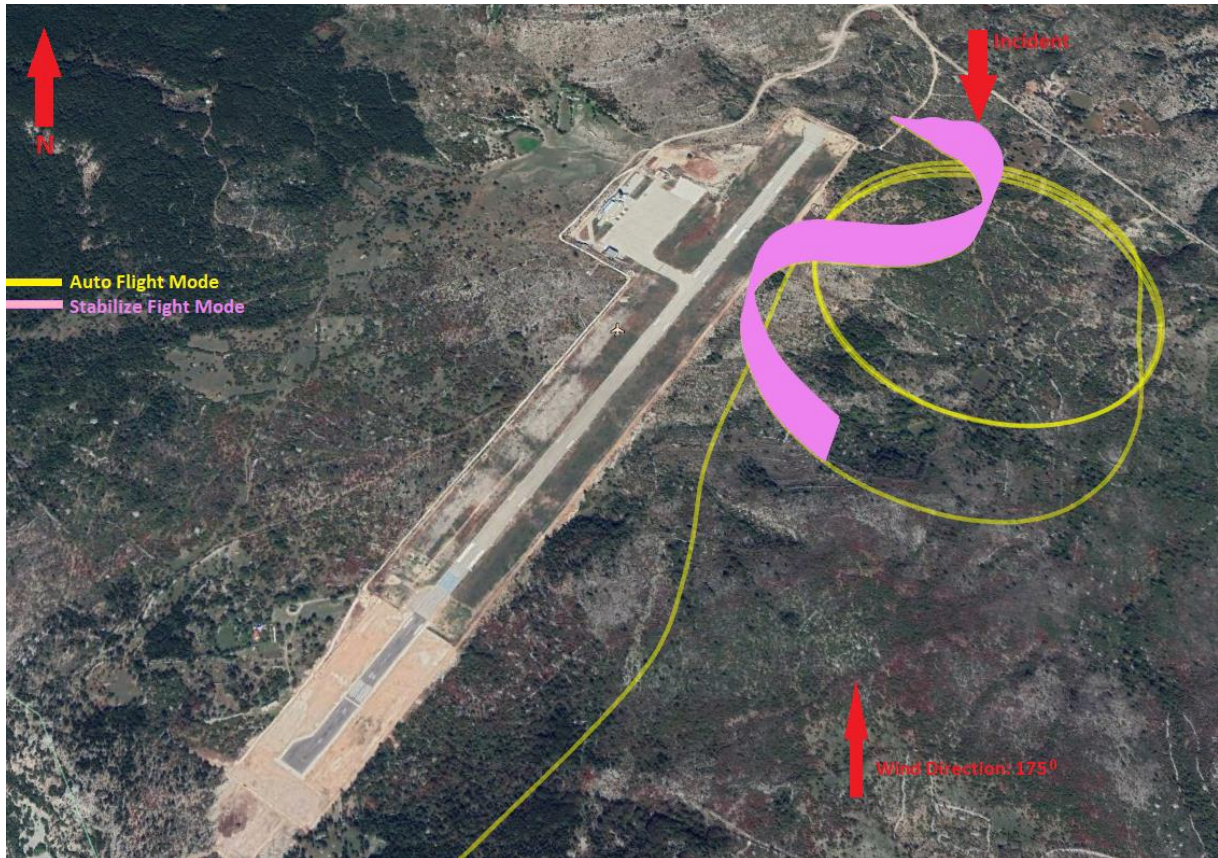
After the descent, the aircraft uncontrollably began to lose altitude in the left turn and crashed to the ground about 150 m east of the threshold of runway 22 of the Brač Airport.

Picture 1 – Brač Airport and flight path of the drone in approach

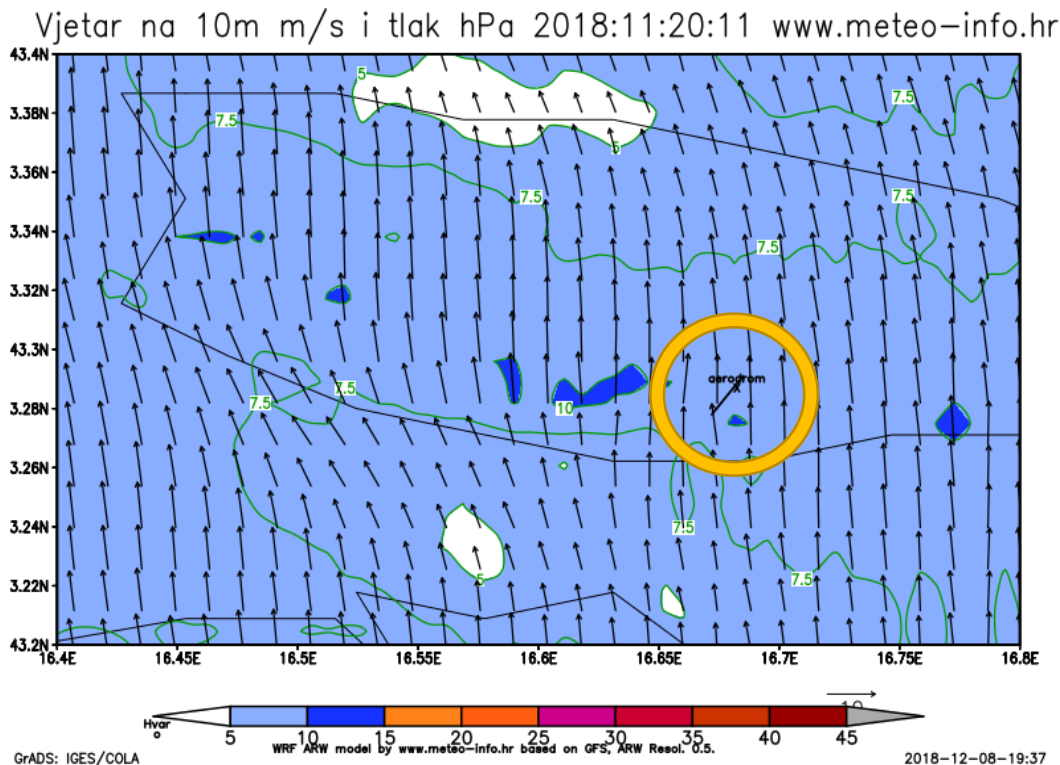
Picture 3 – Wind at 10m, direction and speed, 12:00 LT

Picture 3 shows wind direction and speed at 10 m above the ground obtained by numerical analysis. This data is fully consistent with the wind data measured at the surrounding weather stations. The Brač Airport is located in the place marked with a yellow circle.

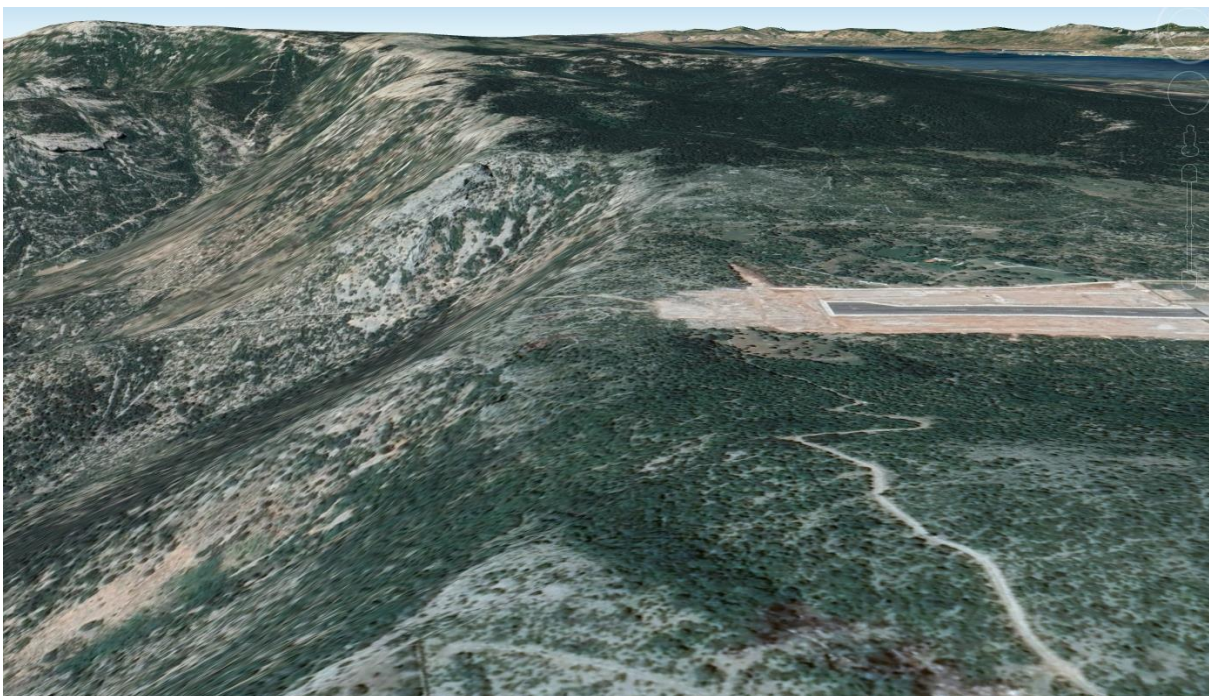
The airport is located on a natural plateau at an altitude of just over 500 m. On the south side of the plateau there is a slope which descends to sea level. The threshold of the runway 04 is almost at the edge of the mentioned slope (Picture 4) and is about 2 km away from the coastline. The distance from the threshold of the runway to the edge of the slope is about 250 m.

Picture 4 – Presentation of the relief in the area of the Brač Airport

In situations where stronger winds are blowing from the south directions, the air will flow uphill on the slope, and on the plateau behind the edge of the slope, the flow will be descending and accompanied by turbulence.

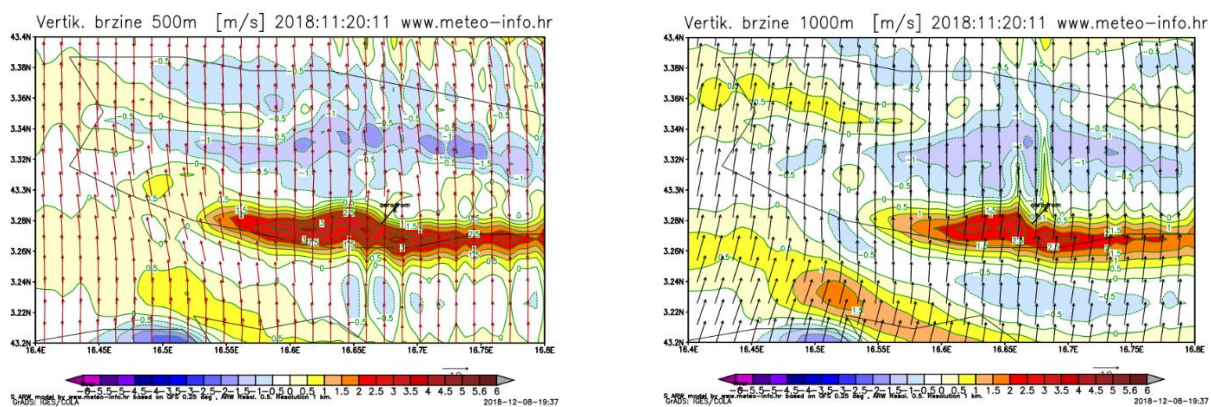
By numerical analysis a simulation of vertical air flow in the area of the island of Brač during the accident was made (Picture 5), and Picture 6 shows the air flow in the area of the Brač Airport.

Picture 5 –Presentation of vertical wind speeds at 500 m of altitude (left picture) and at 1000 m of altitude (right picture) at the time of the accident

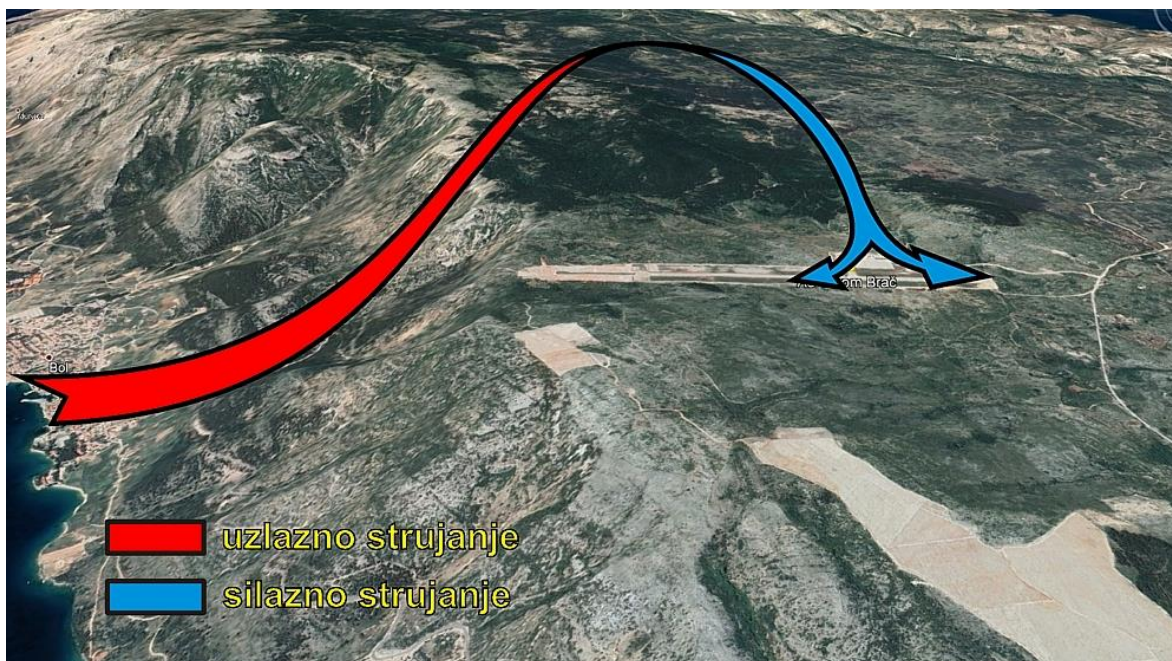
Picture 6 –presentation of the air flow in the area of the Brač Airport at the time of the accident

It can be seen from Picture 6 that the relief of the south part of the island can, with moderate and strong winds from the southern quadrant, create a downward airflow just behind the edge of the slope. In the area of the runway, especially its northern part, in such situation, descending air currents which “spread” upon impact to the ground can be expected.

The analysis of the meteorological situation shows that the relief of the area where the airport is located affects the air currents in presence of south winds. In such situation, the threshold of the runway 22 of the Brač Airport is the zone of descending air current that 'spreads' when approaching the ground. In the area of the 'spread' of the air current, the wind direction is not stable but varies. An aircraft approaching the runway 22 'upwind' in such a situation can easily at some point get struck by a gust of wind from another direction. In case the speed is low (close to stall speed) and the gust of wind is in the rear of the aircraft, the flight performance of the aircraft may be significantly impaired.

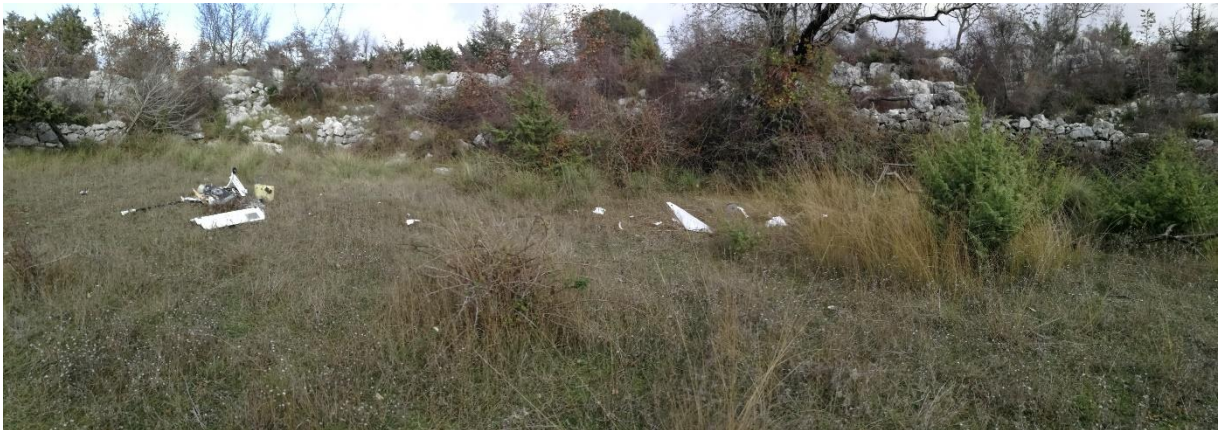
The aircraft hit the ground on a steep path at a speed of about 100 km/h and was completely destroyed. The impact site was about 150 m east of the threshold of runway 22 of Brač Airport.

Picture 7 – Remains of the drone at the impact site

The stall of the wings of the aircraft occurred when the aircraft entered the left turn. The flight speed before entering the turn was barely slightly higher than the stall speed, and the wind was of variable direction. It is highly likely that the gust of wind to the rear of the aircraft further reduced the flight speed, and the lateral tilt in the turn further contributed to the stall.

When the stall occurred, the aircraft began to decline suddenly, and the altitude above ground was too low for the aircraft to regain the required speed and to recover. Namely, the recovery of aircraft from stalling is possible only at the expense of additional loss of altitude. If the aircraft is low above ground, there is not enough altitude for recovery and return to normal flight. In such case, the impact of the aircraft to the ground is inevitable.

The cause of this accident was stalling at a low altitude occurred due to one of the following two reasons or combination of both:

- Entering the turn at too low flight speed (close to the stall speed),
- Gust of wind to the rear part of the aircraft in a situation when the flight speed was too low (close to the stall speed).

The speed of the aircraft during the approach for landing should always be sufficiently high, i.e. so much higher than the stall speed so as to prevent the gusts of wind to compromise the speed required for flying of the aircraft.

The approach of the aircraft should take place along the path that is common in aviation (downwind - base - final) and which at the same time allows for the optimal control and stabilization of the aircraft in approach.
