**Air, Maritime and Railway Traffic Accident Investigation Agency**

# **FINAL REPORT**

**ON SERIOUS INCIDENT OF THE AIRCRAFT  
BOEING 737-800,  
registration TC-AMP**

**Croatian airspace – 7 miles west of LQBI,  
2 October 2018**

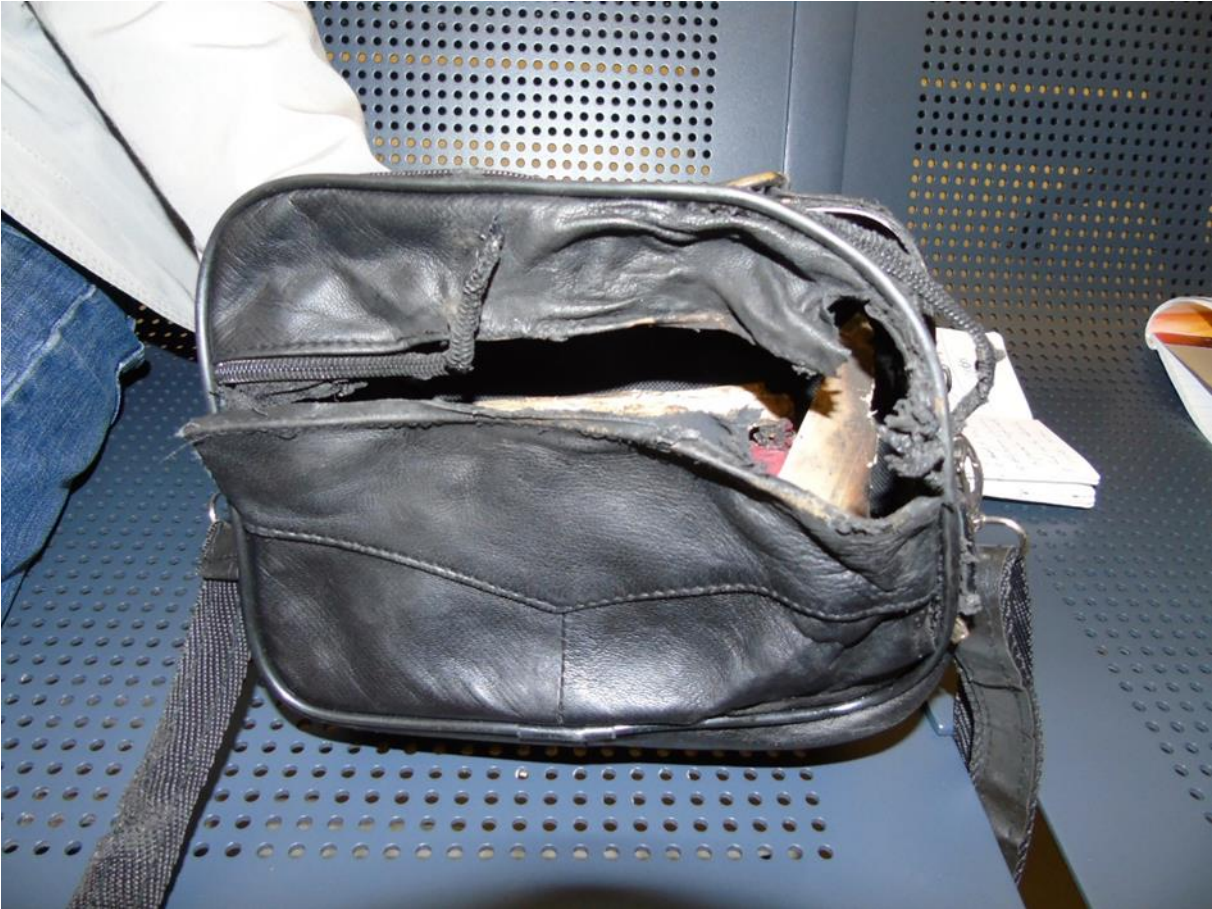
After the minor explosion of the electronic evaporator, the passenger's personal bag was ignited (Picture 2). During the burning of the bag, a damage occurred to the passenger seatbelt which was burnt (Picture 3).

Picture 2 – Damaged passenger’s personal bag

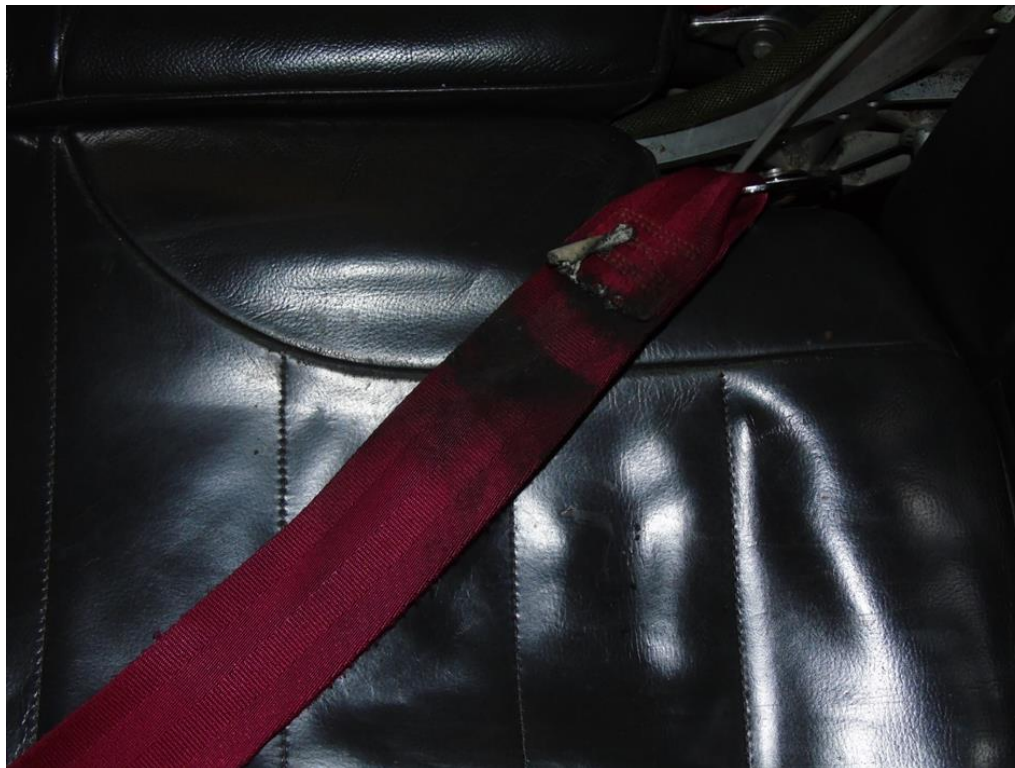
The aircraft sustained minor material damage in the form of burned passenger seatbelt on the seat no. 21D.

Picture 3 – Burnt passenger seatbelt on the seat no 21D

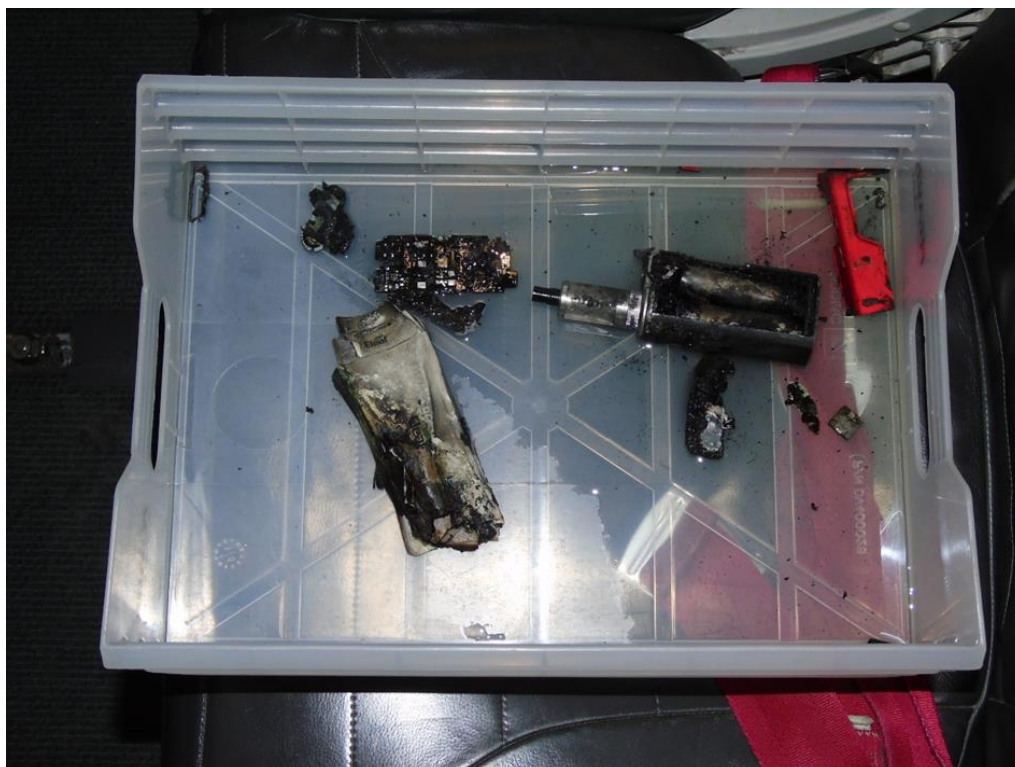
The cabin crew had applied lithium battery fire extinguishing actions in accordance with the applicable procedures. After the fire was extinguished by the cabin halon fire extinguisher, the entire electronic evaporator was placed in water to lower the temperature of the batteries, as required by the prescribed procedures (Picture 4).

Picture 4 –The electronic evaporator cooled in water after the explosion

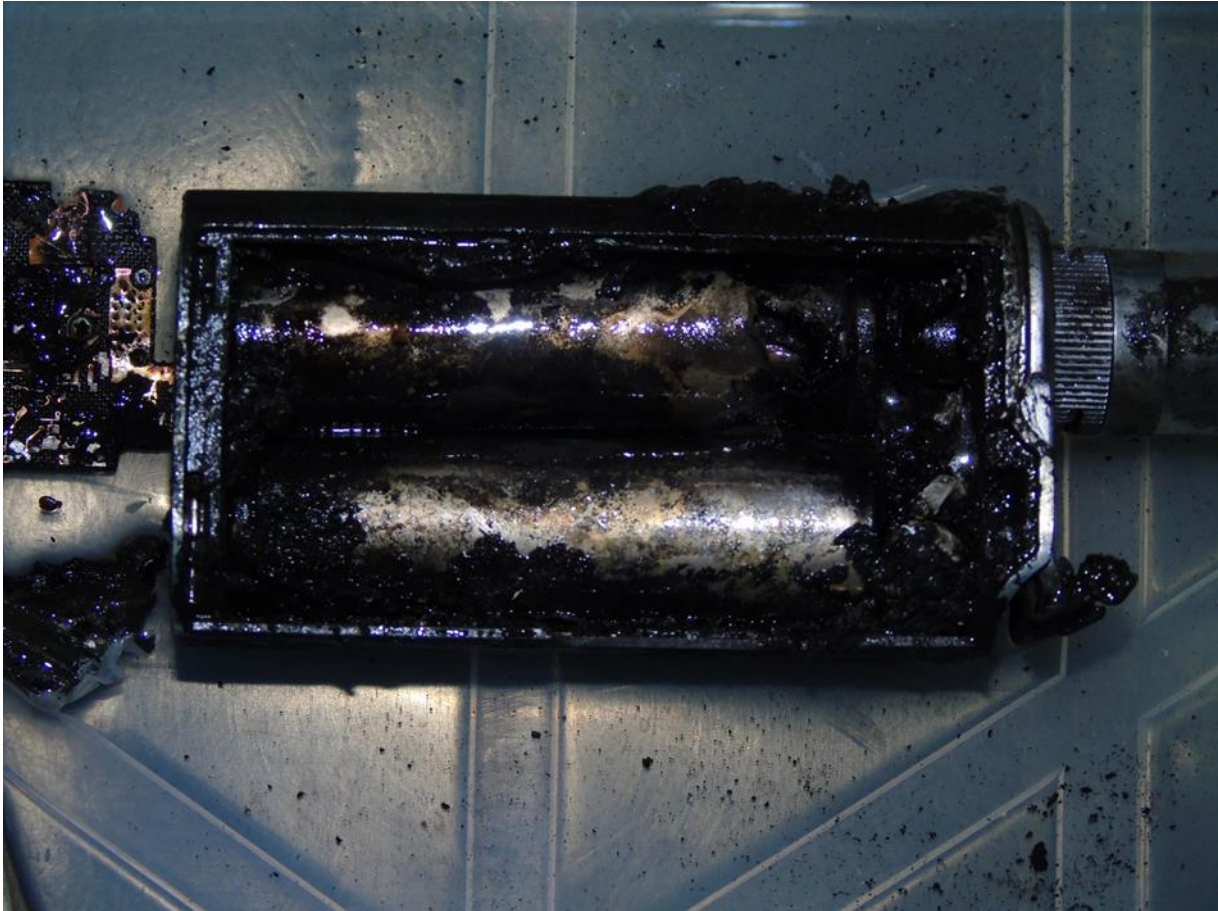
By charging lithium-ion batteries via USB cable, i.e. without the intended charger, overheating and explosion can occur if the battery condition is not monitored, because this charging mode does not control the input voltage and current parameters.

Picture 5 – Lithium-ion batteries 18650 after the explosion on the aircraft in question

It can be concluded with great certainty that the cause of the subject serious incident was the overheating of lithium-ion batteries due to improper charging, which resulted in the explosion of the lithium-ion batteries.

The operator, the company Pegasus Airlines, should implement the new Passenger safety cards that comply with the international standards and norms, such as EASA CAT.OP.MPA.170 and ICAO Doc. 10086, and with the conclusions of the DGCA Safety Study.
