Air, Maritime and Railway Traffic Accident Investigation Agency

FINAL REPORT

**ON ACCIDENT OF THE AIRCRAFT CESSNA 150,
REGISTRATION 9A-DMI**

**17 AUGUST 2019,
A6 MOTORWAY NEAR EXIT RAVNA GORA**

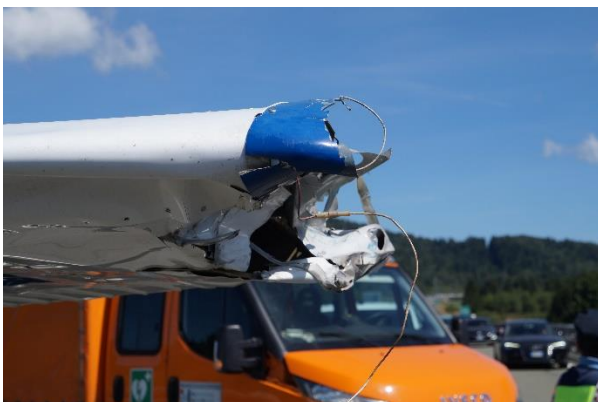
Although during the landing no separation of major structural parts of the aircraft happened, a significant material damage occurred in a form of: dents in the fuselage skin in several places, bending of the propeller blades, bending of the engine mount, rupture of the engine cowling, separation of the landing gear wheel, rupture of the wing skin etc. Some of the damage are shown in Pictures 1 and 2.

Picture 1 – Damage to the tip of the wing

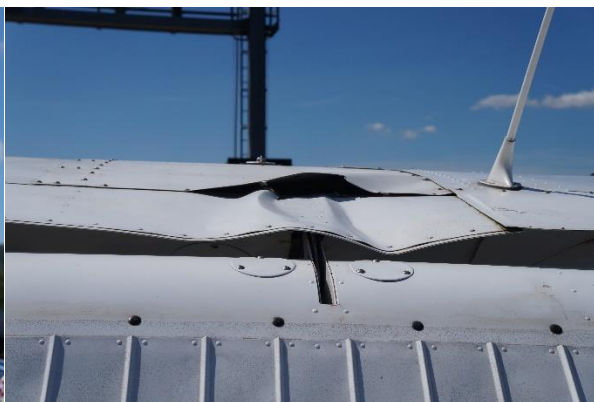
Picture 2 – Damage of the wing skin

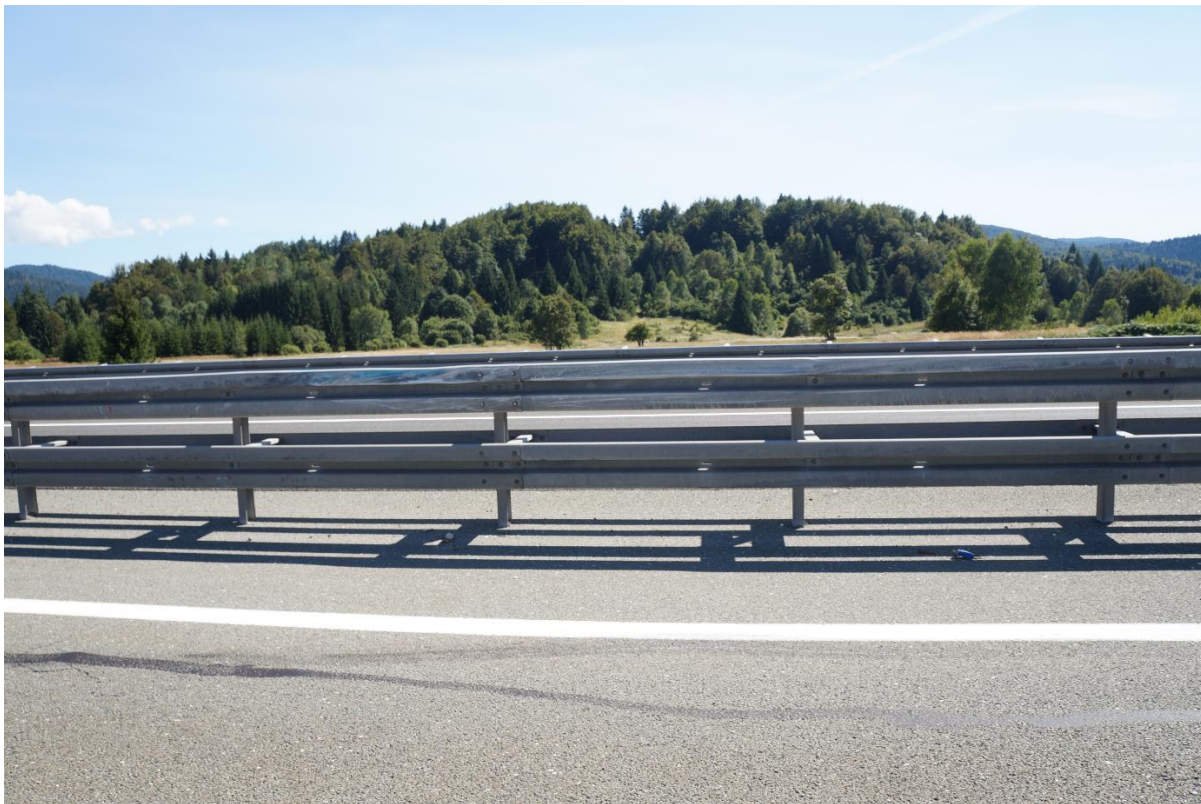
During the accident in question, a minor damage to the motorway guardrail occurred when the fuselage made a contact with it (Picture 3), in the form of minor dents and scratches.

Picture 3 – Damage to the motorway guardrail

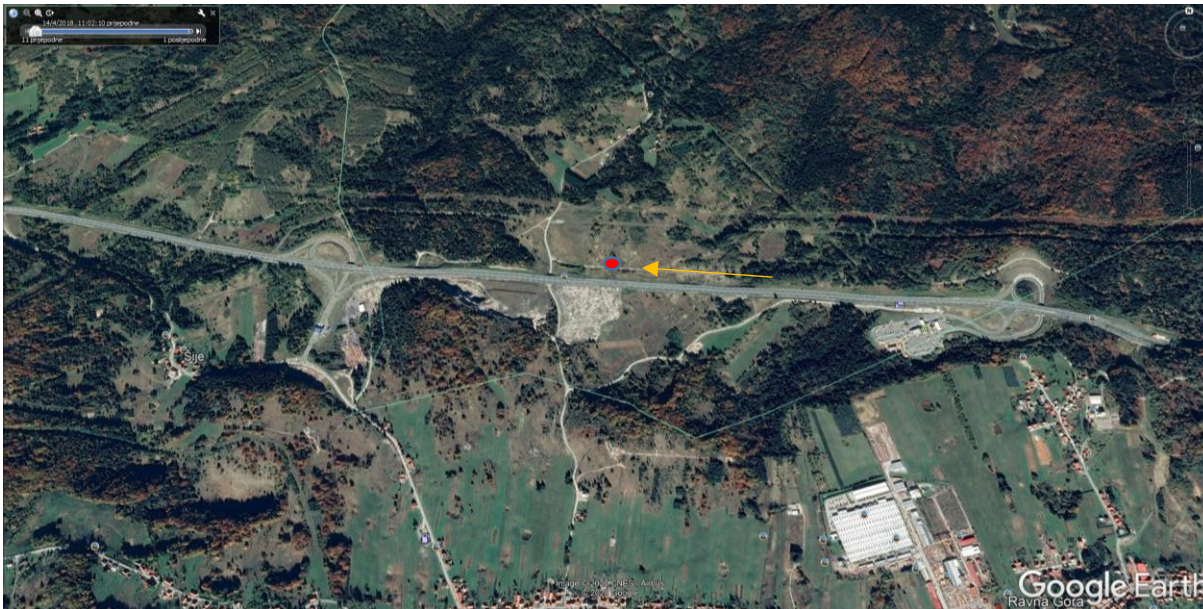
road traffic was increased. On the picture 5 the direction of the landing of the aircraft is marked with a yellow arrow, while the red circle indicates the place where it stopped.

Picture 5 – Direction of the landing (yellow arrow) and stopping place (red circle)

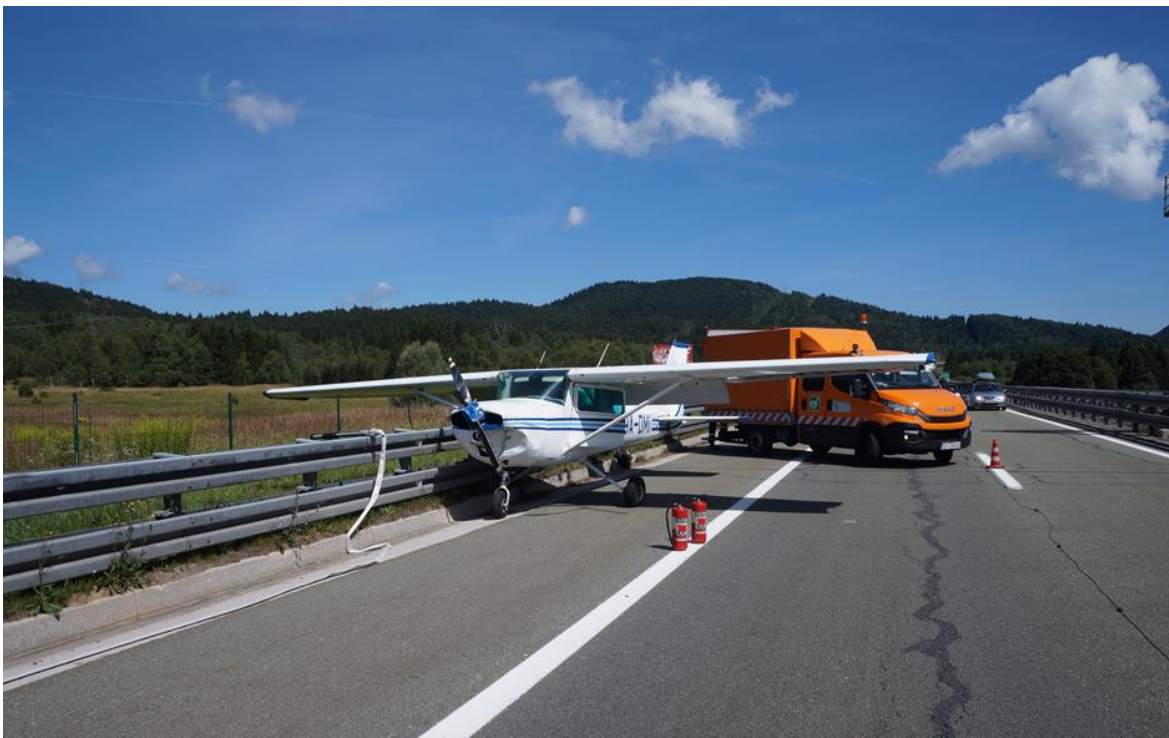
During landing on the northern lane of the A6 motorway, the aircraft hit the left guardrail, and then the right one where it stopped (Picture 6). Although there was no separation of major structural units of the aircraft, a significant material damage occurred to the aircraft.

Picture 6 – Place where the aircraft stopped on the A6 motorway

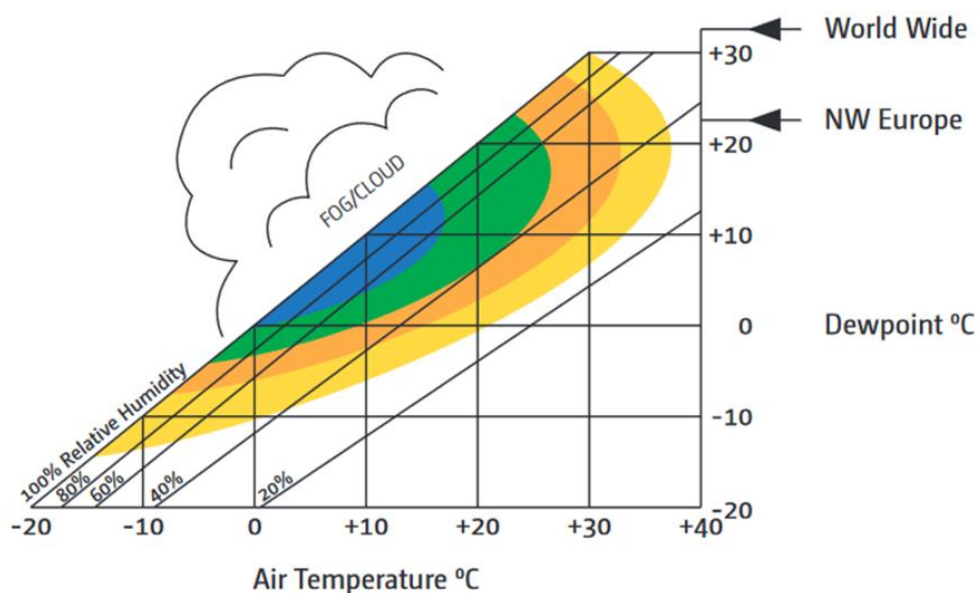
Atmospheric conditions of possible carburettor icing are shown in Picture 7. Aeronautical meteorological reports usually do not contain specific meteorological warnings of possible icing; therefore, pilots' knowledge and transfer of experience is very important. The reason for the lack of possible warnings about the conditions of possible icing is that in many cases it is impossible to measure

Picture 7 – Chart of atmospheric conditions for carburettor icing

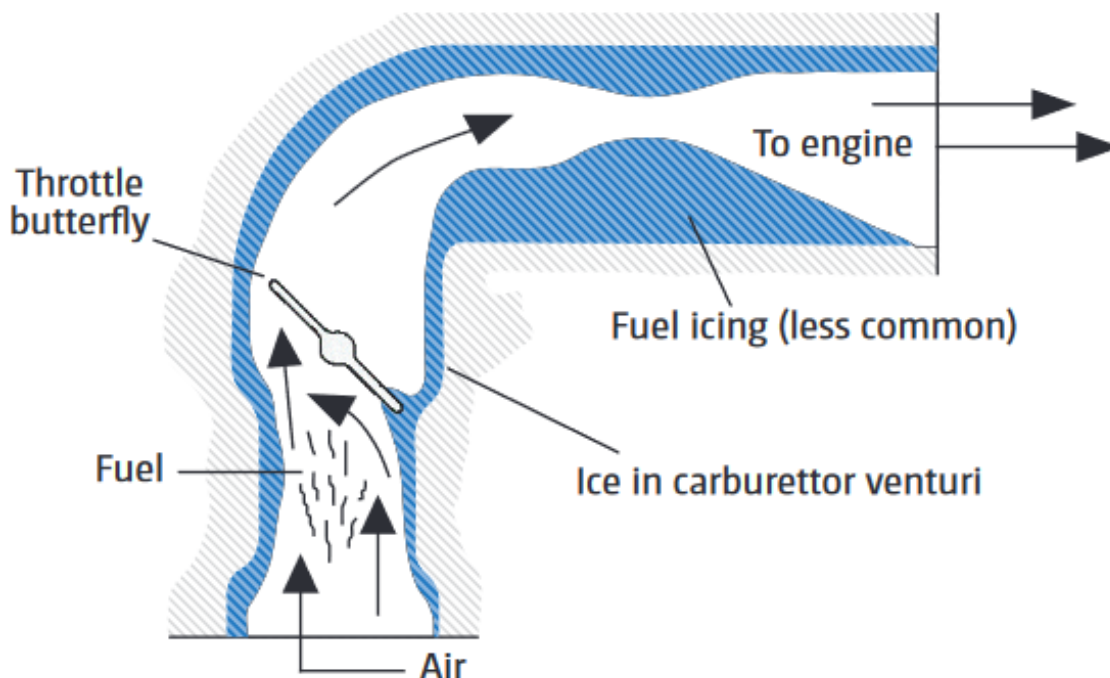
If the air temperature inside the carburettor drops below the dew point, moisture condenses and ice accumulates on the inner walls of the carburettor or on the throttle butterfly, which directly regulates the engine power (Picture 8). Accumulations of ice inside the carburettor blocks the air flow, thus changing the ratio of air and fuel in the mixture, which can result in constant, equal loss of engine power, rough engine operation, and ultimately engine failure.

Picture 8 – Carburettor cross-section with possible icing points
