**Air, Maritime and Railway Traffic Accident Investigation Agency**

# **FINAL REPORT**

**ON SERIOUS INCIDENT OF THE AIRCRAFT AIRBUS 320 NEO,  
REGISTRATION SE-ROJ**

**4 SEPTEMBER 2021,  
AT SPLIT AIRPORT**

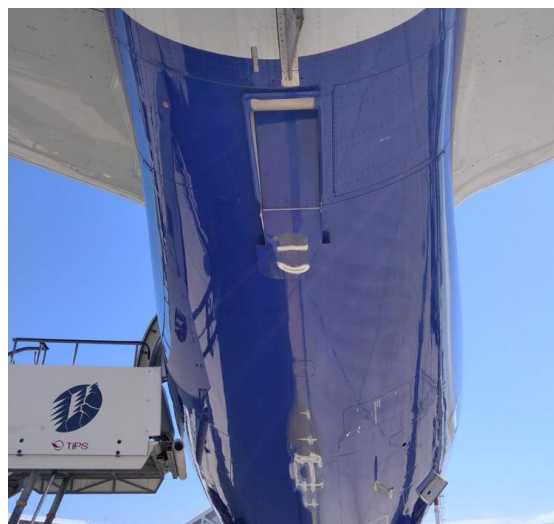
During the landing, damage to the plating and other structural parts typical for such event occurred on the aircraft which are shown in Picture 1 and 2. The damage occurred between frame 68 and 72, and between stringers 32LH and 32RH. There was also damage to the drainage pipe and door of the APU (Auxiliary power unit) and the drainage pipe of the rear galley (Picture 1 and 2).

Picture 2 – Skin damage and APU door damage

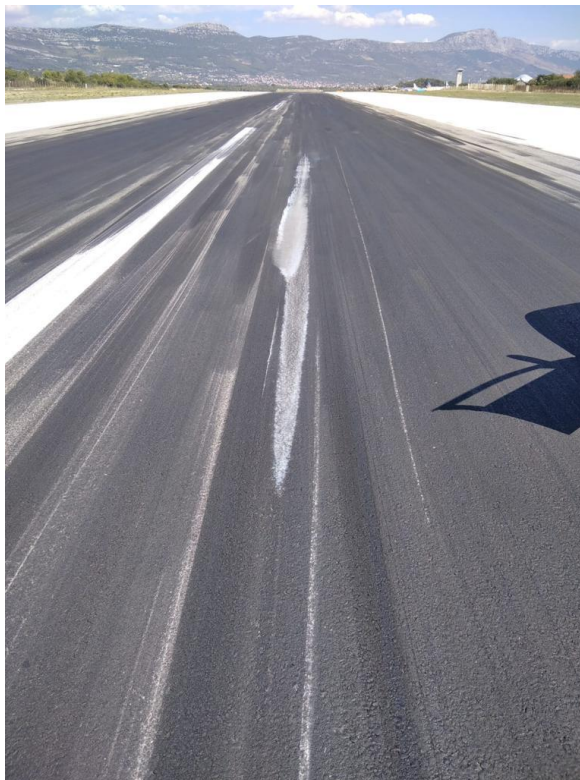
During the serious incident, there was no significant damage other than the stated damage to the aircraft. The point of contact of the tail of the aircraft with the runway is visible on the runway (Picture 3).

Picture 3 – The point of contact of the aircraft with the runway

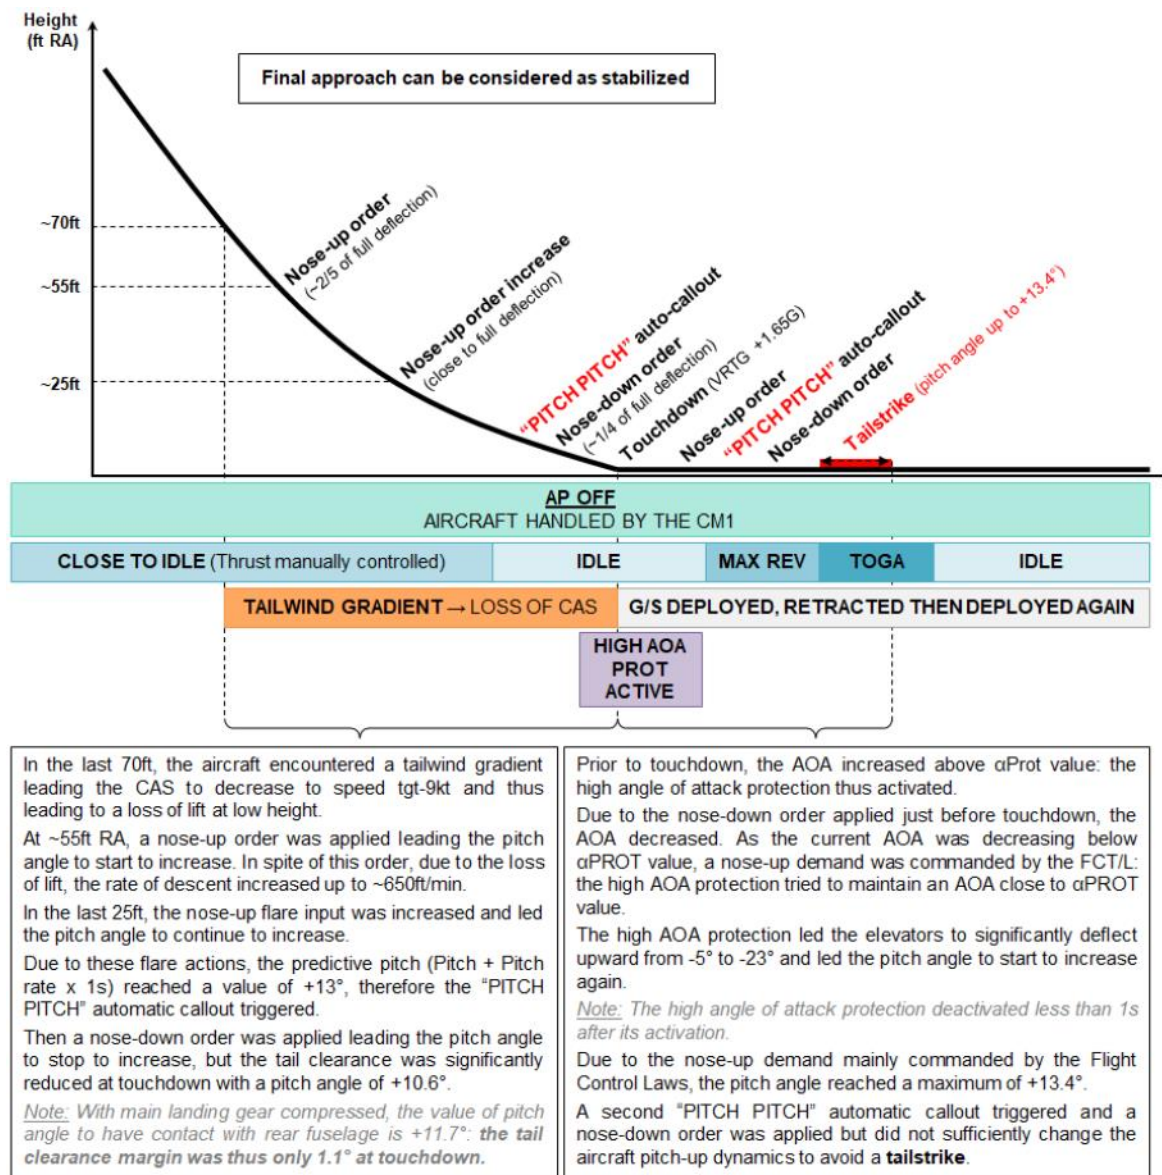
The FDR analysis indicates the following key points:

The Airbus Handling Quality analysis highlighted the following contributing factors of the event:

A significantly reduced tail clearance at touchdown:

- The tailwind gradient encountered in last 70ft participated to a loss of CAS and thus to a loss of lift at low height. The nose-up order applied by CM1 at ~55ft RA led the pitch angle to start to increase without effect on the rate of descent.
- At ~25ft RA, while the CAS continued to decrease towards speed target-9kt, the increase of the nose-up order led the pitch angle to continue to increase up to +10.6° before touchdown.

A nose-up dynamics just after touchdown:

- Due to the flare actions, the angle of attack increased up to +13.2°: the high angle of attack protection thus activated just before touchdown and led to a nose-up demand commanded by the Flight Control Laws.
- This nose-up demand mainly commanded by the Flight Control Laws just after touchdown (with the high AOA protection active) led the pitch angle to reach a maximum of +13.4°.
