Air, Maritime and Railway Traffic Accident Investigation Agency

FINAL REPORT

ON ACCIDENT OF THE AIRCRAFT Cessna 182, D-EGLF

Bročanac near Slunj, 29 May 2022

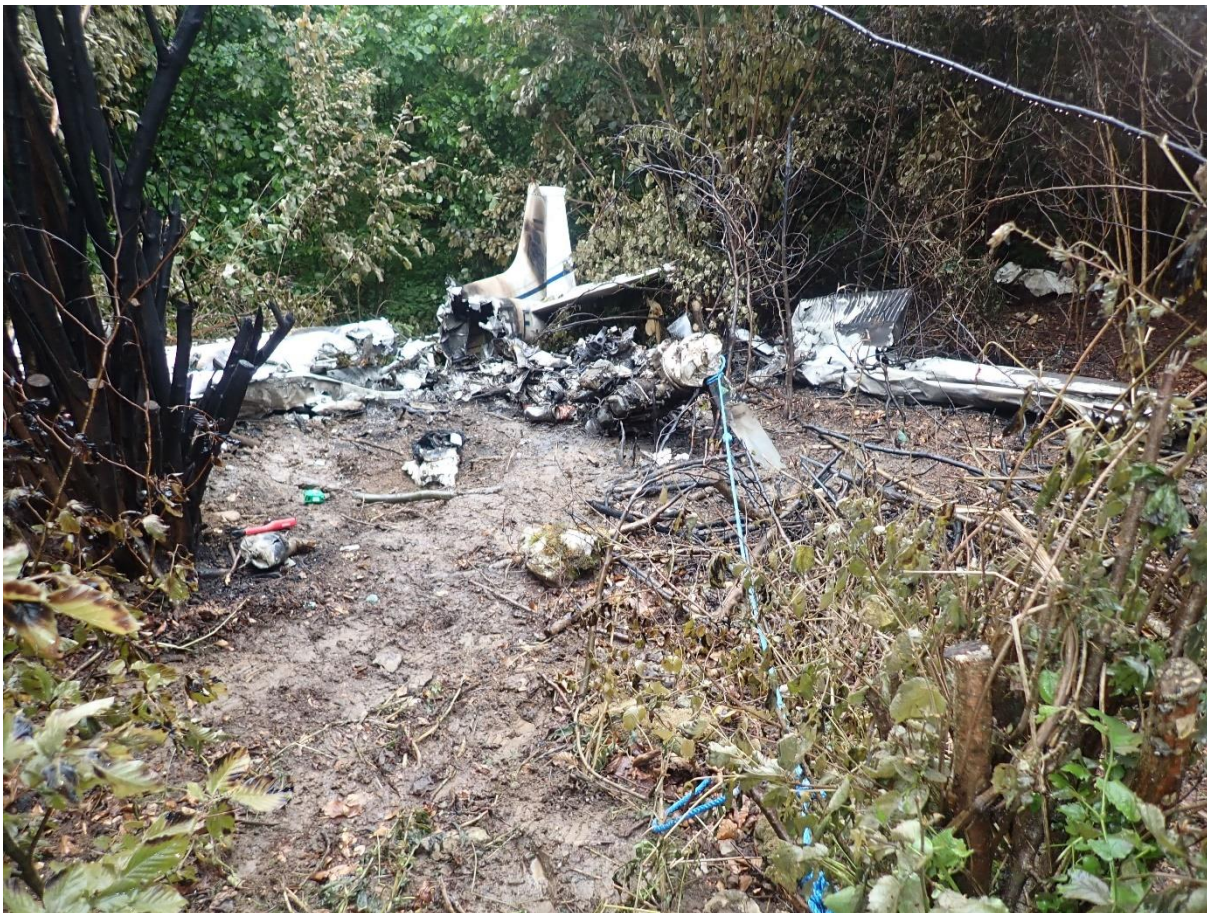
After the crash the aircraft in question burned almost completely. Only the outer parts of the wings and the rearmost part of the fuselage with vertical and horizontal stabilizers remained unburnt. The front and centre of the fuselage, as well as parts of the wings next to the fuselage, were completely burned. The parts located at the front end of the fuselage - the propeller and the propeller cone - were preserved to some extent from burning.

The propeller was found in a vertical position, where one blade was bent under the aircraft fuselage and pressed into the ground, while the other blade remained in an upward position. The blade that was bent under the fuselage did not suffer significant damage from burning, while the paint on the other blade was burnt. That second blade was not significantly deformed, however in one place near its tip there was a visible trace of melting, and the tip itself was torn off and found in the immediate vicinity. The propeller cone was found pressed in the ground and significantly mechanically deformed.

The front left door was found separated from the aircraft, about ten meters from the wreckage and partially burnt.

The outer parts of both wings, which were preserved from the burning to some extent, were mechanically significantly damaged and deformed.

Although damage and deformations were visible on it, the tail of the aircraft with its vertical and horizontal stabilizer was the least damaged. The damage to the mentioned parts was mostly of a mechanical type, and traces of burning were visible mainly in the form of smoky surfaces.

Picture 5 - The wreckage of the D-EGLF aircraft at the accident site
