Air, Maritime and Railway Traffic Accident Investigation Agency

FINAL REPORT

**ON ACCIDENT OF THE AIRCRAFT
CESSNA 172, REGISTRATION HA-SKL**

**28 JUNE 2022,
ISLAND OF BRAČ**

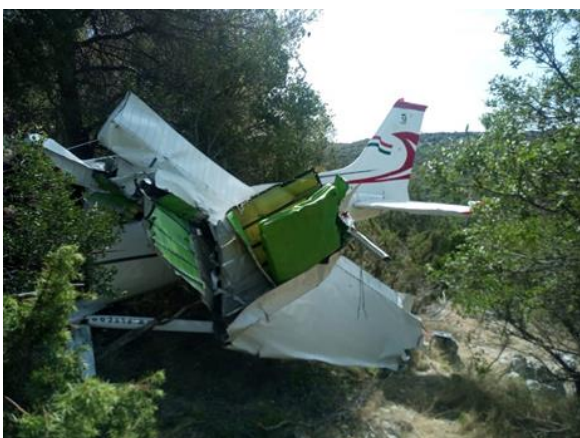
The left wing was partially torn from the fuselage at the joint of the shoulder blade and was laid parallel to the longitudinal axis of the aircraft. The plating of the left wing was partially torn from the structure of the wing itself, and the fuel tank was visible, which also cracked in several places. Along the entire wing, damage to the plating in the form of bending and cracking was established. The leading edge of the wing along its entire length had damage typical of its passage through trees or vegetation, i.e. longitudinal dents were visible. The left-wing strut was bent backwards and laid down. The left-wing flap was found in the retracted position.

Picture 2 – The aircraft's left wing tank

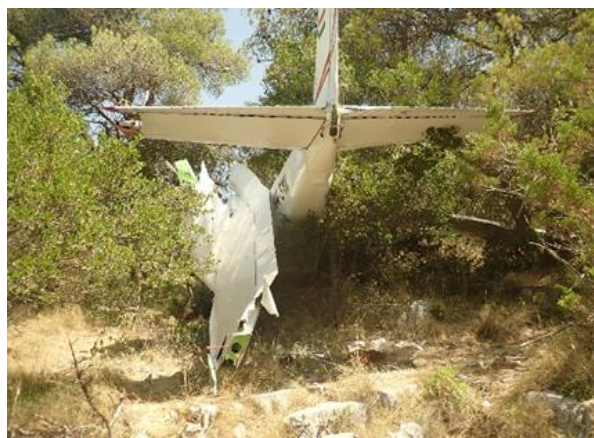
Picture 3 – Bent left wing along the fuselage

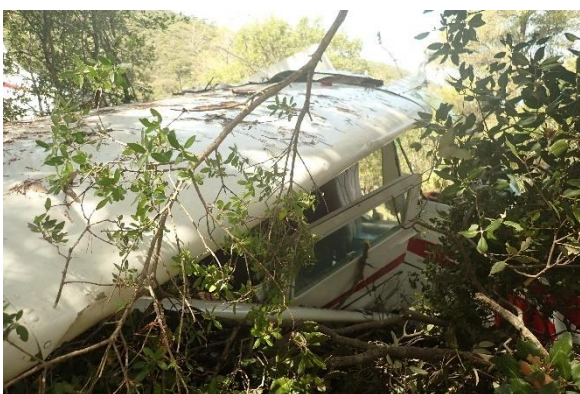
On the right wing, dents are visible on the leading edge, and bending of the plating on the top of the wing near the junction with the fuselage is visible. Damages to the plating of the wing tip and aileron tip are also visible.

Picture 4 – The right wing of the aircraft

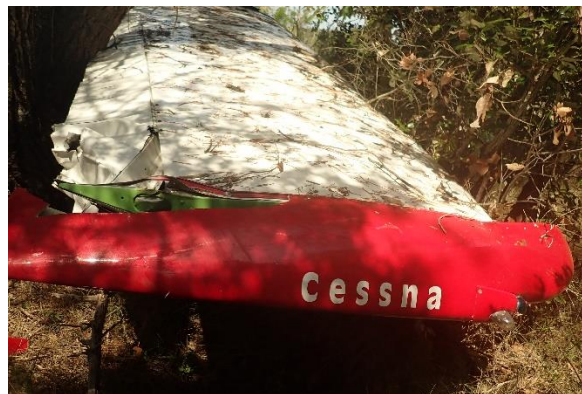
Picture 5 – The tip of the right wing of the aircraft

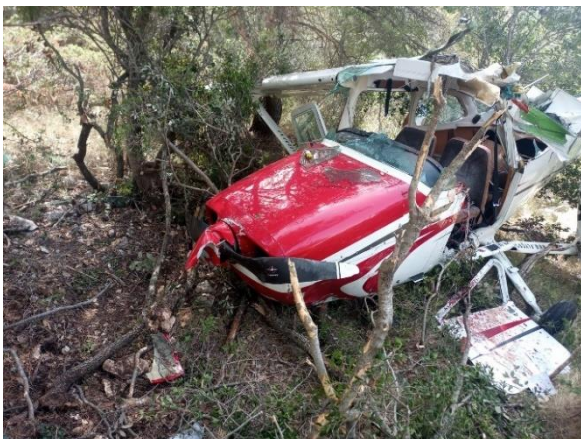
The windshield window frame of the aircraft cabin was completely cracked on the left side, and the pilot door frame was separated from the fuselage. The windshield and rear left window were completely blasted to pieces while the windows on the right side were not. The fuselage from the cabin to the tip of the tail was damaged in the form of bending of the plating, stringers and certain frames.

Picture 6 - Damage to the front of the aircraft

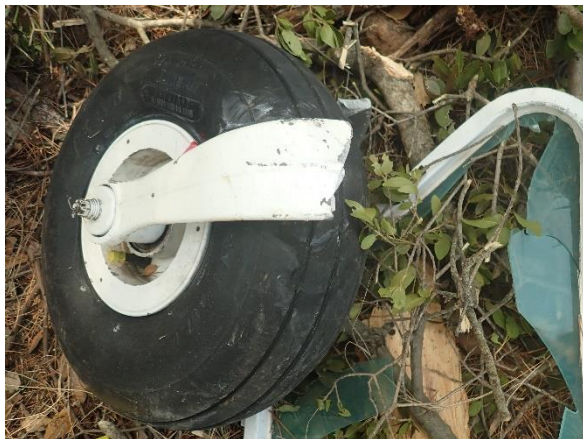
The front landing gear broke at the area of the upper part of the fork.

Picture 7 – Broken front landing gear fork

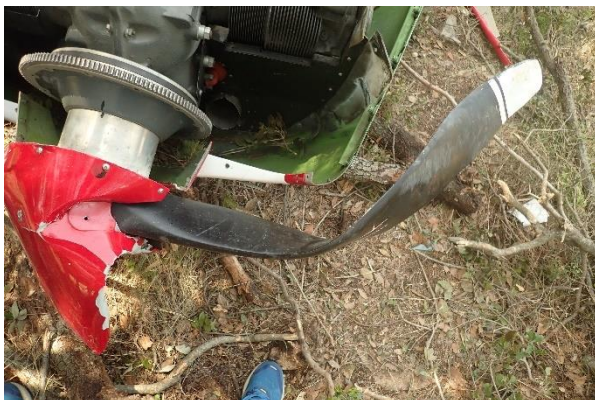
There are visible damages on both propeller blades caused by hitting an obstacle during its rotation. Bending of the crankshaft from the point of exit from the engine block to the propeller joint, is also visible.

Picture 8 – Bending of propeller arm no. 1

According to the damages on the power unit (bending of the crankshaft and bending of the propeller), it can be seen that the engine was running at a high number of revolutions and with considerable power. This is confirmed by the damage to the tree described earlier, caused by the rotating propeller.

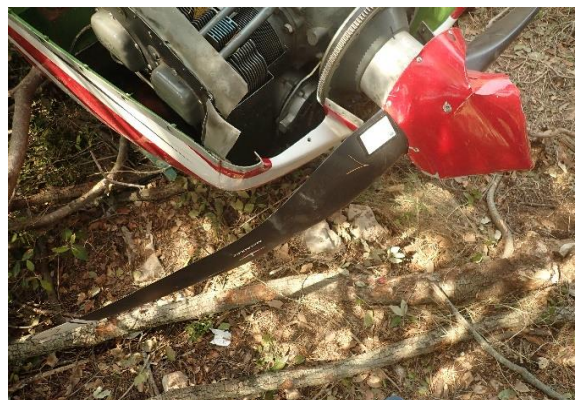
Picture 9 – Bending of propeller arm no. 2

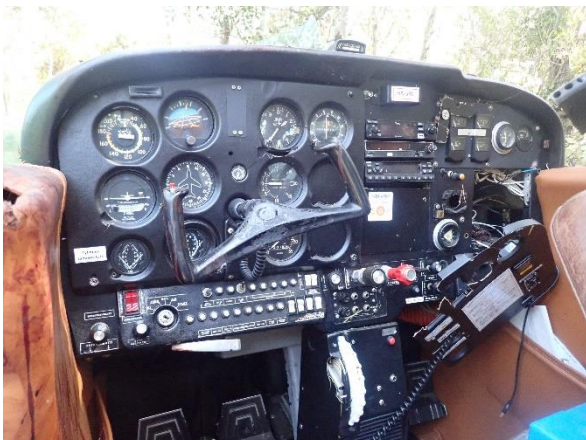
The instrument panel was found with damages to the decorative mask that separated on the right side from the instrument panel itself. The markings on the switches are in Hungarian. QNH (Q-Atmospheric Pressure at NH-Nautical height) pressure set on the altimeter is 1018 hPa. The ELT device (Emergency Locator Transmitter) was on and was turned off upon the arrival of the AIA investigators.

It was established that the right rudder was cracked in the part where the shaft enters the instrument panel. The main switch and ignition switch were found in the off position. The fuel injection pump is in the depressed and secured position. The power lever was found in the fully retracted position i.e. the maximum power position, while the fuel mixture lever was also found in the retracted position i.e. the rich mixture position. The carburettor heating lever is in the fully retracted position, i.e. the carburettor heating is turned off. The fuel valve was found in the off position.

The flap control lever was found in the up position (Flap 0°) as was the flap position indicator also showing 0°.

Picture 10 – Instrument panel

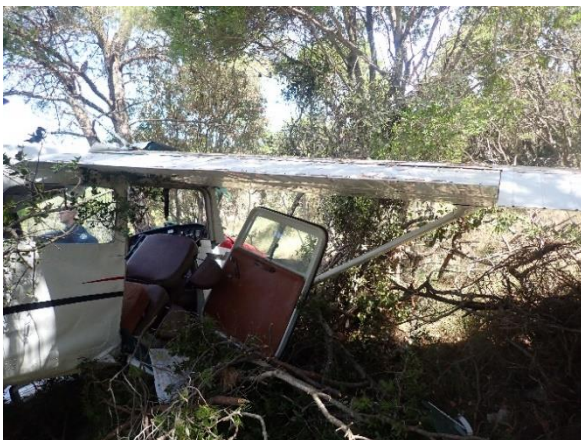
The right wing was found attached to the fuselage, and in the fuel tank of the said wing there was about a third of the fuel, which in colour and smell corresponded to the type of fuel Aviogas 100 LL and which is used as propellant fuel for this type of aircraft. No traces of fuel leakage were found on the right wing of the aircraft, including the filler cap, the drain valve and the fuel tank itself. The right wing flap was found in the retracted position.

Picture 12 – Retracted right wing flap

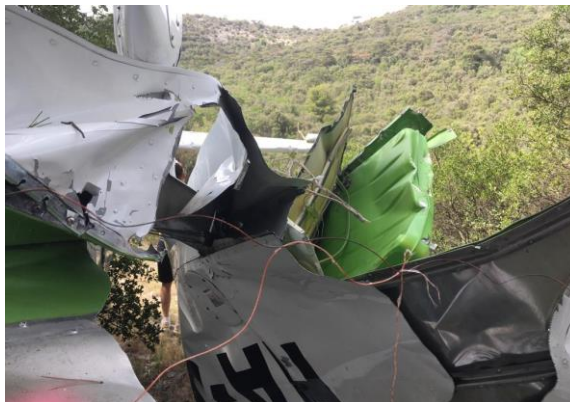
An examination of the left wing revealed that there was no fuel in the tank. The steel cables of the control surfaces of the ailerons and flaps broke due to the separation of the wing from the fuselage.

Picture 14 – Left wing fuel tank

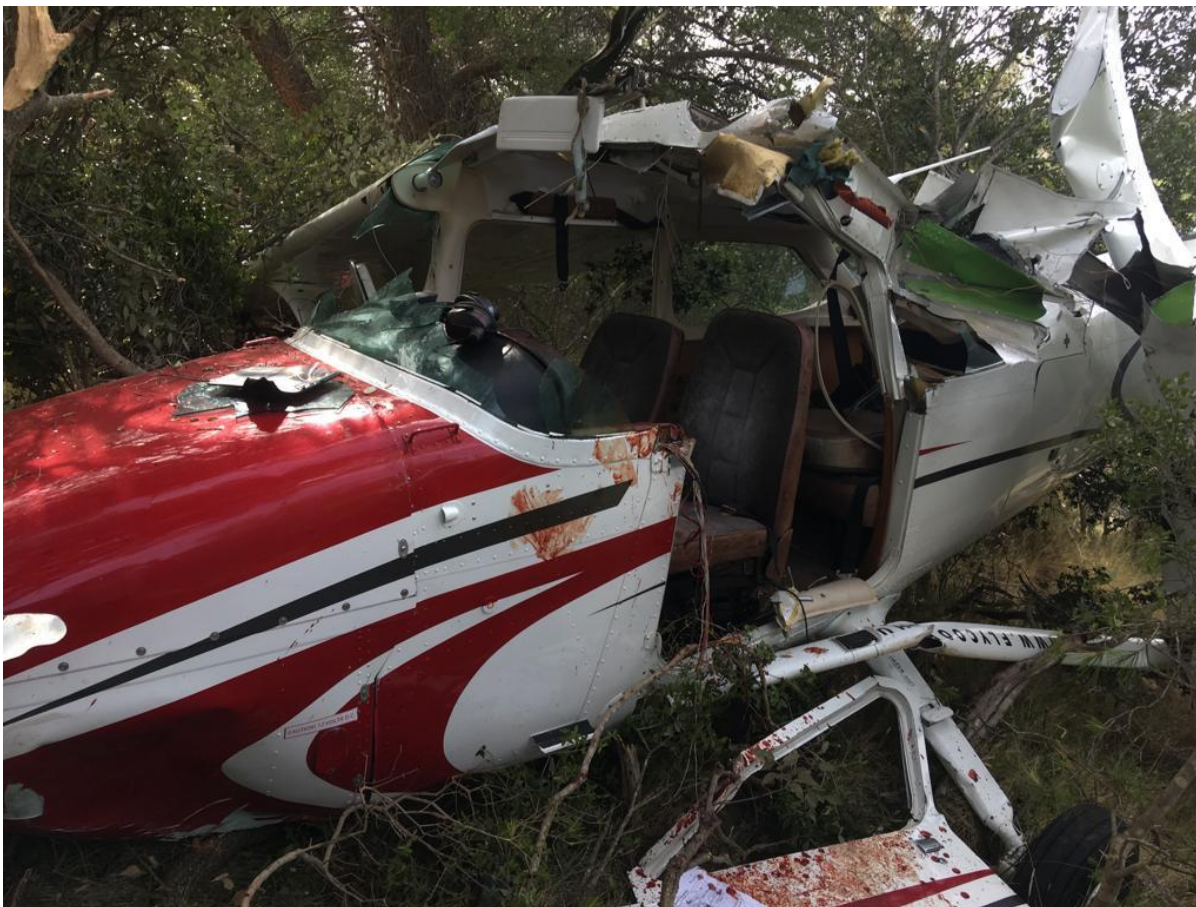
Due to the rupture of the front landing gear and the slope of the terrain, the aircraft fuselage was laid with the tail up, while the front part was on the ground. An inspection of the steel cables for controlling the depth and direction of the rudder revealed no technical defects that would affect the controllability of the aircraft in terms of depth and direction.

Picture 15 – Aircraft fuselage

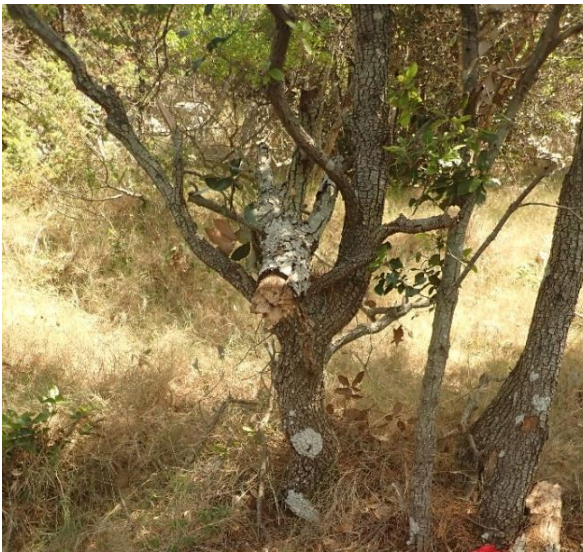
On the line of arrival of the aircraft and its passage through the vegetation, damages to the vegetation on the left side, seen from the aircraft, are visible, while the vegetation on the right side remained undamaged. Also, on the left side of the line of passage of the aircraft, scattered debris torn from the tip of the left wing (the tip of the left wing is significantly damaged, while there is no such damage on the right wing).

Picture 16 – A broken branch on a nearby tree

Damages to the vegetation around the accident site indicate that, just before the crash, the aircraft passed through bushes and small trees with its left wing, which means that it was tilted to the left side along its longitudinal axis. This is also confirmed by the debris that fell from the top of the left wing, scattered over a length of about fifteen meters.

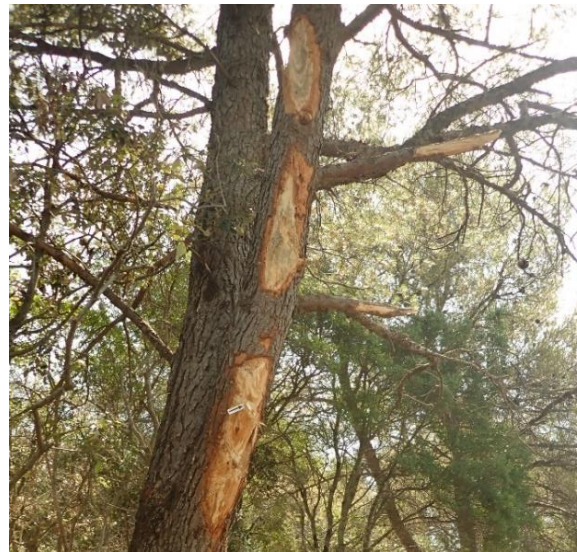
The pine tree next to which the aircraft stopped was cut in three places and the bark peeled off.

Picture 17 – Traces of the impact of the rotating propeller to the tree

The pine tree next to which the aircraft remained lying was cut in three places. These damages were caused by a propeller that hit a tree by its left side. Considering that on this aircraft the propeller rotates to the right, the left side of the propeller moves from bottom to top, so the tree was cut in this manner.

The described damages to the tree indicate that the aircraft hit the tree with the left part of the propeller. The front end of the aircraft with the propeller was at that moment about 4 m above the ground. After hitting the tree, the aircraft fell towards the ground and rotated around the tree, with the propeller cutting the tree two more times.
