**Air, Maritime and Railway Traffic Accident Investigation Agency**

## **FINAL REPORT**

### **ON ACCIDENT OF THE AIRCRAFT Flight Design CT-SW, registration D-MVPP**

**31 March 2023  
Pula Airport**

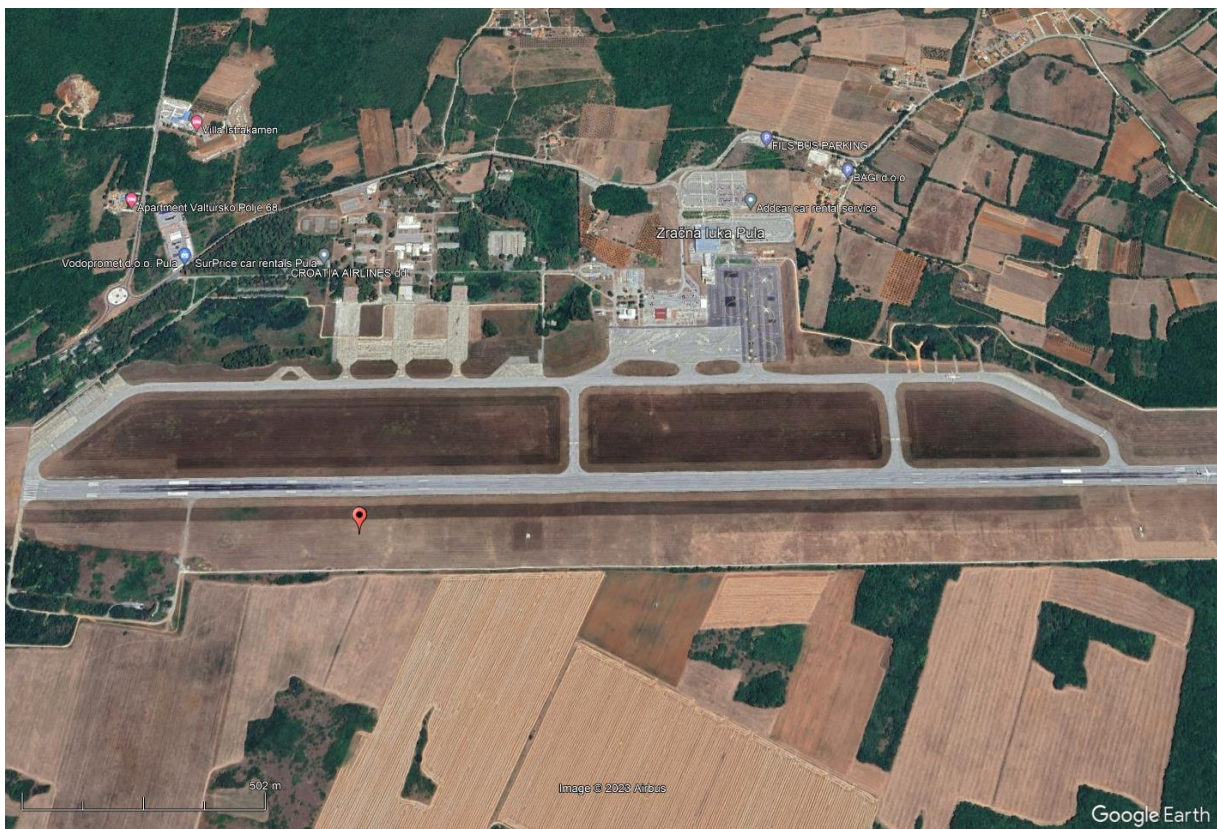
Picture 1 – crash site (red mark) at Pula Airport

The aircraft crashed on a landscaped grassy area inside the airport fence, 70 m to the south, i.e. to the left of the runway in terms of the take-off direction and 753 m before the western end of the runway, i.e. threshold 27.

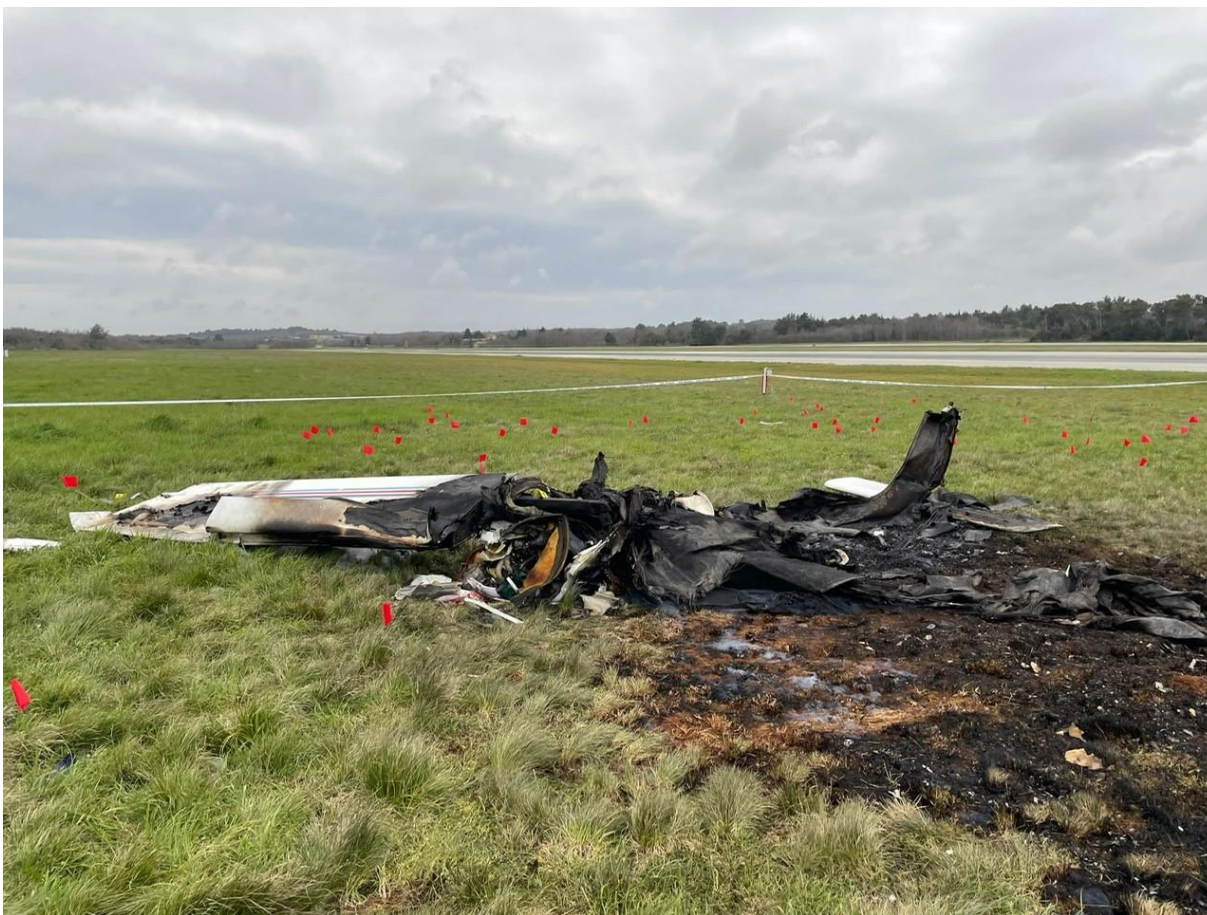
The aircraft was destroyed. After the crash, a fire broke out in which the aircraft's fuselage and left wing were burned completely, while the vertical and left horizontal stabilizer were burned significantly. The outer part of the right wing and the right horizontal stabilizer remained unburnt.

In addition to the described fire damage, there was also mechanical damage: the propeller cone was deformed and pressed into the ground, and the propeller fell apart. The nose leg broke and was found under the forward section of the fuselage, and the main landing gear legs were found broken and lying to the left and right of the fuselage.

Picture 2 - The wreckage of the D-MVPP aircraft at the crash site

The fuselage of the aircraft from the fire wall to the tail, including the instrument panel with the associated instruments, was completely burned. The left wing was also completely burnt. The connection of the right wing to the fuselage was broken, and the wing, although folded to the fuselage, was found rotated around its longitudinal axis so that the leading edge of the wing was facing forward. The tail part of the aircraft was not completely burned but was also significantly damaged by the fire. The propeller was completely disintegrated.

The wreckage of the aircraft was found 70 m south of the runway, lying on its belly in a horizontal position. According to the marks on the ground and the condition of the wreckage, it is evident that the aircraft hit the ground at a small angle. The left wing was completely burned, while the right wing was laid perpendicular to the fuselage but rotated 180° around the longitudinal axis. The left side of the aircraft was more damaged in the fire, and numerous smaller parts were found on that side of the aircraft scattered on the surrounding terrain, which points to an explosion.
