THE REPUBLIC OF CROATIA
Air, Maritime and Railway Traffic Accident Investigation Agency
Air Traffic Accident Investigation Department

CLASS: 343-08/23-03-03
No: 699-04/3-8
Zagreb, 4 June 2024

FINAL REPORT
ON SERIOUS INCIDENT OF AIRCRAFT SAAB 340A,
REGISTRATION HA-TAD
8 MAY 2023,
ZAGREB INTERNATIONAL AIRPORT – FRANJO TUĐMAN

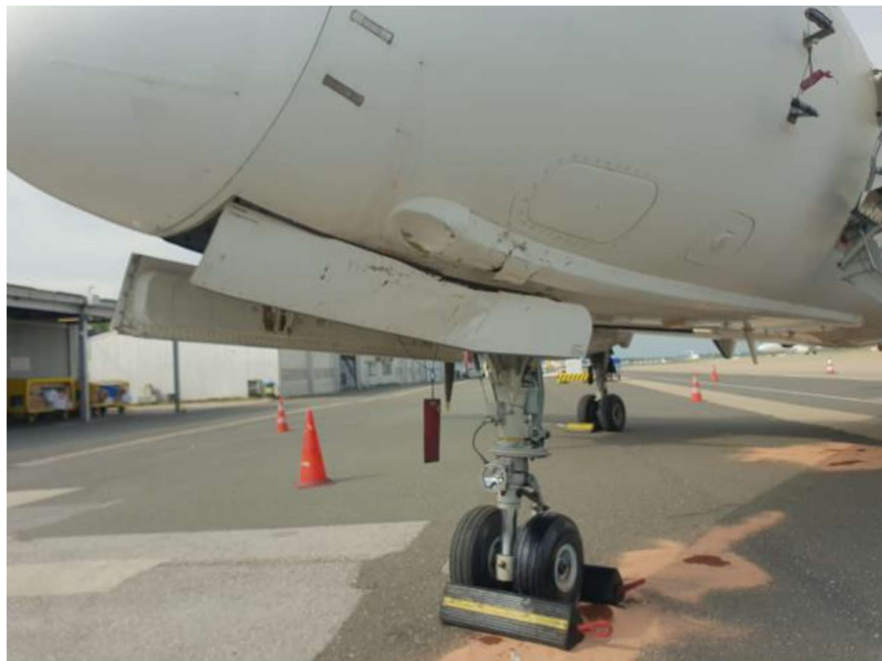
In this incident, as a result of the aircraft hitting the vehicle, both doors of the nose landing gear bent and broke in some places. The glass-plastic lining on the left side of the nose part of the fuselage, above the nose landing gear, broke and the hydraulic pipe, which is protected by said lining, bent and broke. Hydraulic oil leaked from the mentioned pipe, traces of which can be seen on the nose landing gear. The driving light on the front of the nose landing gear was also damaged.

Picture 1 - nose landing gear door

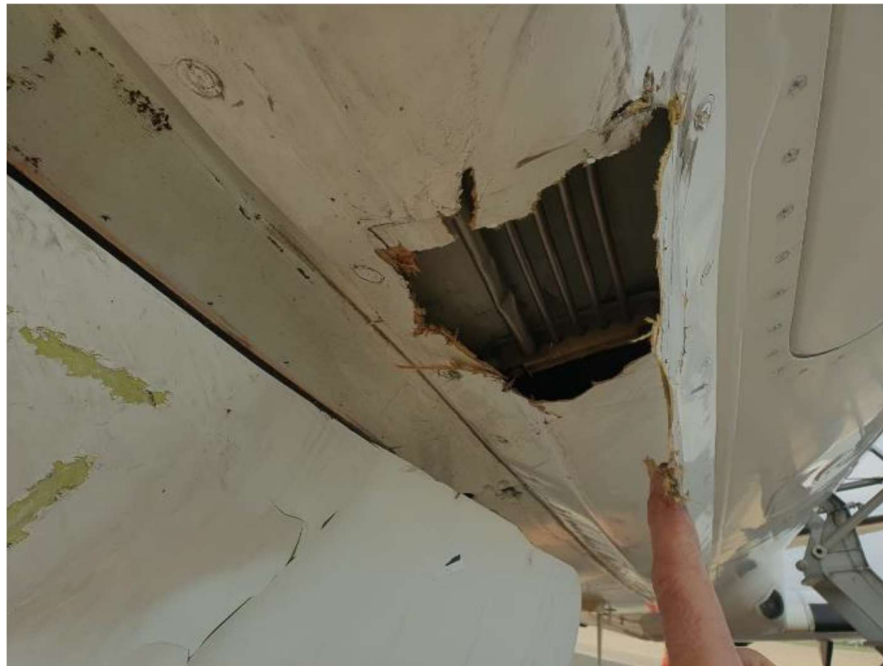
Picture 2 - glass-plastic lining

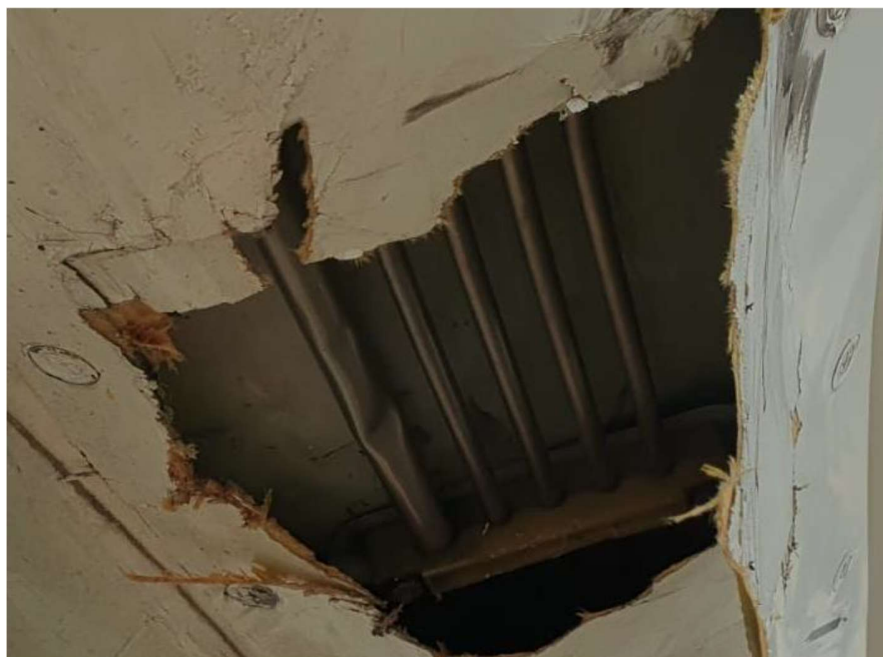
Picture 3 - hydraulic pipe

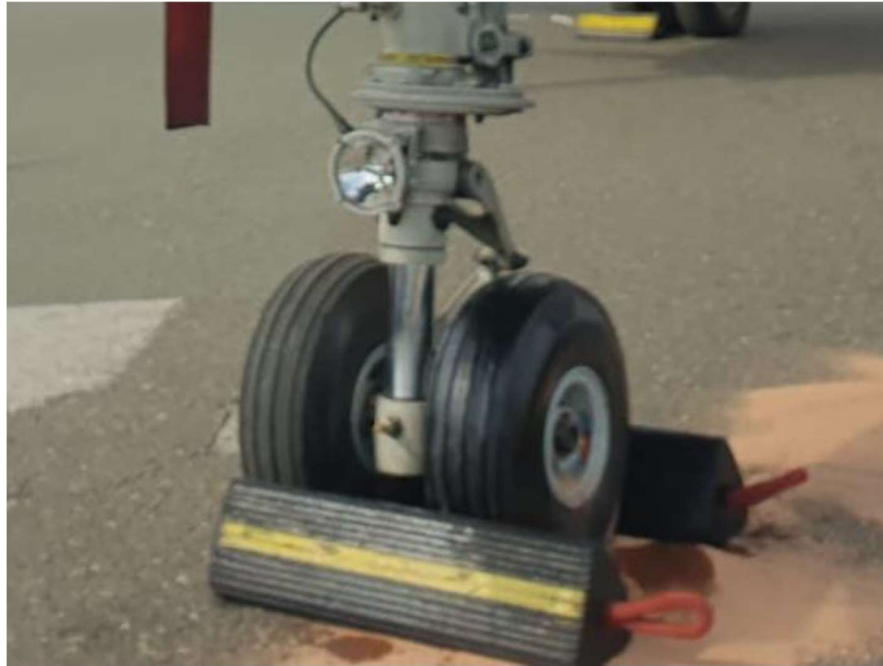
Picture 4 - driving light

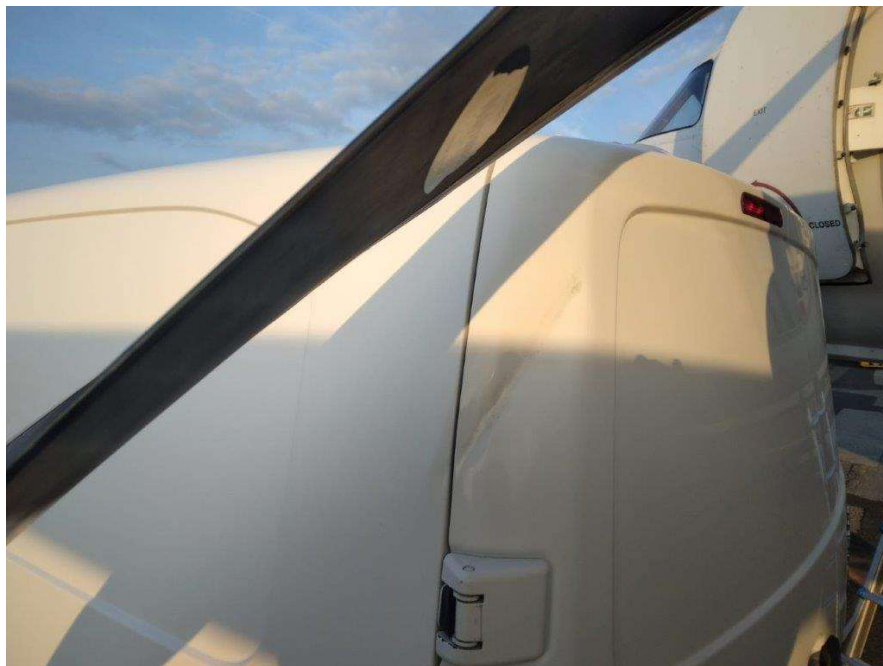
During the uncontrolled movement of the aircraft, it hit two vehicles on the ground. The vehicles were also partially damaged.

Picture 5 - damage to the van

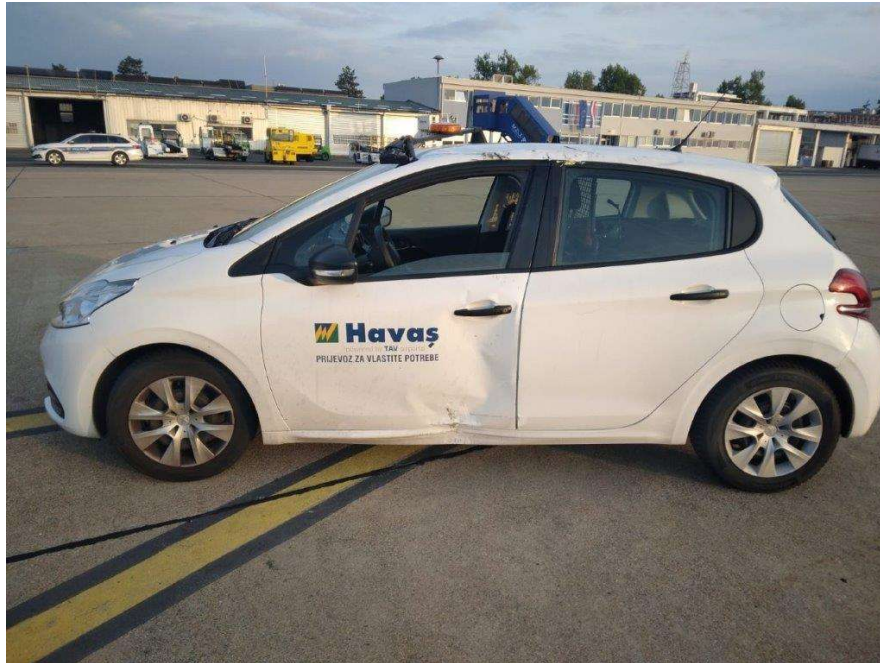
Picture 6 – damage to the aircraft staff vehicle

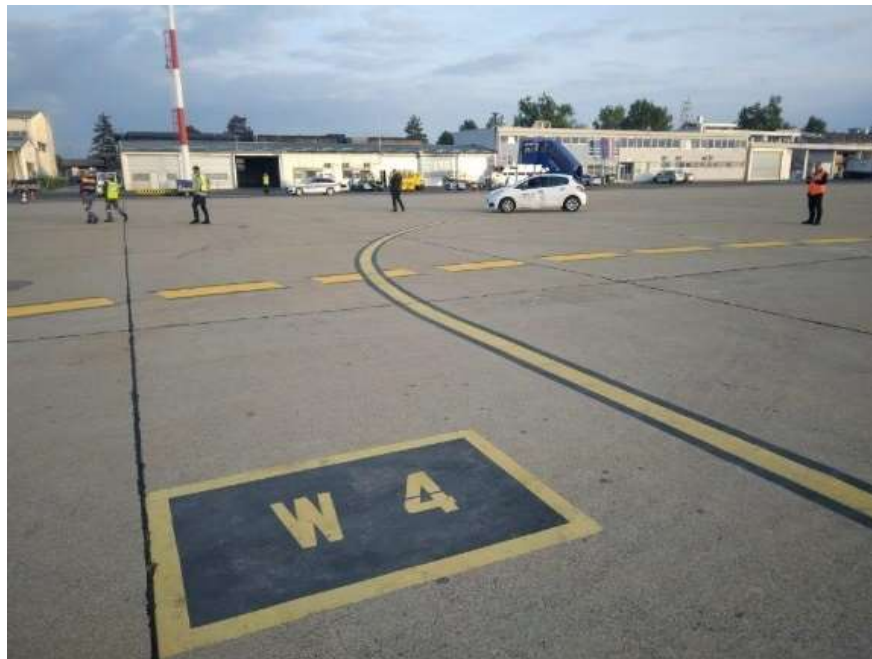
Picture 7 – incident site

The place of the incident was at the airport apron at position W4.

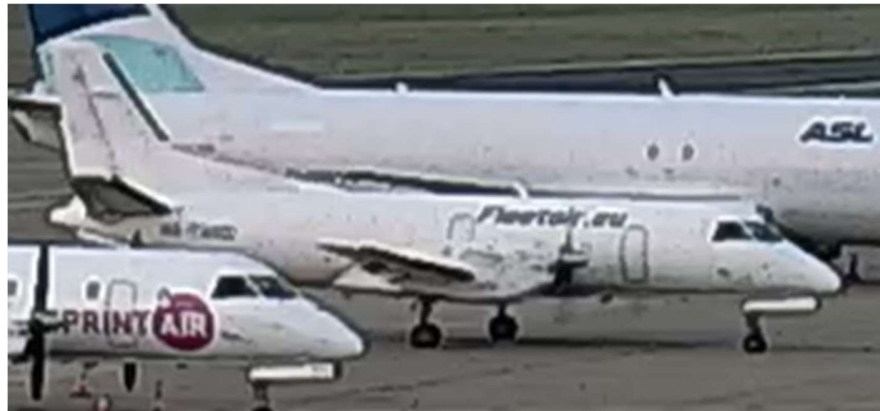
25 seconds passed from the time the aircraft stopped until it started moving again.

Picture 8 - the aircraft shortly before starting to move again

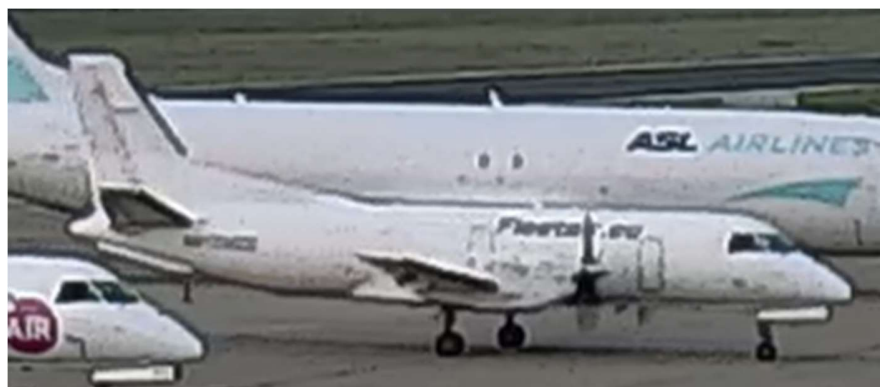
On the recording, approximately 3 seconds after starting the aircraft from the parking position, a change in the angle of attack of the blades and a decrease in the speed of rotation of the propeller can be seen.

Picture 9 - the aircraft shortly after starting to move again
