**PRELIMINARNO IZVJEŠĆE / PRELIMINARY REPORT**

1. OPĆENITI PODACI / ACCIDENT/SERIOUS INCIDENT IDENTIFICATION		
a	MJESTO NESREĆE ILI OZBILJNE NEZGODE	Kerestinec
	AREA OF ACCIDENT OR SERIOUS INCIDENT	
b	DATUM NESREĆE ILI OZBILJNE NEZGODE	25 May 2024
	DATE OF ACCIDENT OR SERIOUS INCIDENT	
c	VRIJEME NESREĆE ILI OZBILJNE NEZGODE	15:40 LT (13:40 UTC)
	TIME OF ACCIDENT OR SERIOUS INCIDENT	
d	PROIZVOĐAČ ZRAKOPLOVA	Cessna
	AIRCRAFT MANUFACTURER	
e	TIP ZRAKOPLOVA	
	AIRCRAFT TYPE	
f	MODEL ZRAKOPLOVA	182
	AIRCRAFT MODEL	
g	DRŽAVA PRIPADNOST ZRAKOPLOVA	Hungary
	STATE OF REGISTRY	
h	REGISTRACIJSKE OZNAKE	HA-TUB
	REGISTRATION	
i	OPERATOR ZRAKOPLOVA	Aeroclub 'Tandem'
	AIRCRAFT OPERATOR

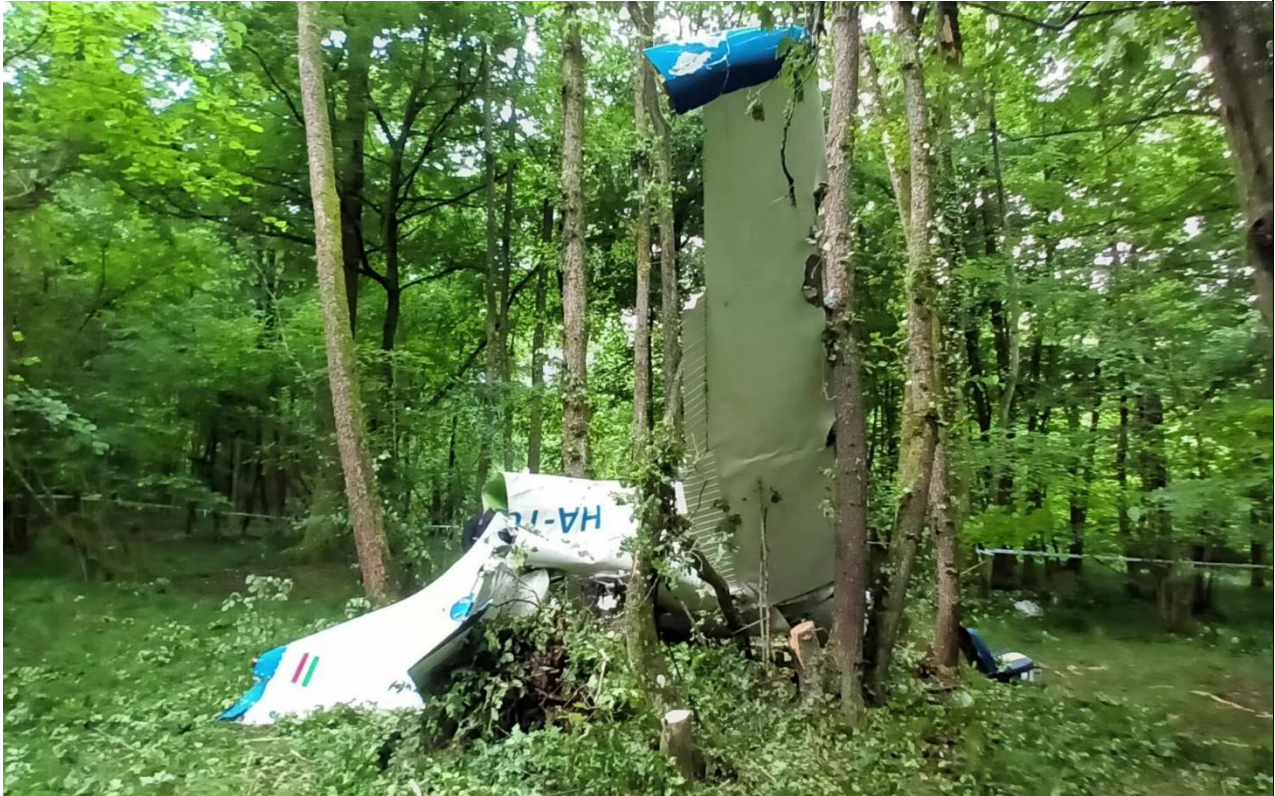
The plane flew into the forest at a low angle. The trees in the forest were up to twenty meters tall. As a result of passing through the treetops, considerable mechanical damage was caused to the plane, and the plane rotated around its longitudinal axis and came to rest on the ground facing on its back. Passing through the treetops gradually slowed the plane, and the stopping distance was long enough to soften the impact to the ground to the extent that most people on board survived. Unfortunately, one passenger – a parachutist – died, while the other four people suffered injuries that were not life threatening.

Picture 1 – the plane wreckage at the crash site

The engine stopped working, the cause of which will be determined in the further course of the investigation.
