# **FINAL REPORT**

## **ON VERY SERIOUS MARINE CASUALTY**

**Collision of boat with registration number “MT 1839” and  
boat with registration number “CZ 111 018”**

**Pelješki kanal, 12 July 2017**

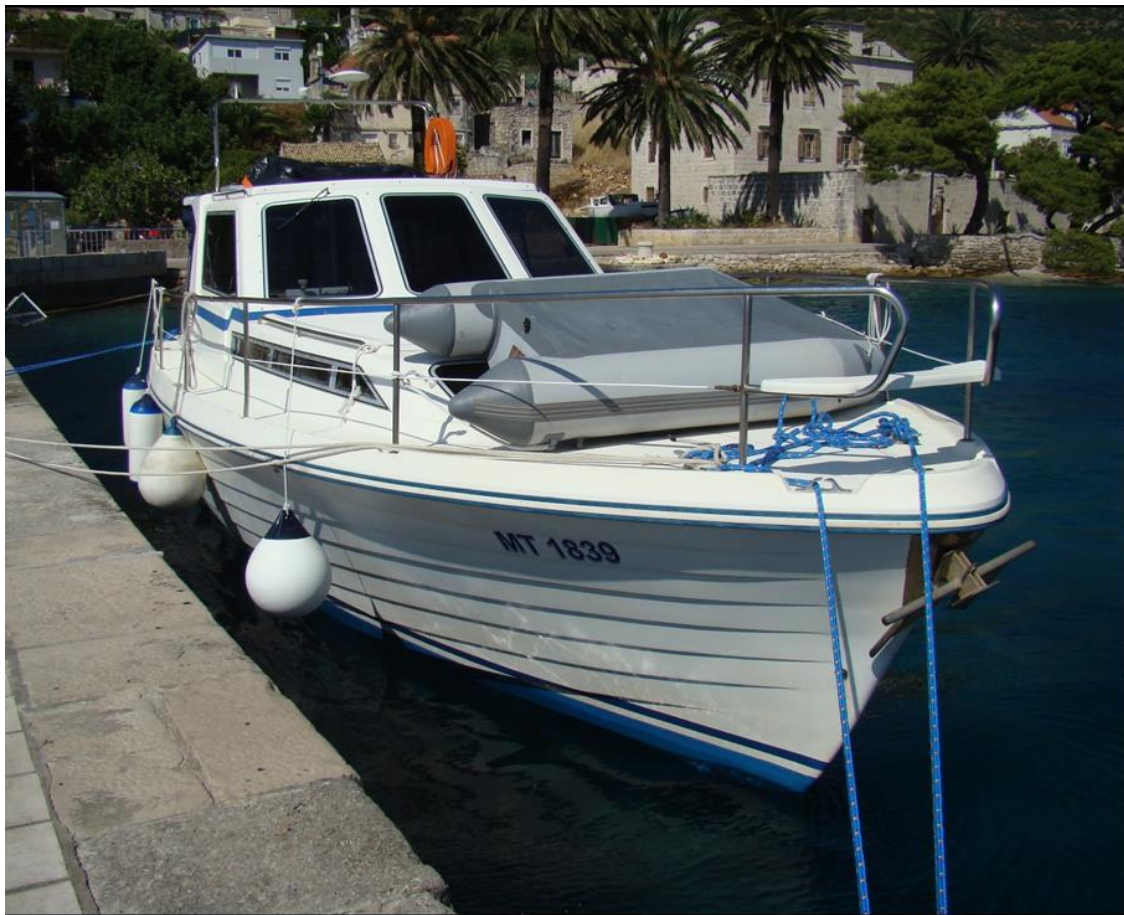
**Picture 1** Boat with registration number "MT 1839" berthed in Kučište after the marine casualty  
*(source: Harbour Master's Office Dubrovnik)*

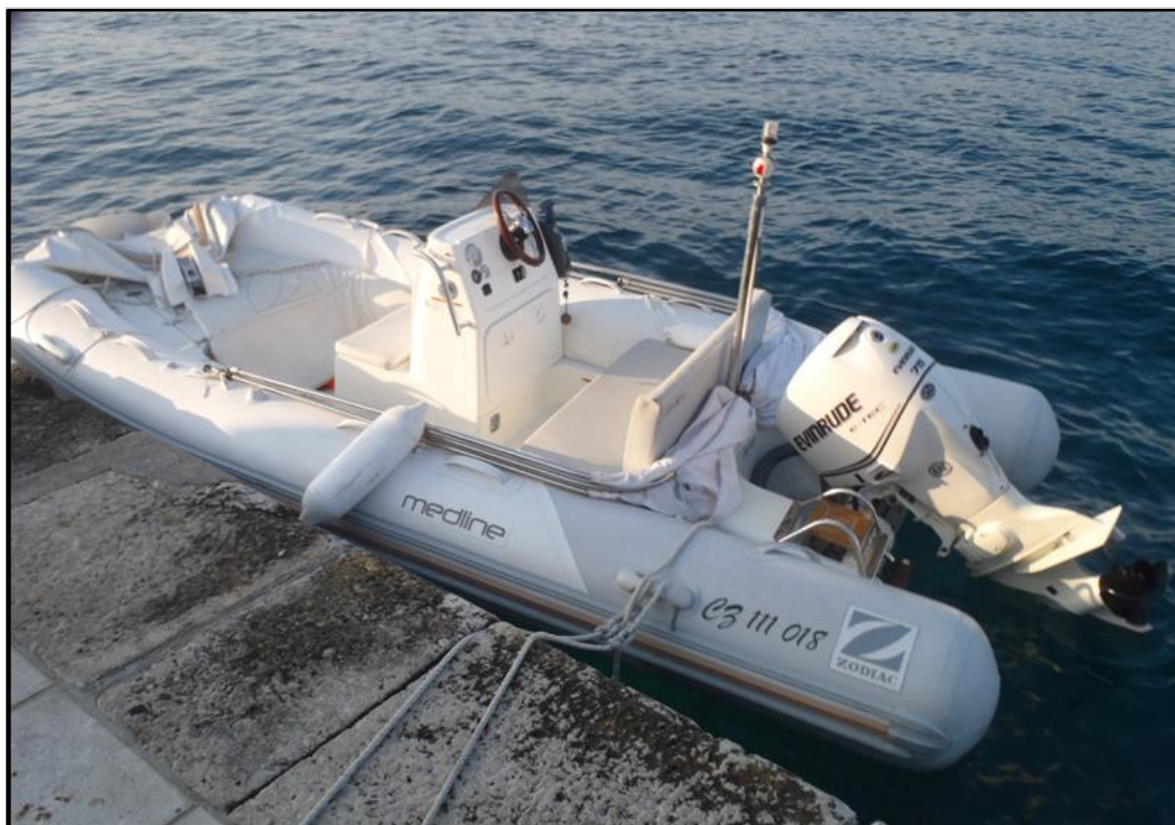
Picture 2 Boat with registration number "CZ 111 018" berthed in Kučište after the marine casualty  
(source: Harbour Master's Office Dubrovnik)
