**Air, Maritime and Railway Traffic Accident Investigation Agency**  
**Air Traffic Accident Investigation Department**

## **FINAL REPORT**

**ON ACCIDENT OF THE AIRCRAFT  
CESSNA 182, registration OE-DDU**

**Dubrovnik Airport, 25 July 2018**

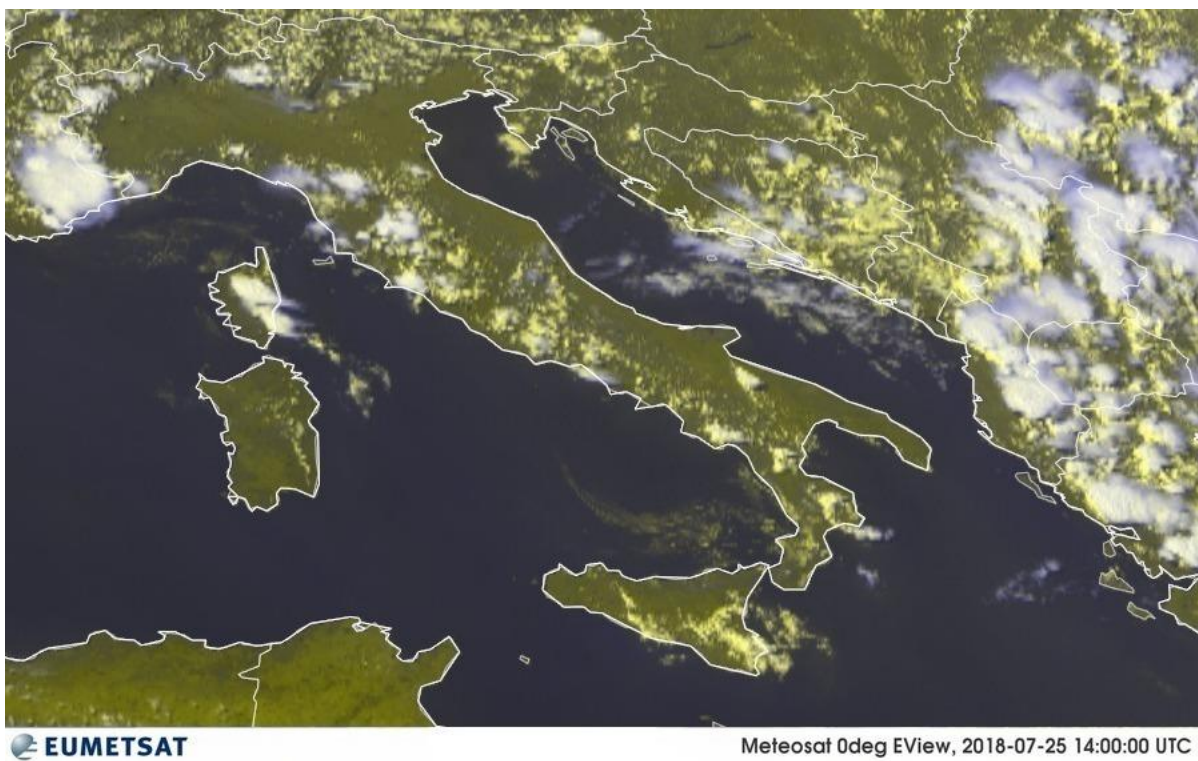
Picture 3 – Satellite images of clouds at 16:00 LT

The area of Dubrovnik Airport was located on the edge of shallow cyclones with the centre in the Black Sea, whose small valley extended to the Adriatic, supporting an unstable weather. The unstable situation was confirmed by satellite images at 16:00 and 17:00 LT (Pictured 3 and 4) showing the intensive development of cumulus and cumulonimbus clouds.

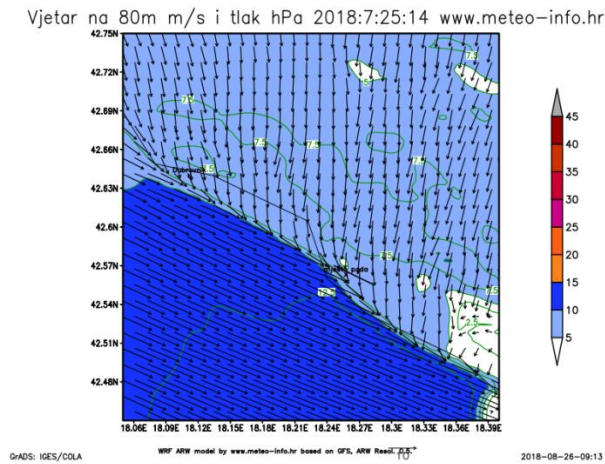
Picture 5 – Wind at 80m, 16:00 LT

- The general wind at 80 m above ground was from the west direction above the mainland and northwest direction above the sea (Pictures 5 and 6). The wind, however, was significantly influenced by local processes - development of clouds, thermal activity, occasional rain showers ...

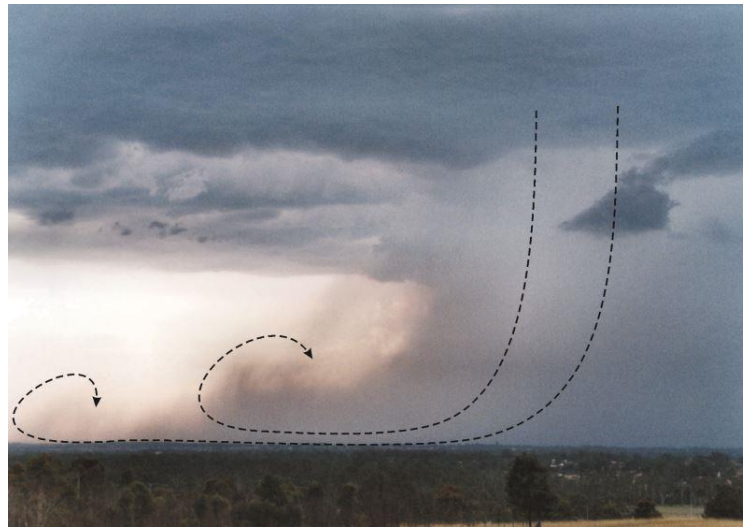
Picture 7 – Example of microburst

- related to the development of the aforementioned clouds, there was also a possibility of forming the so-called microbursts. These are much localized strong downstream airflows which develop beneath cumulonimbus and developed cumulus congestus clouds when they form precipitation in the form of intense local shower (Picture 7). Such a downstream airflow 'spreads' in the lower layer above the ground from the central area underneath the clouds toward out, and turbulence is expected in such situation.
