Air, Maritime and Railway Traffic Accident Investigation Agency

FINAL REPORT

ON ACCIDENT OF THE AIRCRAFT Cessna 182, D-EGLF

Bročanac near Slunj, 29 May 2022

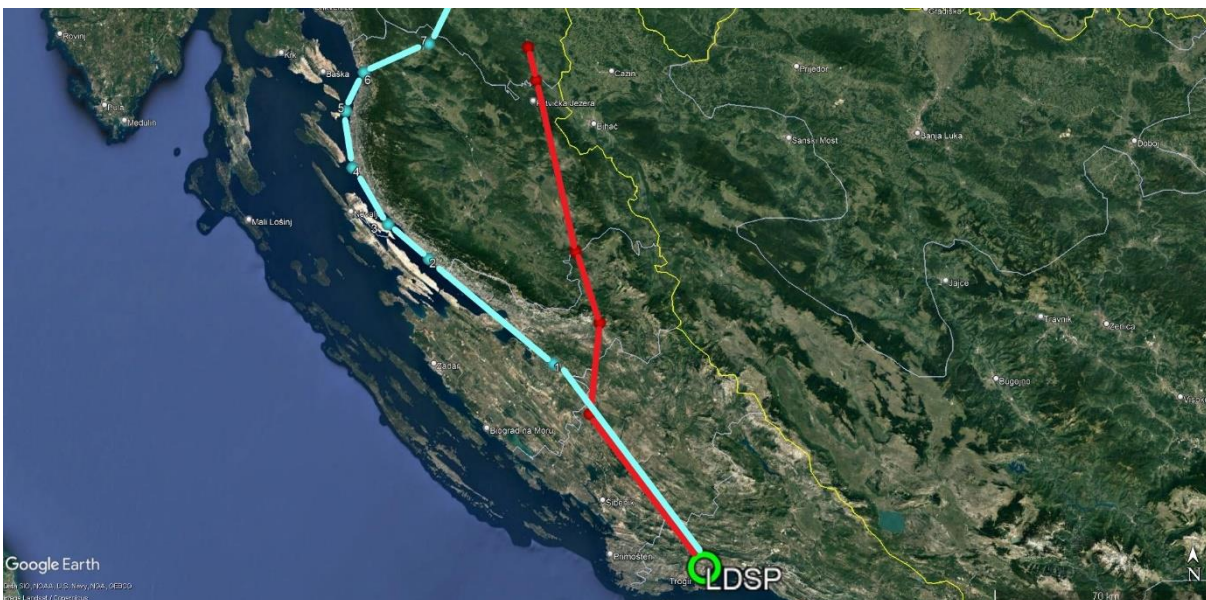
Picture 3 – the actual route the aircraft flew (red line) and the first part of the route reported by the flight plan (blue line)

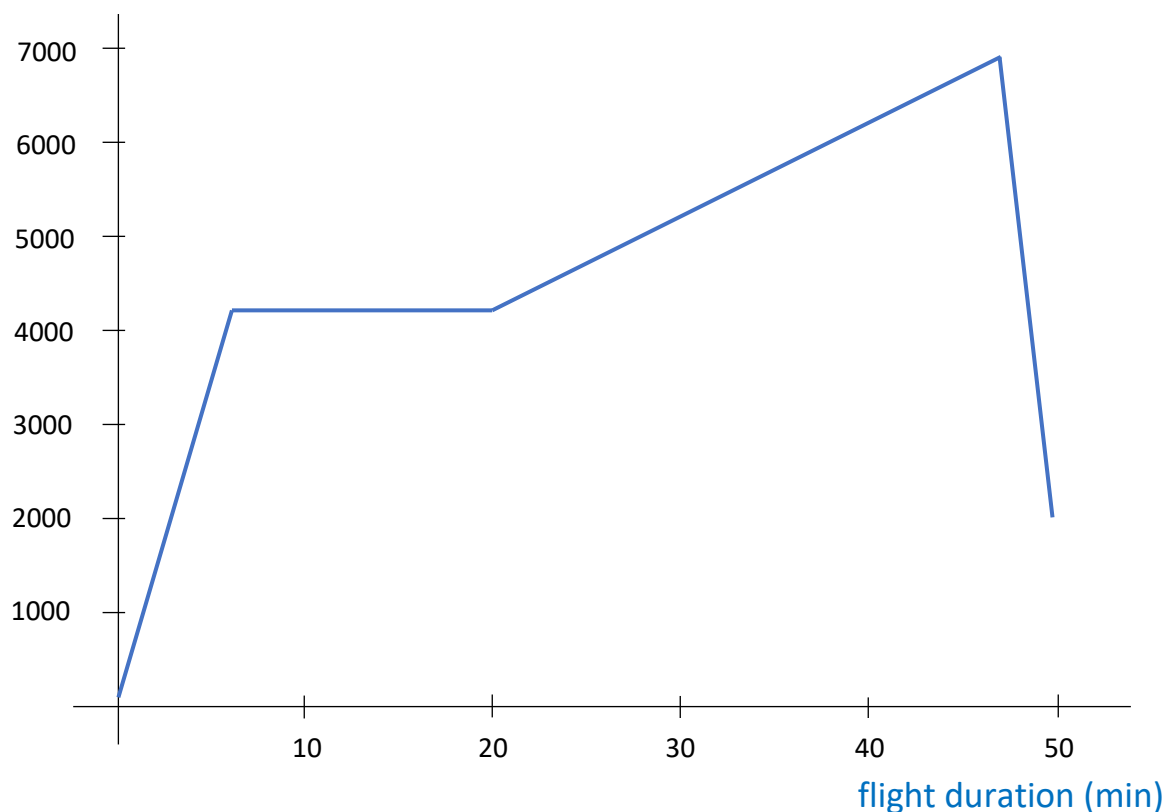
The flight lasted approximately 50 minutes in total. For the first 6 minutes after take-off, the aircraft constantly climbed to an altitude of 4200 ft. The aircraft maintained that altitude until the twentieth minute of the flight, after which the following 27 minutes it gradually increases the altitude to 6900 ft. After that, at 47th minute of the flight, it began to lose altitude for approximately 3 minutes, during which the aircraft descended from 6900 ft to 2000 ft, when it disappeared from the radar.

Picture 4 - display of the altitude of the D-EGLF aircraft during the flight

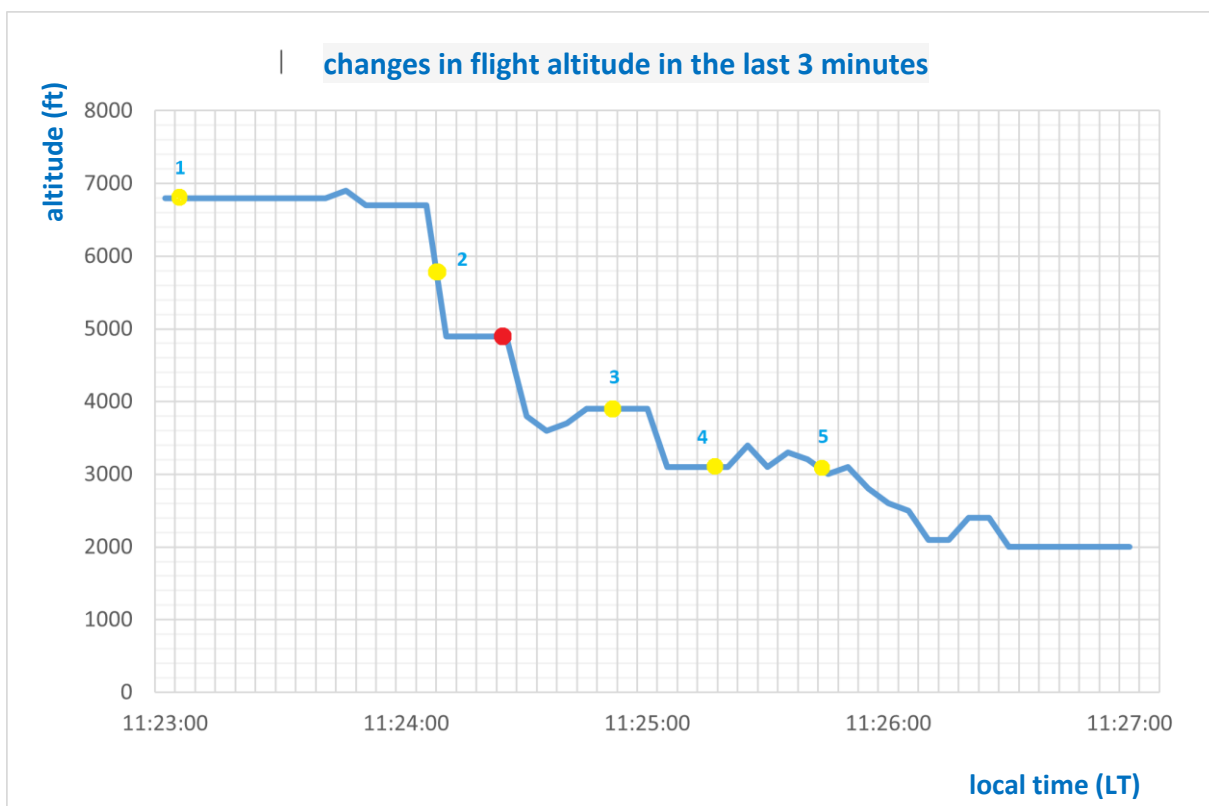
The yellow dots on the diagrams indicate the following communication:

- 1 last communication for the duration of the controlled flight, in which the pilot asked for clarification in finding the OBUTI point;
- 2 the controller gave the pilot clarifications about the position of the OBUTI point, to which the pilot did not respond;
- 3 pilot announced MAY DAY;
- 4 The controller asked for the identification of the aircraft, to which the pilot gave the requested information and repeated MAY DAY;
- 5 When asked by the controller to explain the problem, the pilot replied that he was losing altitude and said 'I have no idea' in German, probably to one of the passengers. That was the last communication between the aircraft and control.
