THE REPUBLIC OF CROATIA
Air, Maritime and Railway Traffic Accident Investigation Agency
Air Traffic Accident Investigation Department

CLASS: 343-08/23-03-03
No: 699-04/3-8
Zagreb, 4 June 2024

FINAL REPORT
ON SERIOUS INCIDENT OF AIRCRAFT SAAB 340A,
REGISTRATION HA-TAD
8 MAY 2023,
ZAGREB INTERNATIONAL AIRPORT – FRANJO TUĐMAN

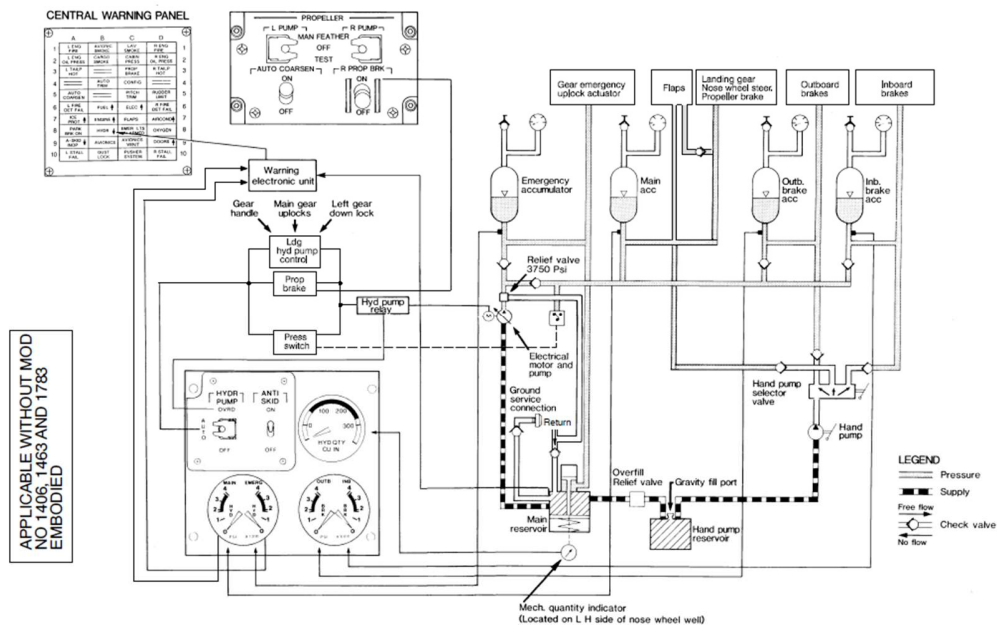
Picture 10 - hydraulic system scheme

The hydraulic system is used to operate the flaps, landing gear, brakes, nose wheel steering and propeller brake. The system is composed of an electrically driven hydraulic pump that provides pressure for four hydraulic accumulators. A hand pump is also installed for emergencies (annex 4 contains details on using a hand pump). The main accumulator provides pressure to operate the flaps, landing gear, nose wheel steering and propeller brake. The emergency accumulator provides pressure to release the emergency landing gear lock. There are two more accumulators that supply the brakes with pressure.

The pump is started automatically in situations when the main accumulator pressure drops below 2100 psi (psi – pound per square inch; 1 psi = 0.06895 bar) and until it rises to 2900 psi, then when landing gear extension is selected and until the left landing gear does not lock in the down position when landing gear retraction is selected until both main landing gears are locked in the retracted position, when the nose wheel steering control is engaged, and when the propeller lock is engaged.

The hydraulic system is also equipped with a hand pump that is used in case of need, i.e. when the electric pump cannot achieve the necessary pressure in the hydraulic system.
